# The Plate and Print Flaws of the 2d Lithograph Pictorial

## Plates 27 and 28

Jerry Weirich

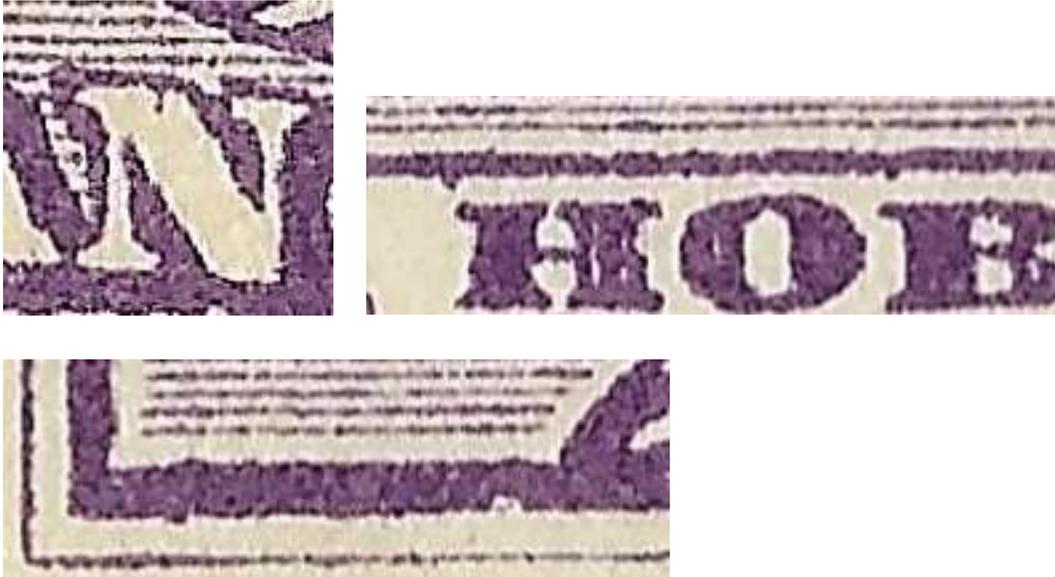
27-3

- a) Vertical color flaw in top of N of Tasmania.
- b) Color spur on color frame above of H of Hobart.
- c) Small color spur on color frame above B of Hobart (not constant).
- d) Nick in base solid color, 4.0 mm from left frame (variable).
- e) Tiny color spur on base solid color, 1.25 mm from left frame (variable).

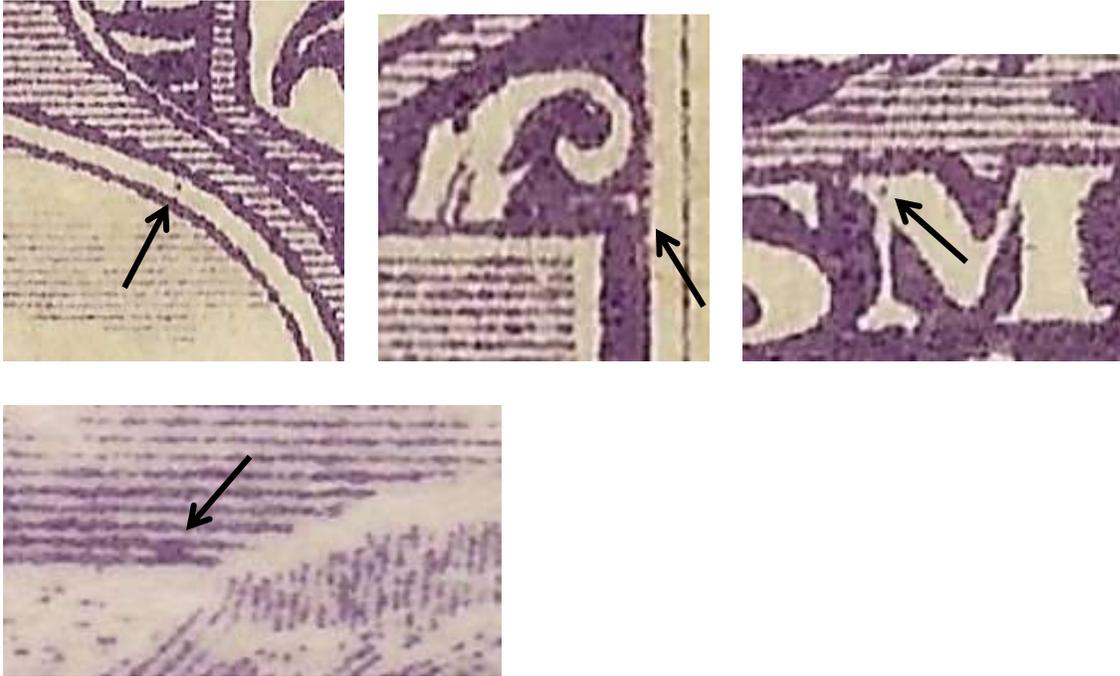
27-5

- a) Color dot between vignette frames at upper right.
- b) Small white flaw in right solid color, 6.75 mm below top frame (variable).
- c) Color dot in top left of M of Tasmania (not constant).
- d) Color flaw on skyline left of mountain summit (not constant).

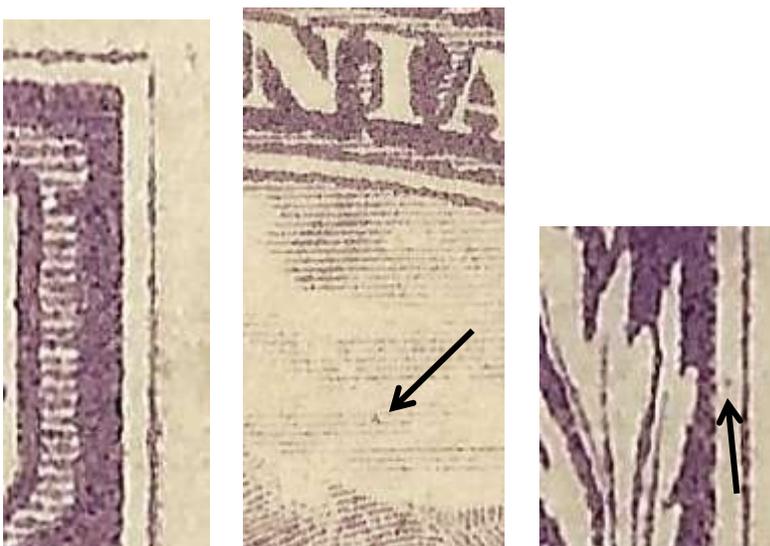
27-6

- a) Thinned top right frame, with thinned or broken top right frame in later printings (variable).
- b) Small color flaw in sky, about 1.5 mm above mountain skyline and below I of Tasmania.
- c) Small color dot inside right frame, 10.0 mm above bottom frame.

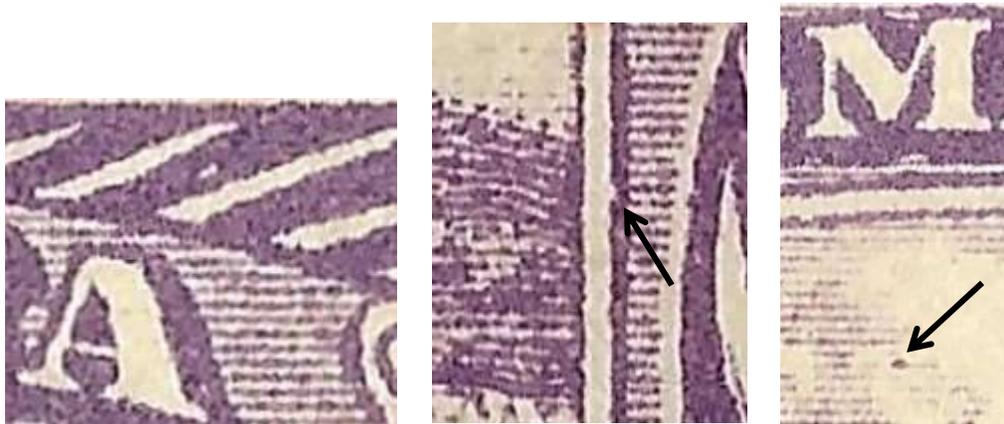
**27-7**

- a) Small white flaw between 7<sup>th</sup> and 8<sup>th</sup> spoke from right.
- b) Shallow notch in right outer vignette frame, 12.0 mm below top frame.
- c) Color flaw in sky below M of Tasmania, 6.0 mm below top frame.

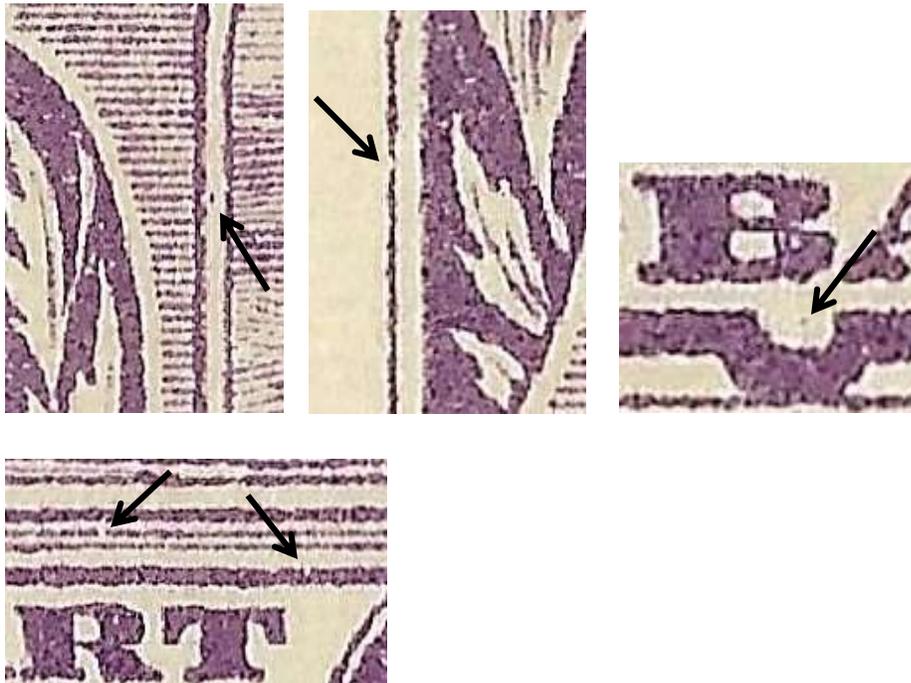
**27-9**

- a) Color dot between left vignette frames, 10.75 mm below top frame, and adjacent to 24<sup>th</sup> shading line down.
- b) Notch in left frame, 6.25 mm above left corner.
- c) Tiny color dot in center of arc below B of Hobart.

- d) Tiny nick in color frame at top right of T of Hobart (not constant).
- e) Break in panel shading (1<sup>st</sup> line down) above R of Hobart (not constant).

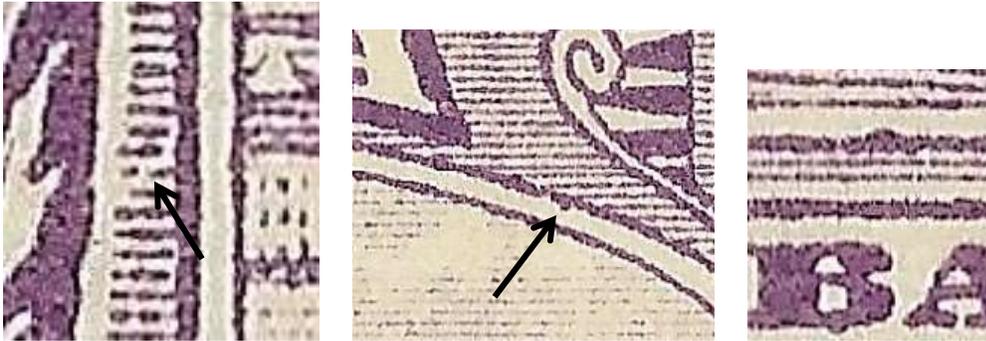
**27-10**

- a) Diagonal white line breaks shading lines in left panel, centered about 9.0 mm above bottom frame (variable). Most frequently, only two lines are seen broken—the 53<sup>rd</sup> line broken near center and the 52<sup>nd</sup> line below broken on left side. Less frequently, the two lines above (the 54<sup>th</sup> and 55<sup>th</sup> lines) are broken at right side.
- b) Small color spur on inside of outer vignette frame at upper right, 5.0 mm below top frame.
- c) Color bulge on lower vignette frame above B of Hobart (variable and not constant).

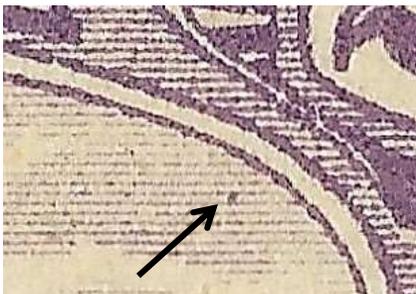
**27-11**

- a) Color flaw in upper right sky, 7.0 mm below top frame.

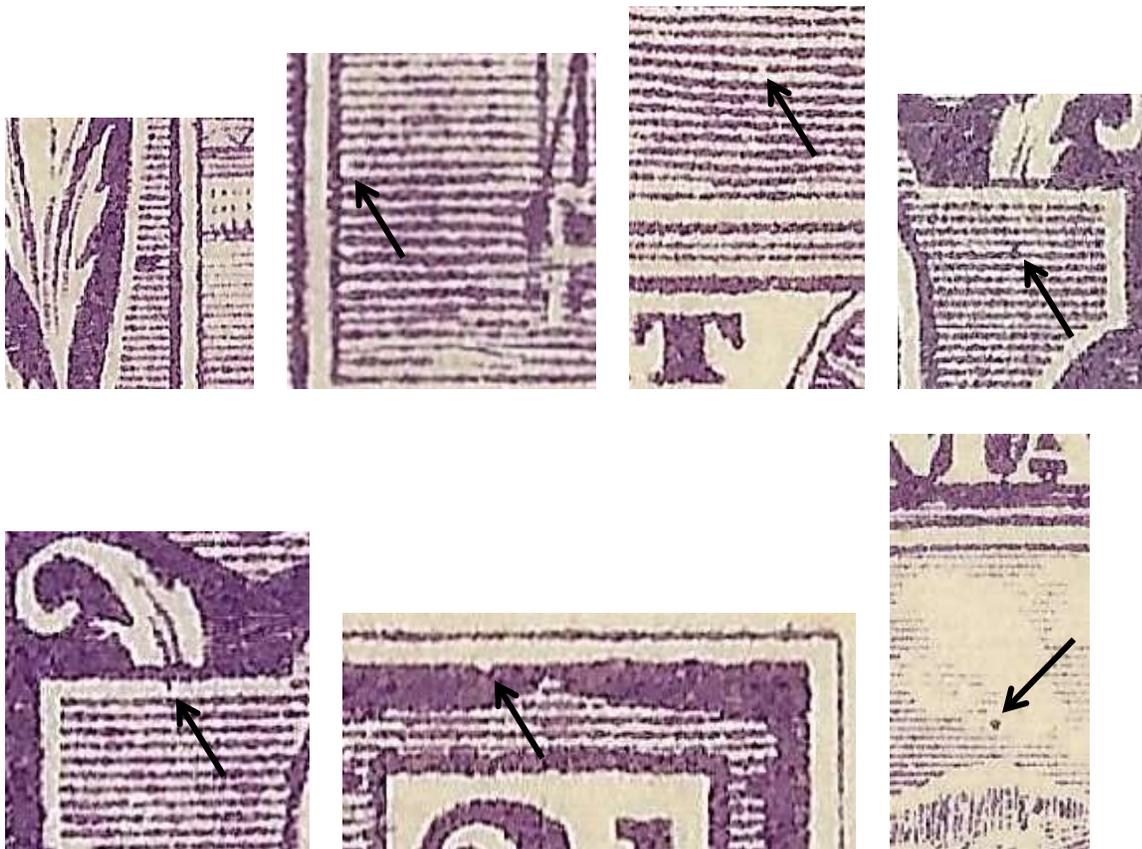
27-15

- a) Color flaw in left panel, 8.0 mm from bottom frame.
- b) Break in left end of water shading (14<sup>th</sup> line up) along inner vignette frame (variable).
- c) Break in water shading (9<sup>th</sup> line up) above T of Hobart.
- d) Small color flaw in upper right panel wing (between 4<sup>th</sup> and 5<sup>th</sup> shading lines down) (variable).
- e) Small color spur into upper left panel wing below topmost fern at left (variable).
- f) Tiny nick in solid color above RVT, 3.75 mm from right frame (variable).
- g) Color flaw in sky above mountain summit (not constant).

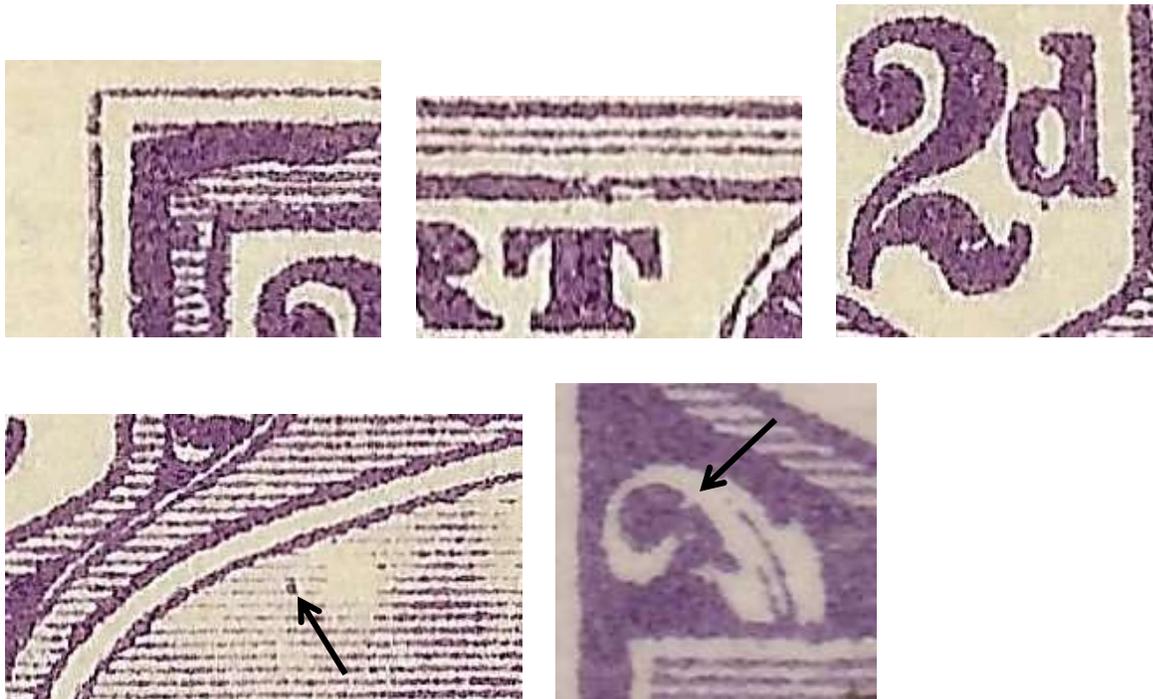
**27-16**

- a) Thin horizontal break in left frame and left color, 0.5 mm below top frame.
- b) White dash in color frame above T of Hobart.
- c) Color dot under d in LVT (variable).
- d) Color flaw in upper left sky (not constant).
- e) Small white spur on inside curve of topmost fern at left (variable).

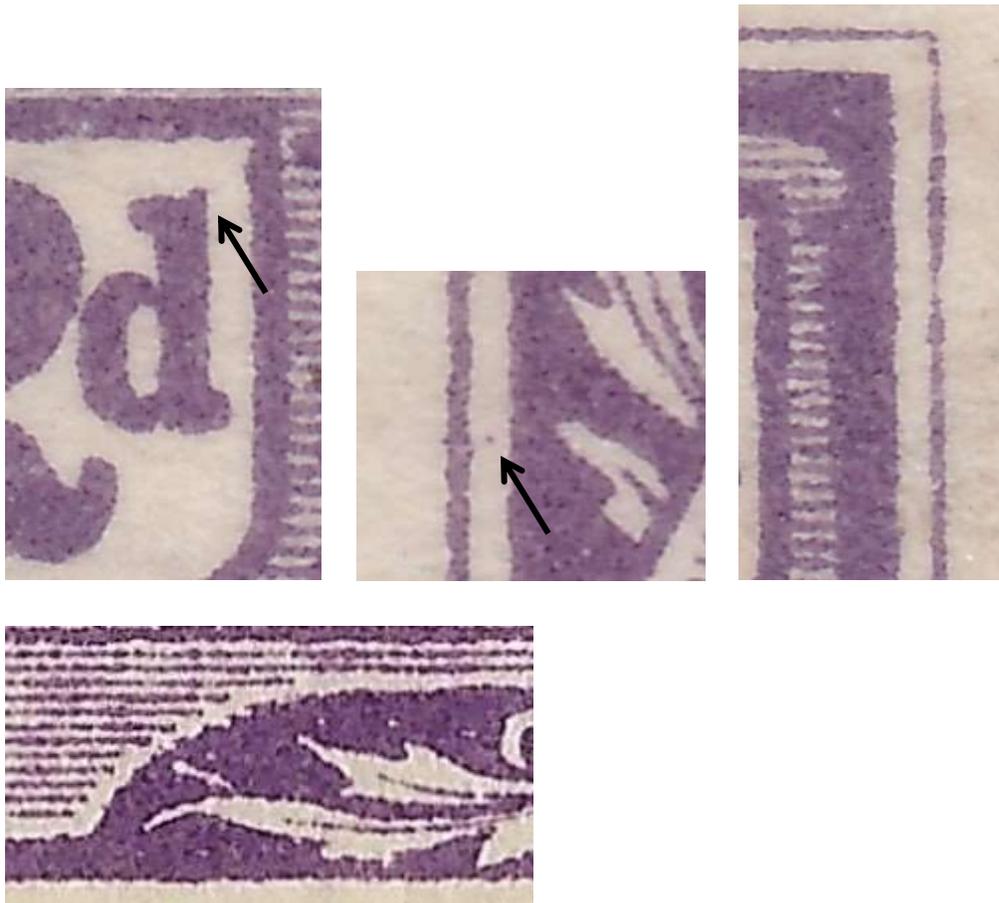
27-17

- a) Master Plate Flaw: Pointed top of d in LVT (variable). Similar flaw on position 17 of plates 23-28. (Also seen on position 17 of at least some of the plates 1-22.)
- b) Color dot inside left frame, 4.25 mm above bottom frame.
- c) Thinned, irregular, and sometimes broken top right frame (variable).
- d) Master Plate Flaw: Irregular edge on curved solid color above and left of the left base ferns (variable). Similar flaw on position 17 of plates 23-28. (Also seen on position 17 of at least some of the plates 1-22.)

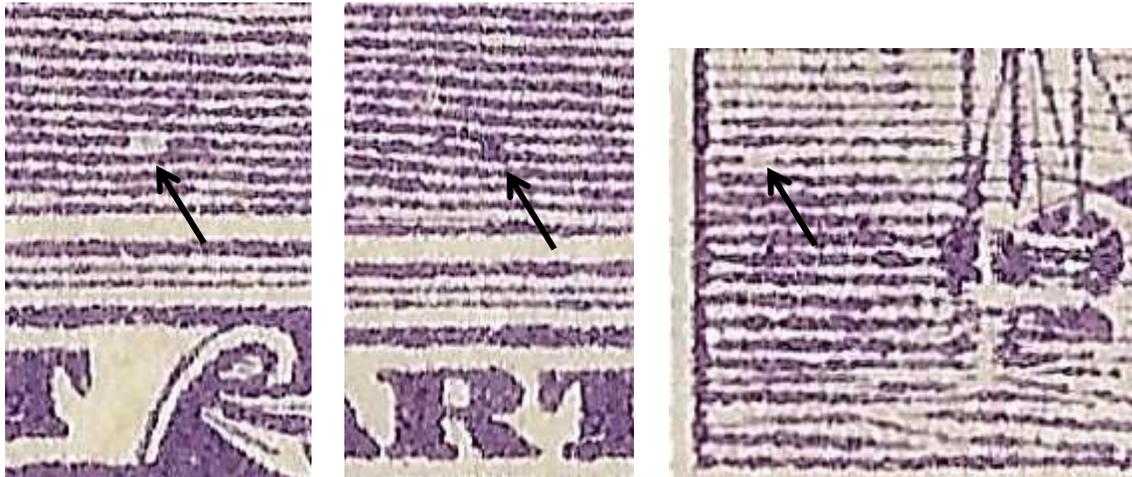
**27-18**

- a) Break in water shading (4<sup>th</sup> line up) over right end of title tablet. Similar flaw on plate 27-28, unlocated variety 1. (See Unlocated Varieties section of this document.)
- b) Color flaw in water (between 4<sup>th</sup> and 5<sup>th</sup> lines up) above R of Hobart.
- c) Break in water shading left of yacht.

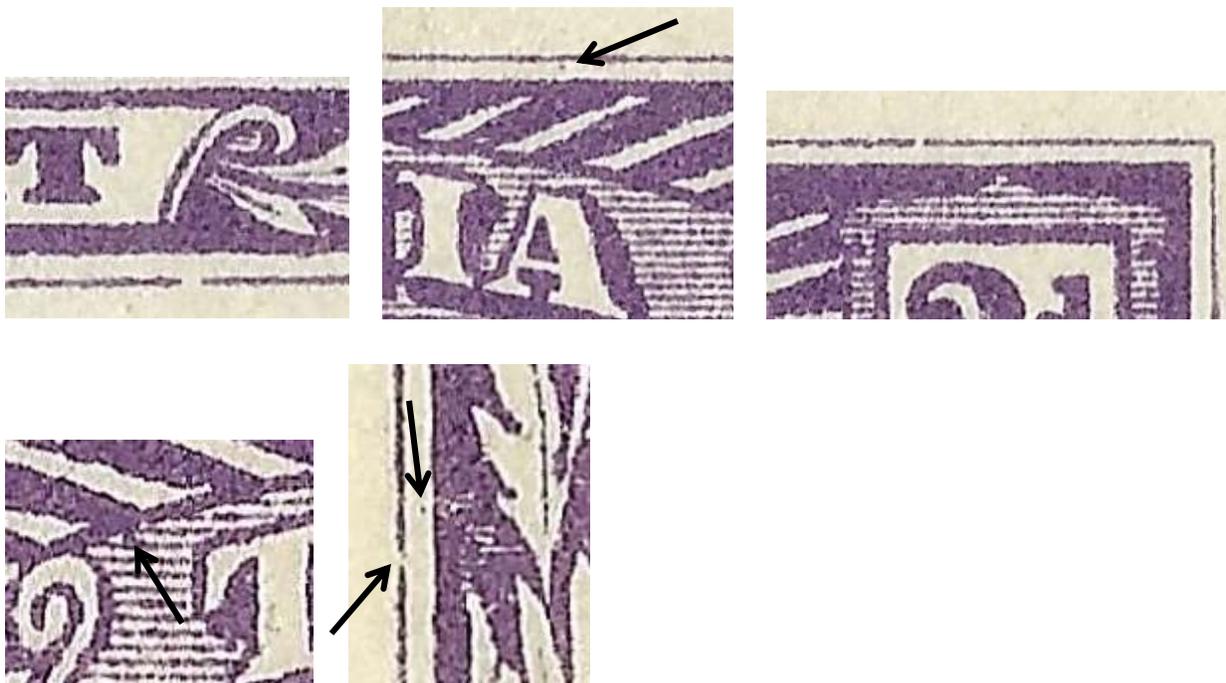
27-22

- a) Break in bottom frame under right end of title tablet, 10.0 mm from right corner. (Similar flaw on plate 27, position 24.)
- b) Color dot inside top frame over third A of Tasmania, 9.75 mm from right frame.
- c) Break in top frame over RVT. 4.5 mm from right corner.
- d) Color dot in upper panel shading between left scroll and T of Tasmania.
- e) Break in left frame, 13.0 mm from top left corner.
- f) Tiny color dot inside left frame, 12.5 mm from top frame (not constant).

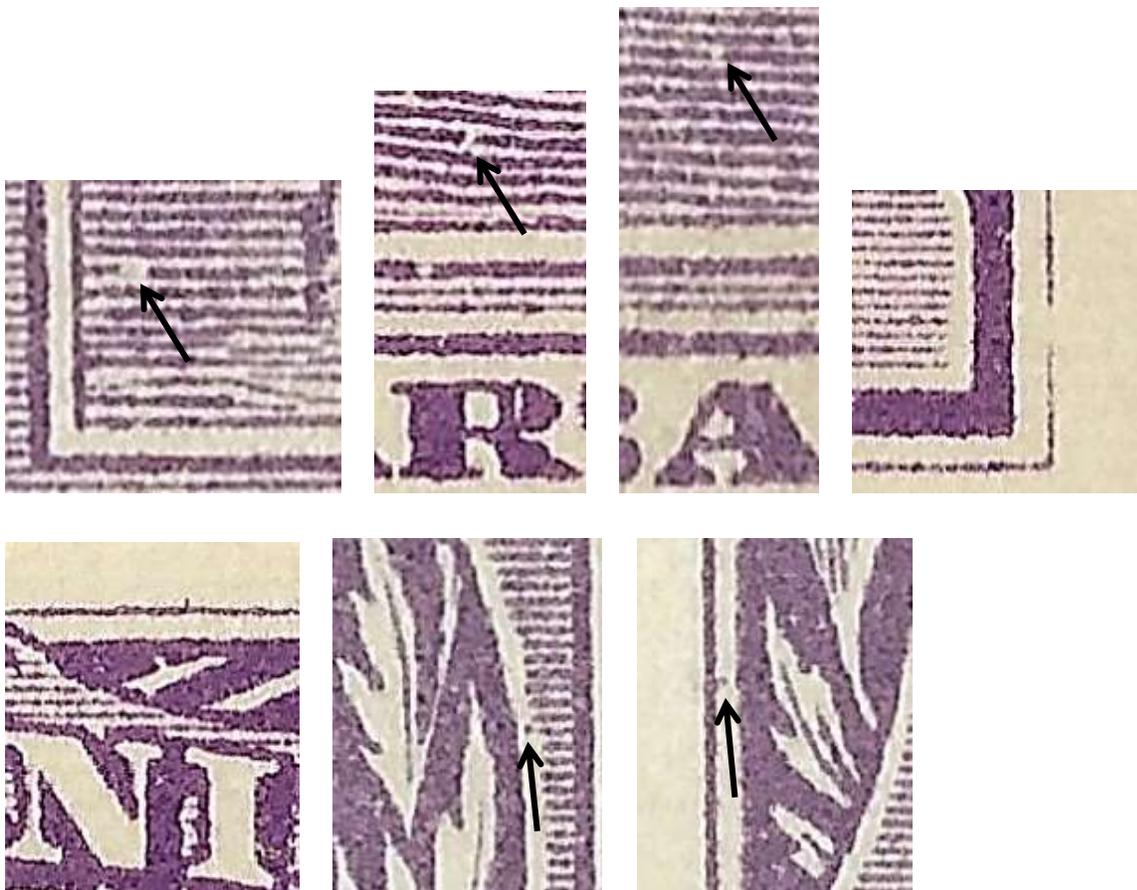
**27-25**

- a) Break in water shading (8<sup>th</sup> line up) just inside left vignette.
- b) Thin break in water shading (5<sup>th</sup> line up) over R of Hobart.
- c) Thin break in water shading (8<sup>th</sup> line up) over A of Hobart.
- d) Break in right frame, 2.0 mm above right corner.
- e) Color spur on top frame above I of Tasmania.

- f) White spur, sometimes a dot, on 10<sup>th</sup> spoke from right (variable and not constant).
- g) Color dot in white margin of left panel, 12.0 mm below top frame.
- h) Color dot inside left frame, 6.0 mm above bottom frame (variable).

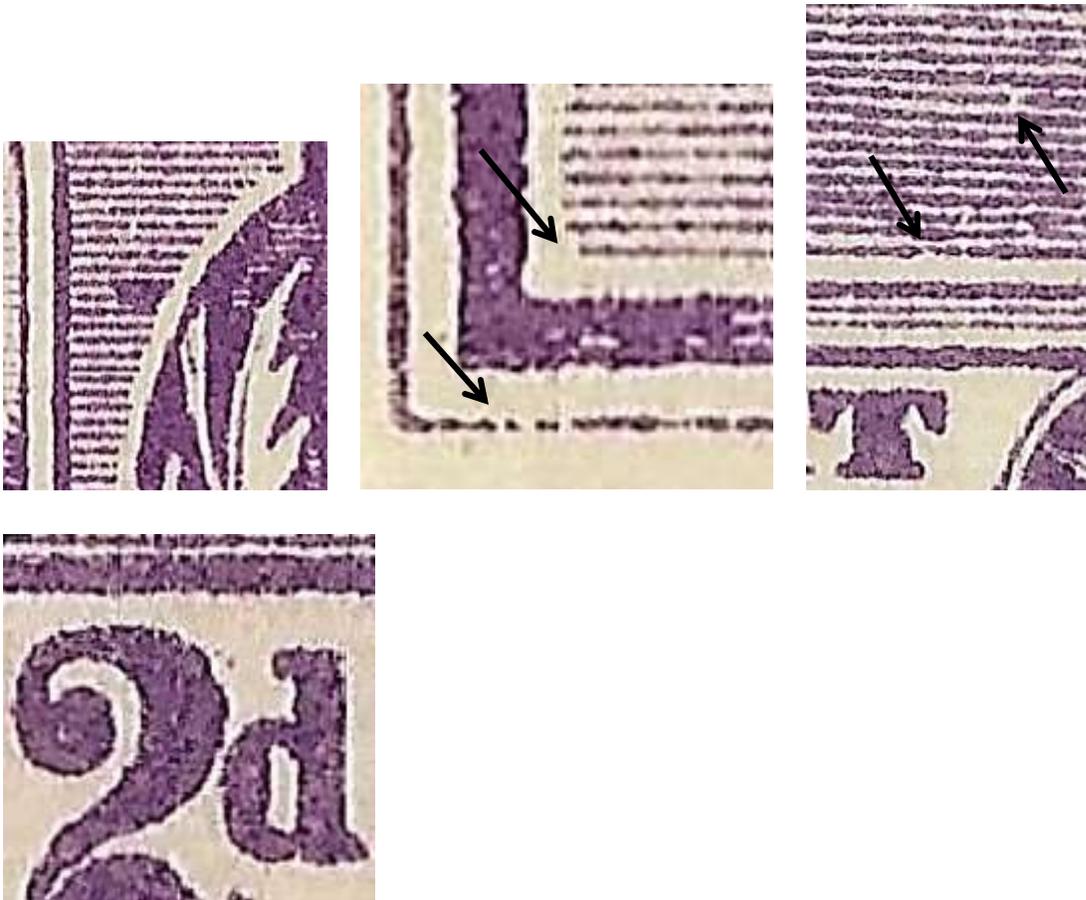
27-26

- a) Color flaw in right panel, 10.0 mm below top frame.
- b) Multiple thin beaks in bottom frame at left.
- c) Shortened shading line at left end of 1<sup>st</sup> line up in lower left panel wing.
- d) Break in water shading (9<sup>th</sup> line up) above right end of title tablet.
- e) Thin break in inner vignette frame above T of Hobart.
- f) Small color dot to top right of 2 in LVT (not constant).

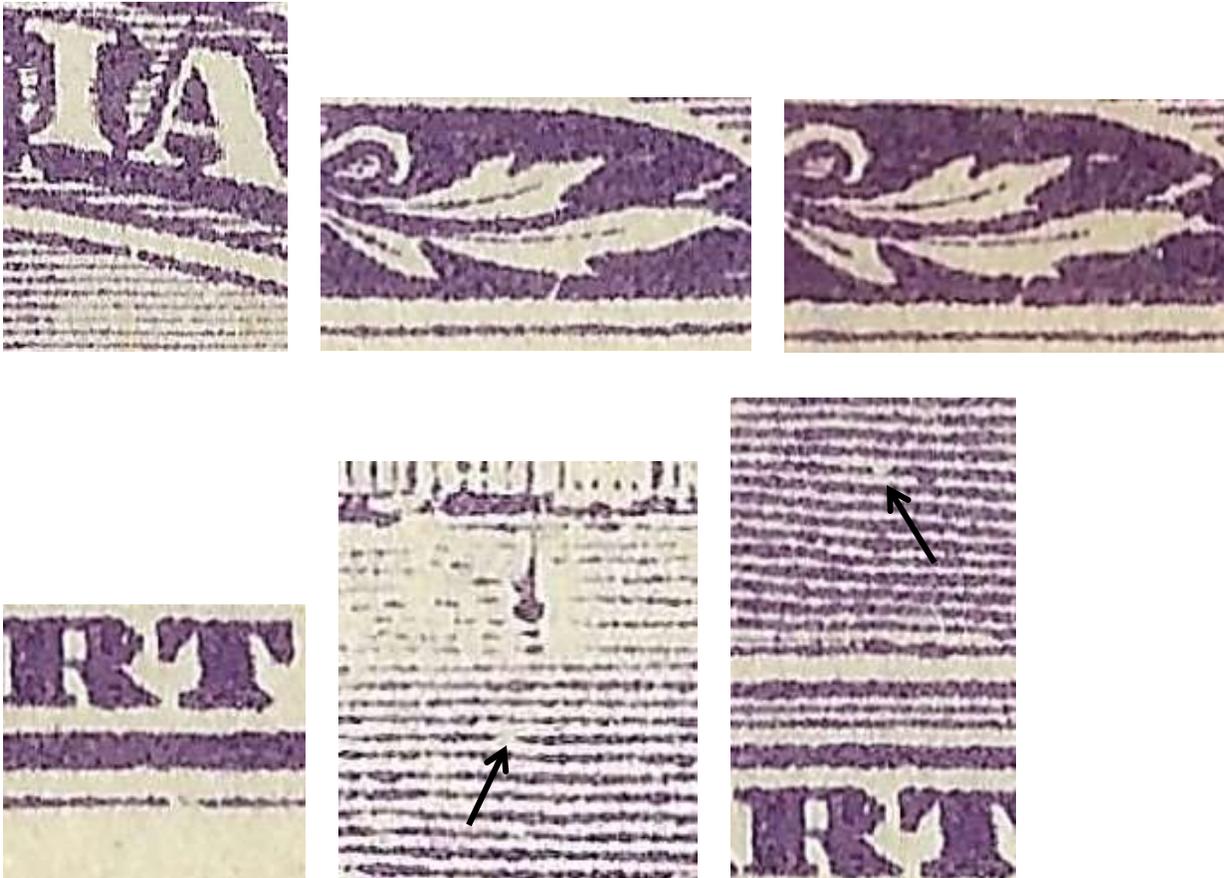
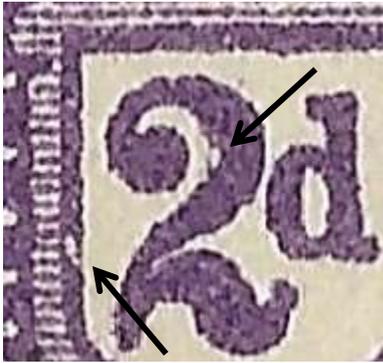
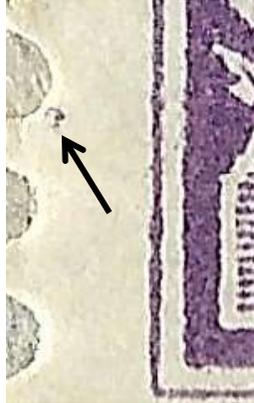
27-28

- a) Break in inner vignette frame below IA of Tasmania.
- b) White line connects right base ferns with lower white margin (variable). The line is frequently broken in the middle. Two scans.
- c) Break in bottom frame below RT of Hobart.
- d) Break in water shading, about 1.0 mm below buoy. Similar flaw on plate 27, position 29.
- e) Break in water shading (10<sup>th</sup> line up) above RT of Hobart.
- f) White flaw in left frame of RVT.
- g) White flaw in 2 in RVT (variable).
- h) Tiny color dot above 2 in RVT (variable and not constant).
- i) Color flaw in left margin, about 3.5 mm above bottom frame. This flaw is frequently cut off by perforations, as a result cannot confirm as constant.

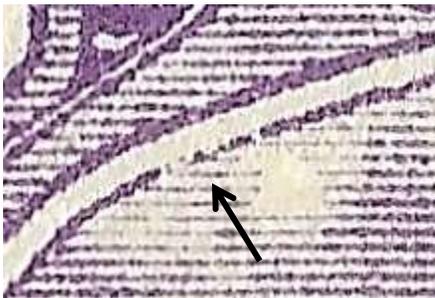
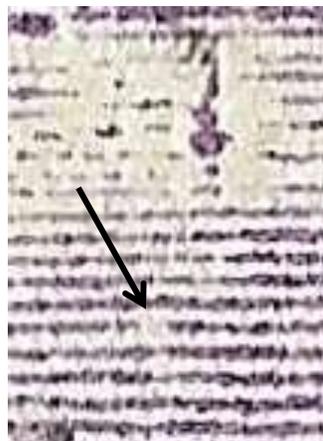
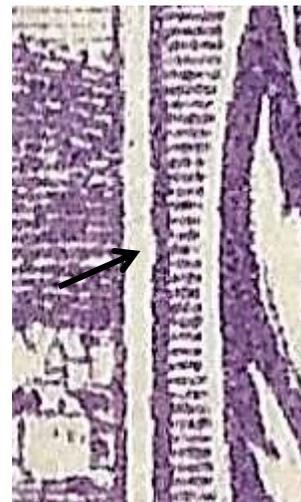
**27-29**

- a) White flaws break inner vignette frame at upper left.
- b) Break in water shading, about 1.0 mm below buoy. Similar flaw on plate 27, position 28.
- c) Shallow notch in outer vignette frame at right near center (variable).
- d) Color dot inside left frame, 3.0 mm from bottom frame (variable).

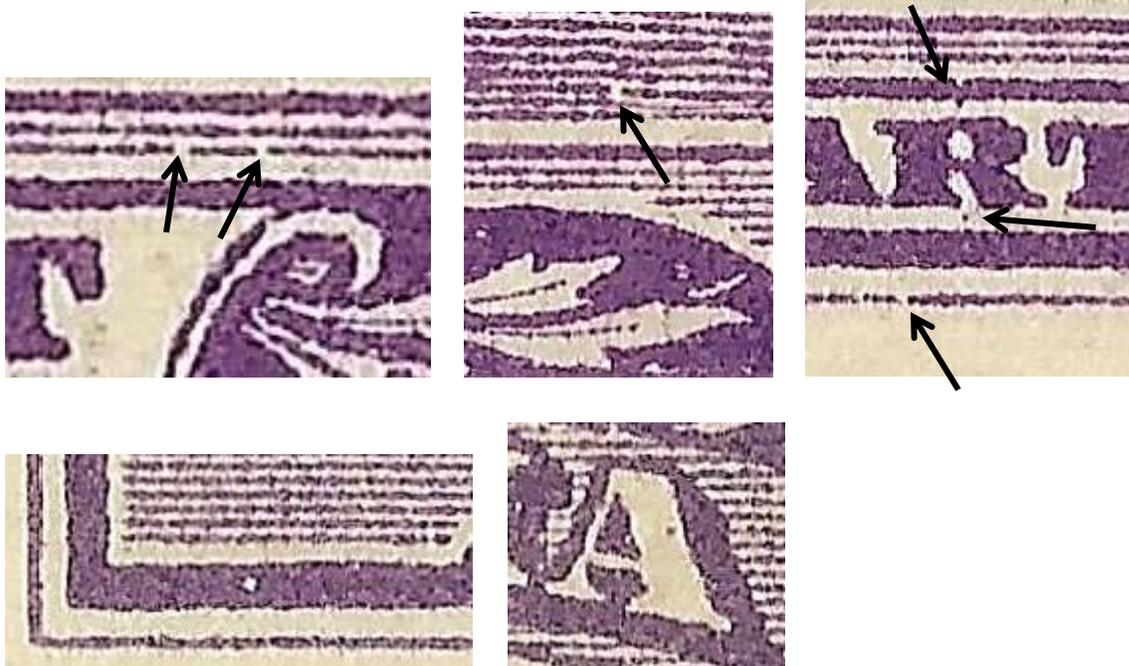
**27-30**

- a) Two breaks in panel shading (1<sup>st</sup> line up) above right end of title tablet.
- b) Break in water shading (2<sup>nd</sup> line up) above right base ferns.
- c) Tiny spur on color above R of Hobart.
- d) Color dot below R of Hobart (not constant).
- e) Thin break in bottom frame below R of Hobart (variable).

- f) White dot in lower left solid color, 2.25 mm from right frame (variable).
- g) Color dot in third A of Tasmania (variable). Similar flaw on plate 28, position 41.

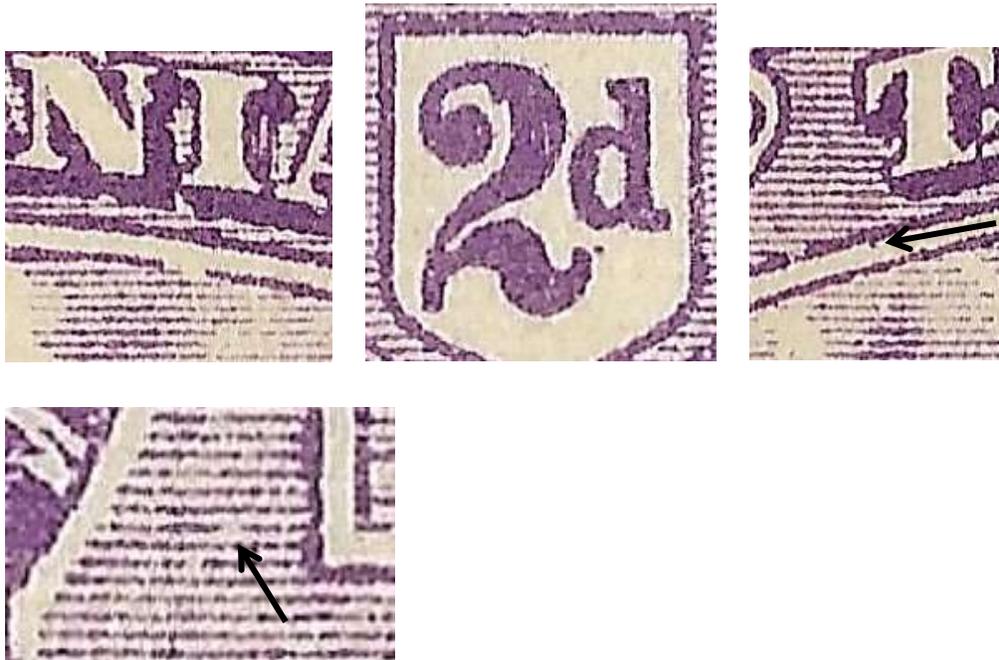
**27-31**

- a) Break in the inner vignette frame below NI of Tasmania.
- b) Color spur on inside top of 2 in RVT.
- c) Color dot adjacent to tip of 2 in RVT.
- d) Color between vignette frames below and to left of T of Tasmania.
- e) Break in left panel shading (16<sup>th</sup> lines up) (variable).

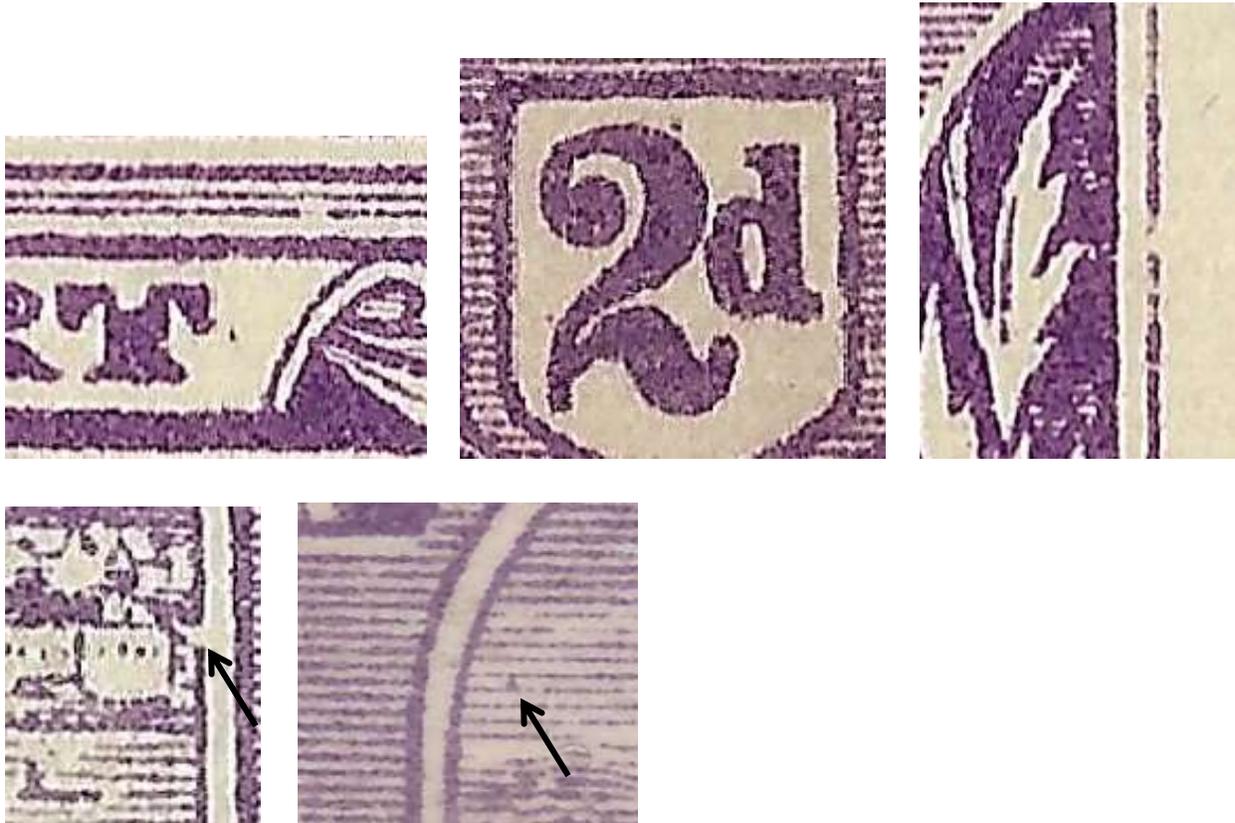
- a) Semi-circular white flaw in top of T of Hobart.
- b) Color flaw after T of Hobart.
- c) Break in panel shading (1<sup>st</sup> line up) above right end of title tablet.
- d) Master Plate Flaw: Two parallel color dashes above 2 in RVT. Top dash variable and not constant. Similar flaw (two parallel color flaws above 2 in RVT) on position 32 of plates 23-28. (Also seen on position 32 of at least some of the plates 1-22.)
- e) Color dot in front near base of 2 in RVT (variable).
- f) Break in center of right frame (variable).
- g) Break in right inner vignette frame level with roof of waterfront building.
- h) Small color flaw in sky at left, between 4<sup>th</sup> and 5<sup>th</sup> lines up from skyline (variable).

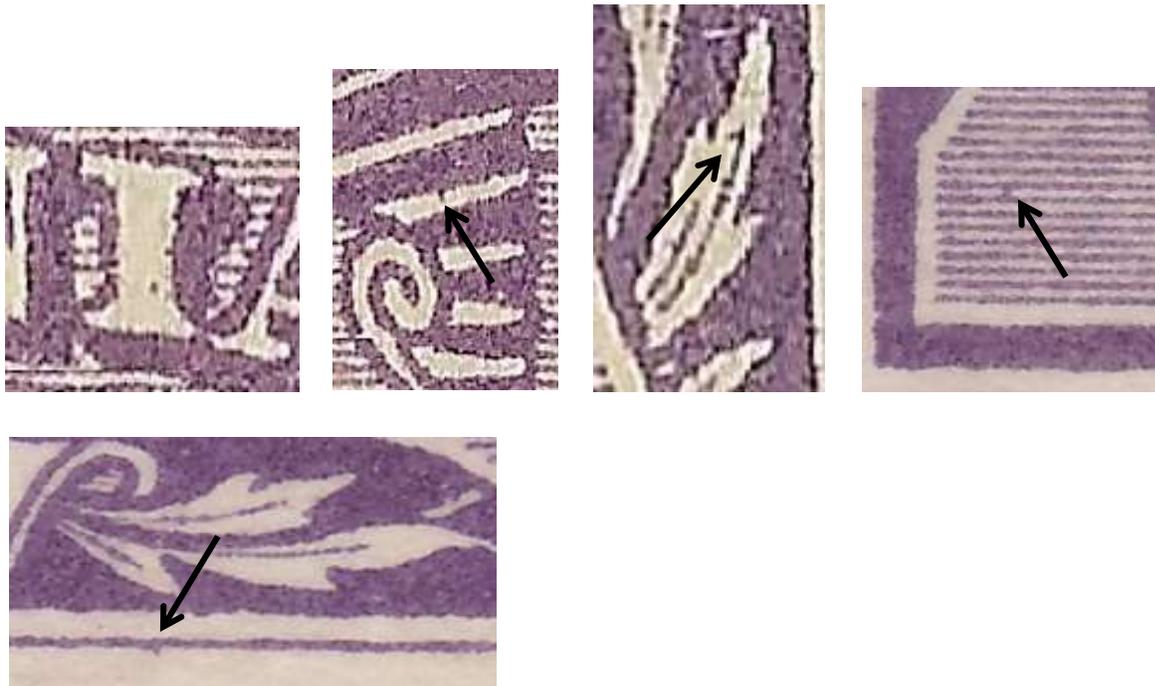
## 27-33

- a) Color dot in I of Tasmania.
- b) Tiny color spur in 5<sup>th</sup> spoke from right.
- c) Tiny color dot on tip of vein in second fern in right fern cluster.
- d) Small color flaw in lower left panel wing between 8<sup>th</sup> and 9<sup>th</sup> shading lines up (variable).
- e) Tiny color spur on bottom frame below right base ferns, 9.0 mm from right frame (variable).

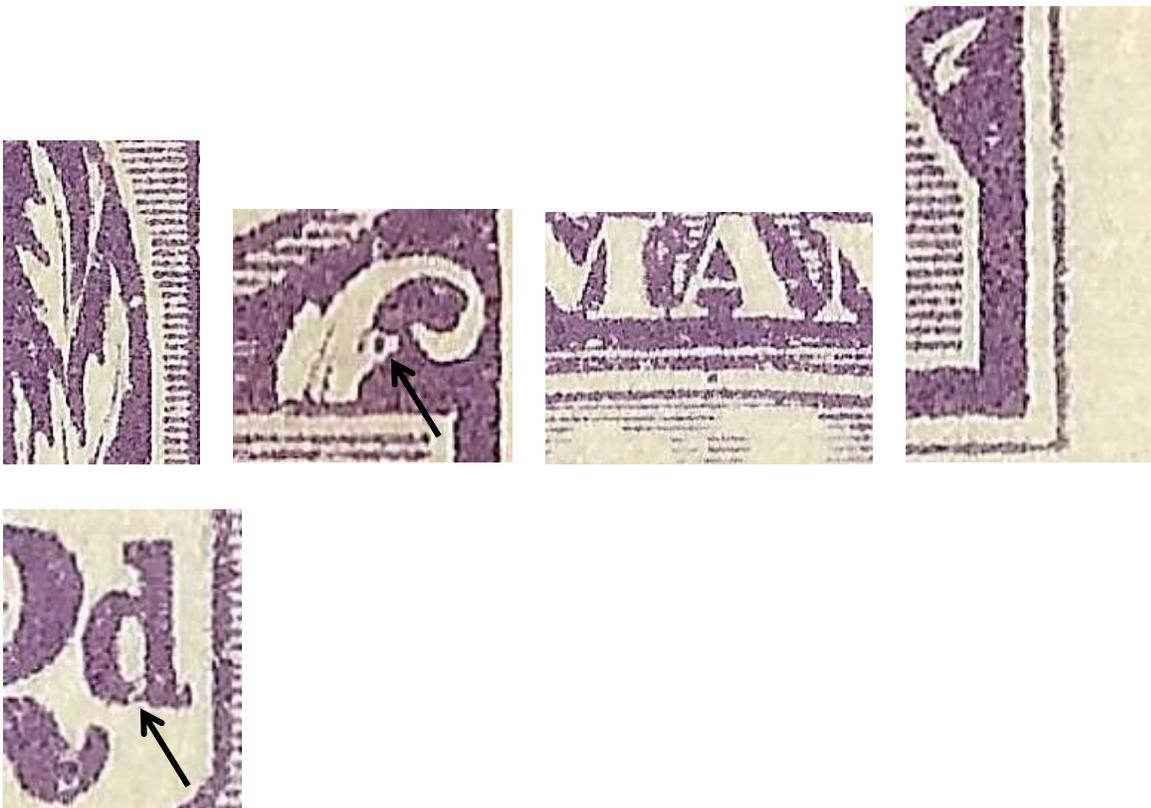
27-36

- a) White dot in solid color between large fern of left fern cluster and left panel.
- b) Color dot in right leaf of the topmost fern at right.
- c) Color dot between vignette frames below second A of Tasmania.
- d) Break in right frame, 3.0 mm above right corner.
- e) Small diagonal white flaw in base of d in RVT (variable).

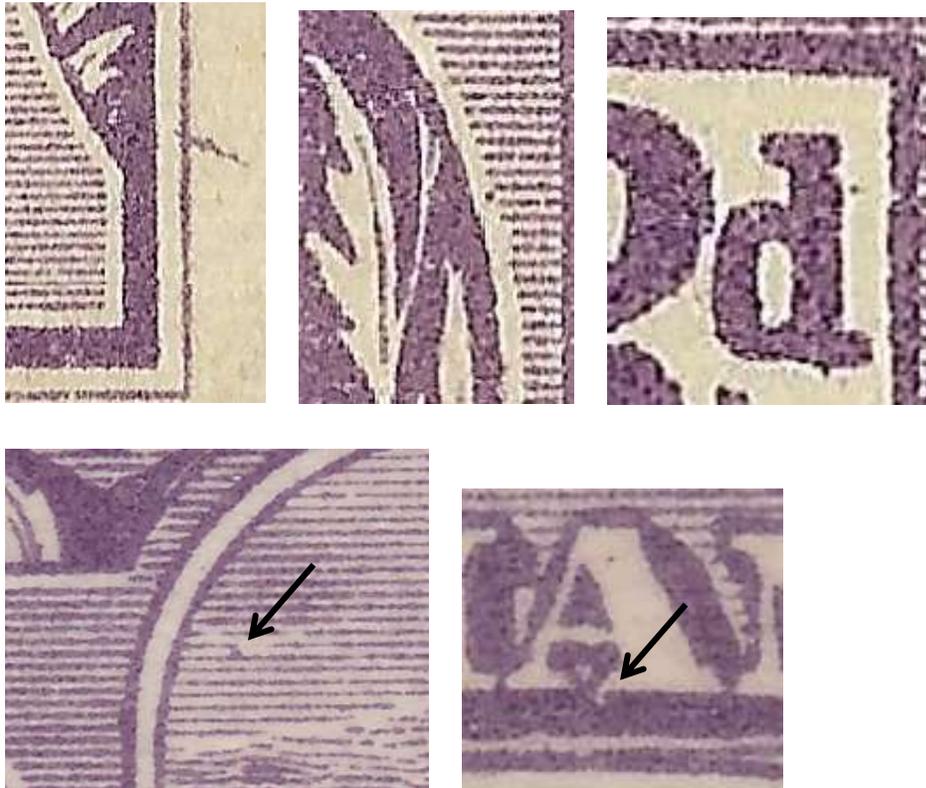
27-46

- a) Diagonal color flaw attached to right frame, 3.25 mm above right corner.

- b) Color dot in white margin of left panel between left end of 25<sup>th</sup> and 26<sup>th</sup> shading lines.
- c) Color dot right of d in RVT.
- d) Small color flaw in sky at left, between 7<sup>th</sup> and 8<sup>th</sup> shading lines up above skyline.
- e) Small white spur on base of right foot of second A of Tasmania.

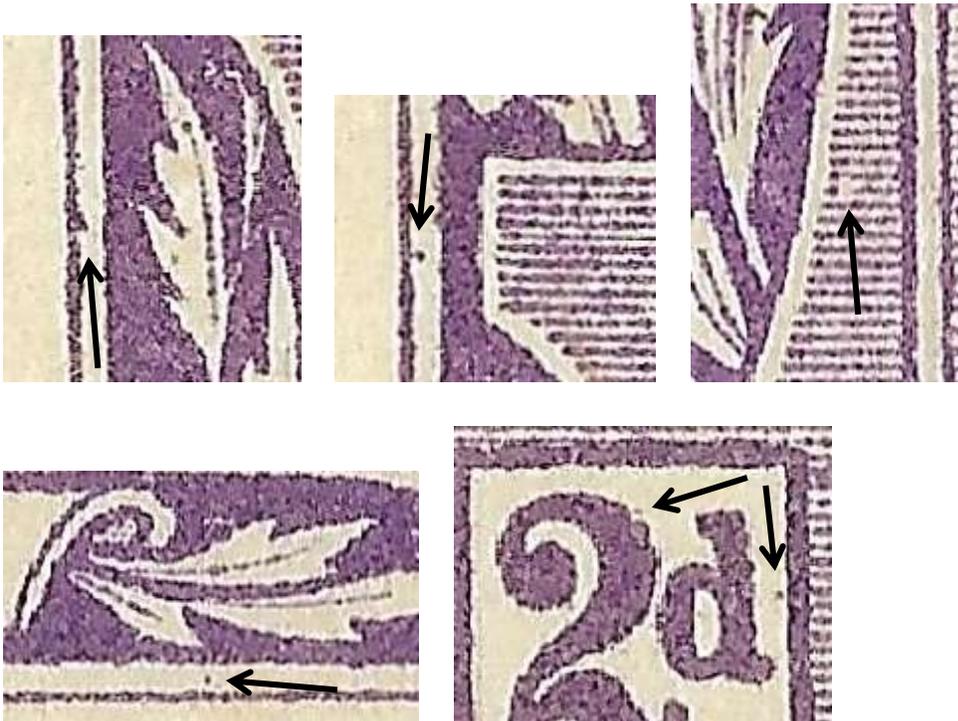
**27-49**

- a) Color spur on left frame, 11.5 mm below top frame.
- b) Color dot inside left frame, 8.25 mm below top frame.
- c) Break in left panel shading, 6.25 mm above bottom frame.

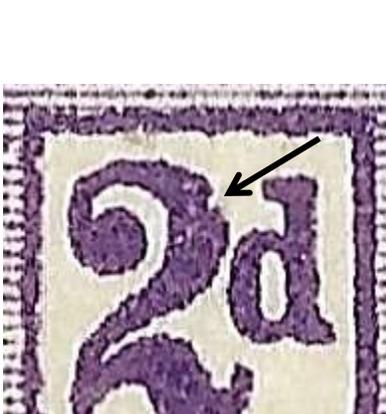
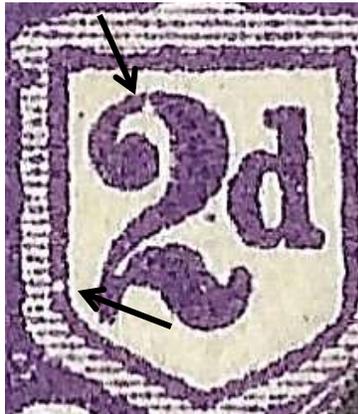
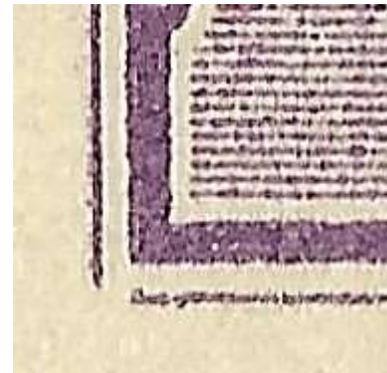
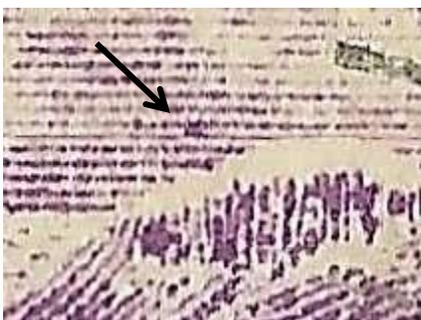
**27-55**

- a) Nick in top right of 2 in RVT.

- b) Color dot between 2 and d in LVT.
- c) Nick inside the top of 2 in LVT
- d) White flaw in lower left frame of LVT (variable).
- e) Broken lower left corner.
- f) Color flaw in sky left of mountain summit.

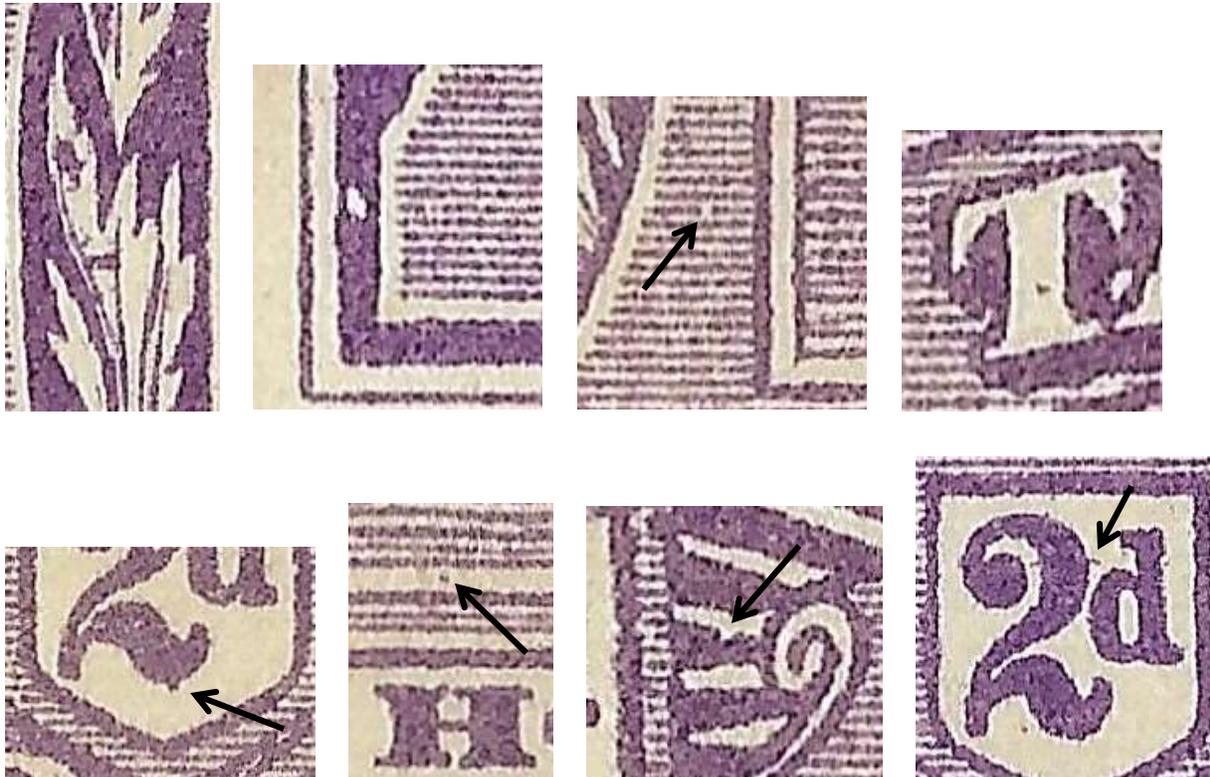
**27-56**

- a) Two color flaws in upper half of large fern in right fern cluster.
- b) White flaw in left solid color, 2.0 mm above bottom frame.
- c) Break in left panel shading, 5.0 above bottom frame.
- d) Color dot in T of Tasmania.
- e) Color spur on base of 2 in LVT.
- f) Color dot between lower vignette frames above H of Hobart.
- g) White spur off 4<sup>th</sup> spoke from left (variable).
- h) Master Plate Flaw: Color flaw off right side of 2 in RVT (not constant). Similar flaw on position 56 of plates 23 to 28. (Also seen on position 56 of at least some of plates 1-22.)

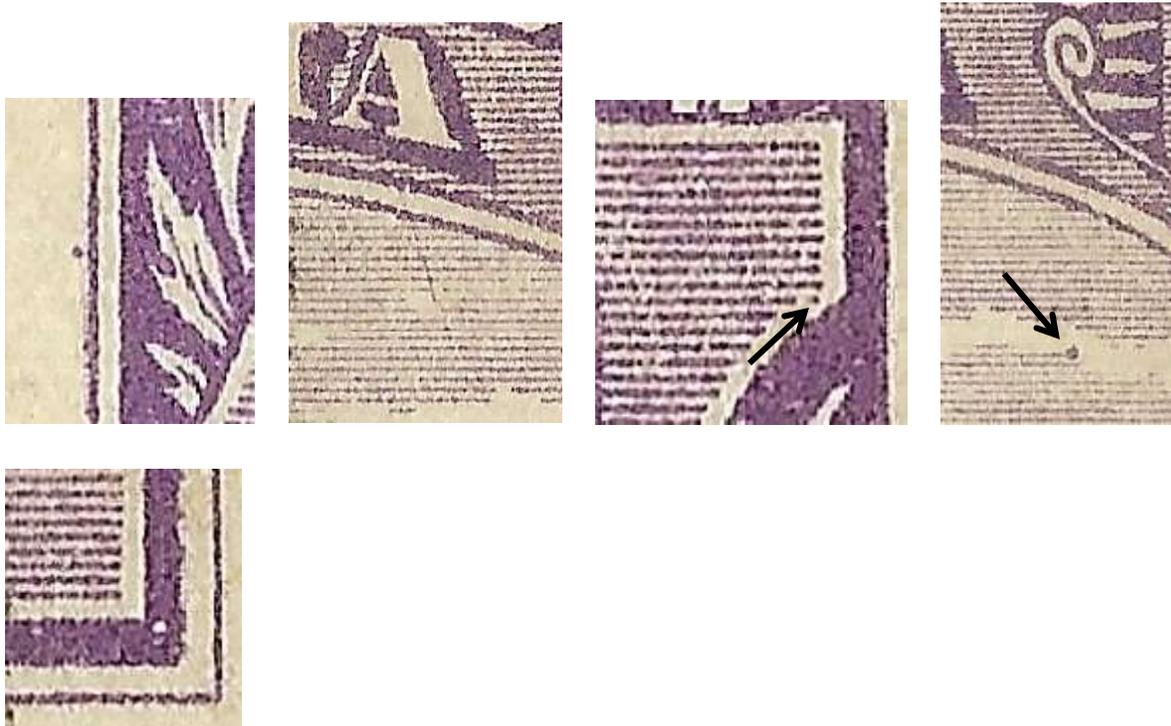
27-57

- a) Color dot just outside left frame, 5.5 mm above base frame.
- b) Diagonal color line in sky below third A of Tasmania (variable).
- c) Color dot below right end of 10<sup>th</sup> shading line in upper right panel wing.
- d) Small color flaw in sky, 6.5 mm inside right frame and 8.0 mm below top frame (variable).
- e) White dot in solid color in lower right corner (not constant).

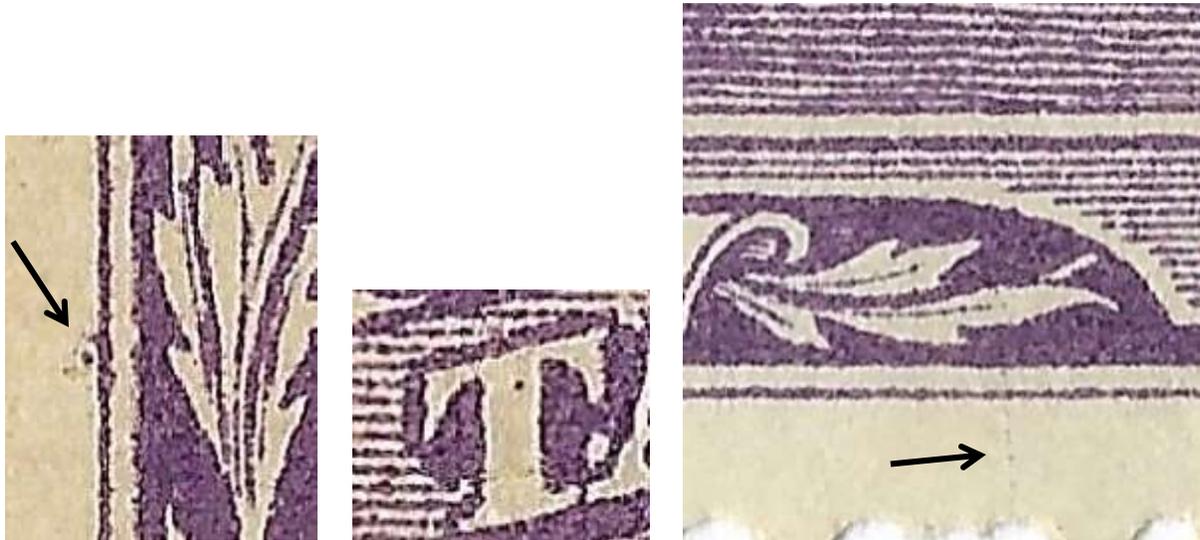
- a) Two color flaws (a dot and a spur) on outside of left frame, 8.5 mm above bottom frame.
- b) Color dot in T of Tasmania (variable).
- c) Hairline: Faint color hairline from lower right base fern across bottom frame into bottom margin (not constant). Only one copy seen.
