# The Plate and Print Flaws of the 2d Lithograph Pictorial

## Plates 27 and 28

Jerry Weirich

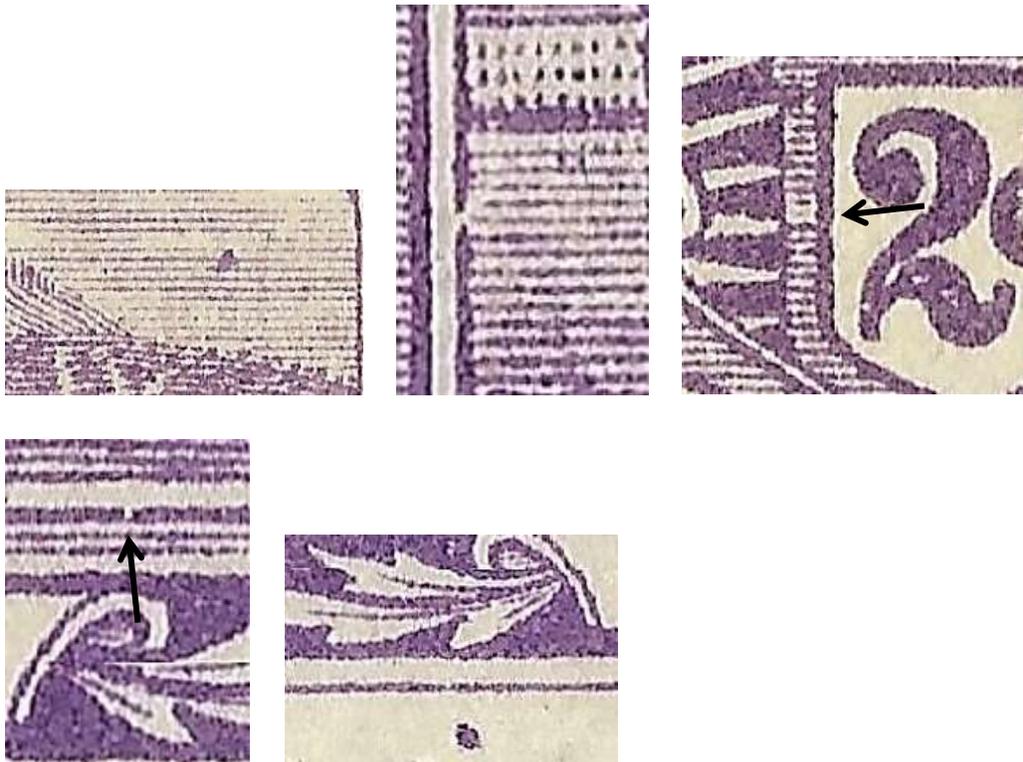
- a) Color spot in sky, 9.5 mm below top frame and 6.0 mm from right frame.
- b) Diagonal white flaw breaking left inner vignette frame and two shading lines in water, about 7.5 mm above bottom frame.
- c) Breaks and weaknesses in left shading of RVT near center (variable). Similar flaws on plate 28, positions 21 and 34.
- d) Nick in outer vignette frame above right end of title tablet.
- e) Color dot below bottom frame under left base ferns (not constant).

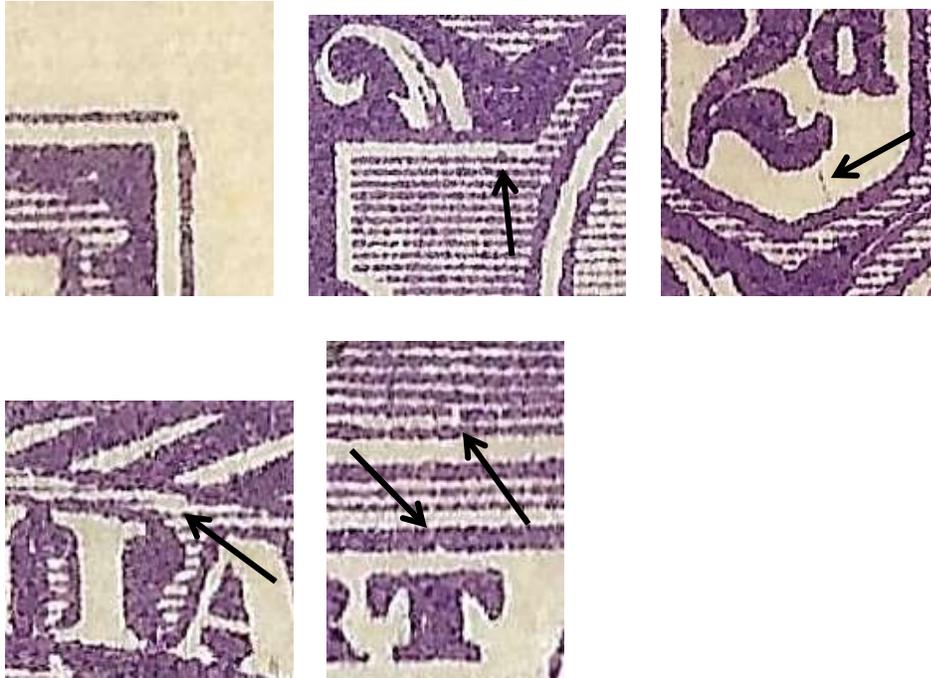
- a) Top right corner broken or thinned.
- b) Color spur on right panel shading (1<sup>st</sup> line) in upper left panel wing.
- c) Color line in LVT between 2 and lower frame.
- d) Shading line above I of Tasmania shortened at right end.
- e) Tiny nick in color title tablet frame above T of Hobart.
- f) Thin break in water shading (1<sup>st</sup> line up) above T of Hobart (variable).

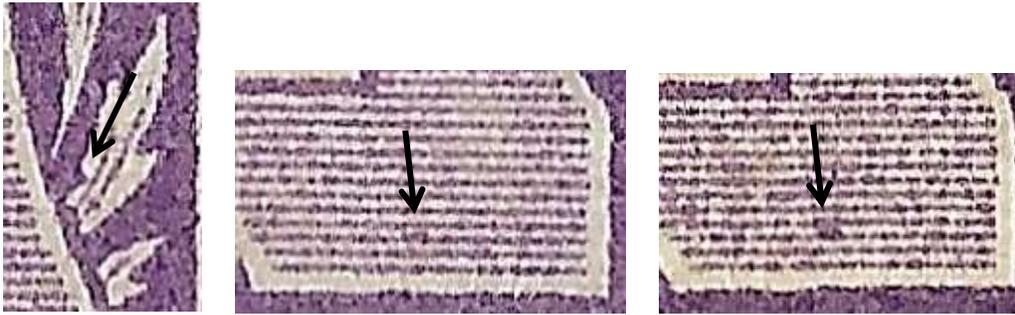
- a) Color nick in left side of the second lowest fern in right fern cluster.
- b) Color bulge shading line (3<sup>rd</sup> line up) in lower right panel wing (variable). On occasion, the bulge will occupy the entire space between the 3<sup>rd</sup> and 4<sup>th</sup> lines. Two scans.

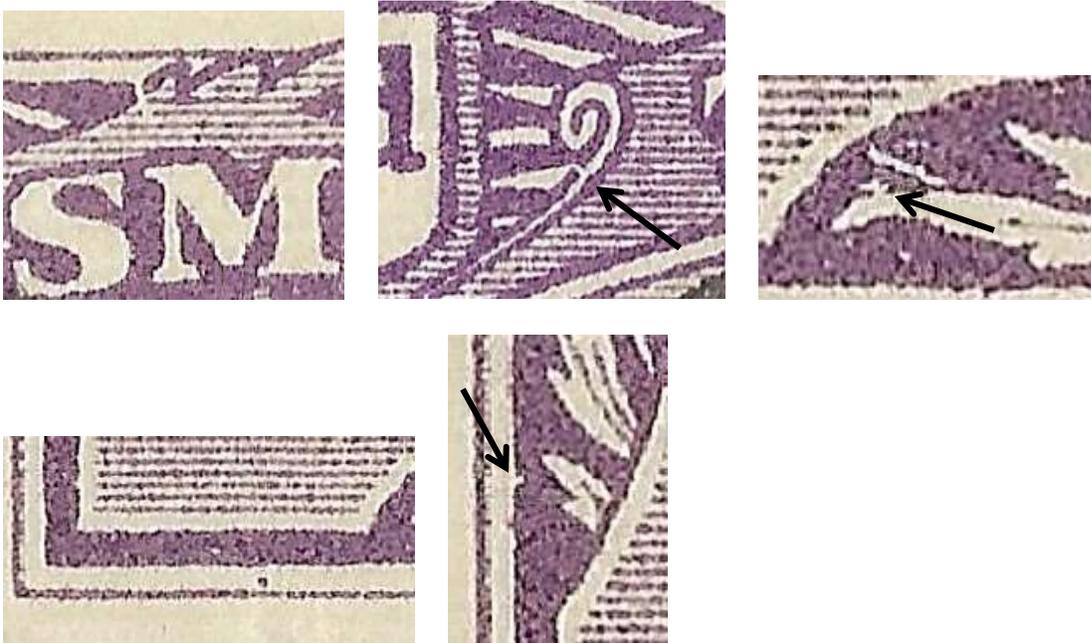
- a) Vertical white dash breaking ornament frame and shading above SM of Tasmania.
- b) White flaw breaking color frame line at right end of 2<sup>nd</sup> spoke from left.
- c) White flaw above tip of fern in left base ferns.
- d) Color dot inside bottom frame below lower left panel wing.

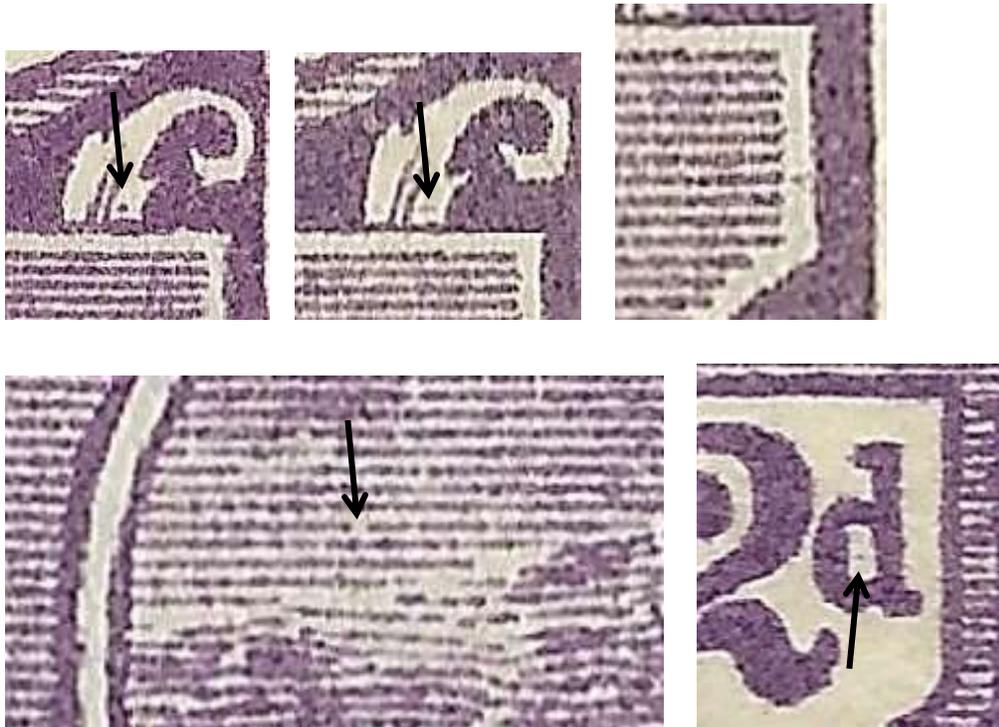
- a) Color flaw, usually horizontal, in base of topmost fern at right (variable). Two scans.
- b) Color dot in white margin of upper right panel wing adjacent to 7<sup>th</sup> shading line (variable).
- c) Break in sky shading (4<sup>th</sup> line up) above mountain ridge at left, 2.0 mm inside vignette frame.
- d) Color dot inside loop of d in RVT (variable). Similar flaw on plate 28, position 25.

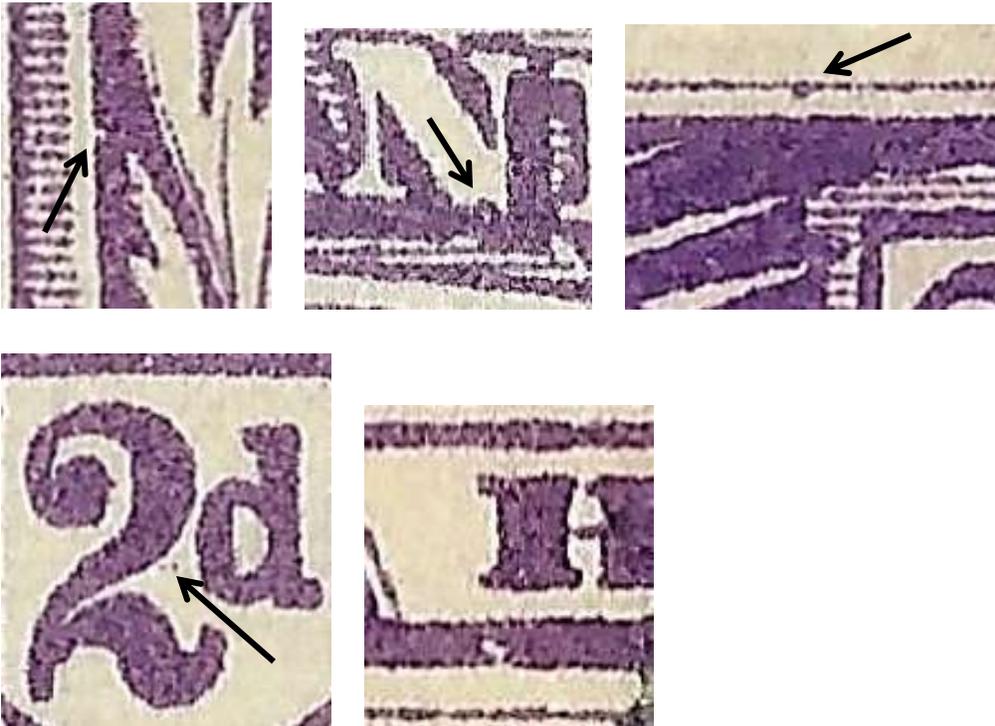
- a) Nick in solid color left of large fern in right fern cluster, 10.0 mm above bottom frame.
- b) Small dent, usually shallow, in right base of N of Tasmania.
- c) Small color spur or bulge on top frame, 5.5 mm from right frame (variable).
- d) Color flaws between 2 and d in RVT (variable).
- e) White flaw in title tablet frame below H of Hobart (variable and not constant).

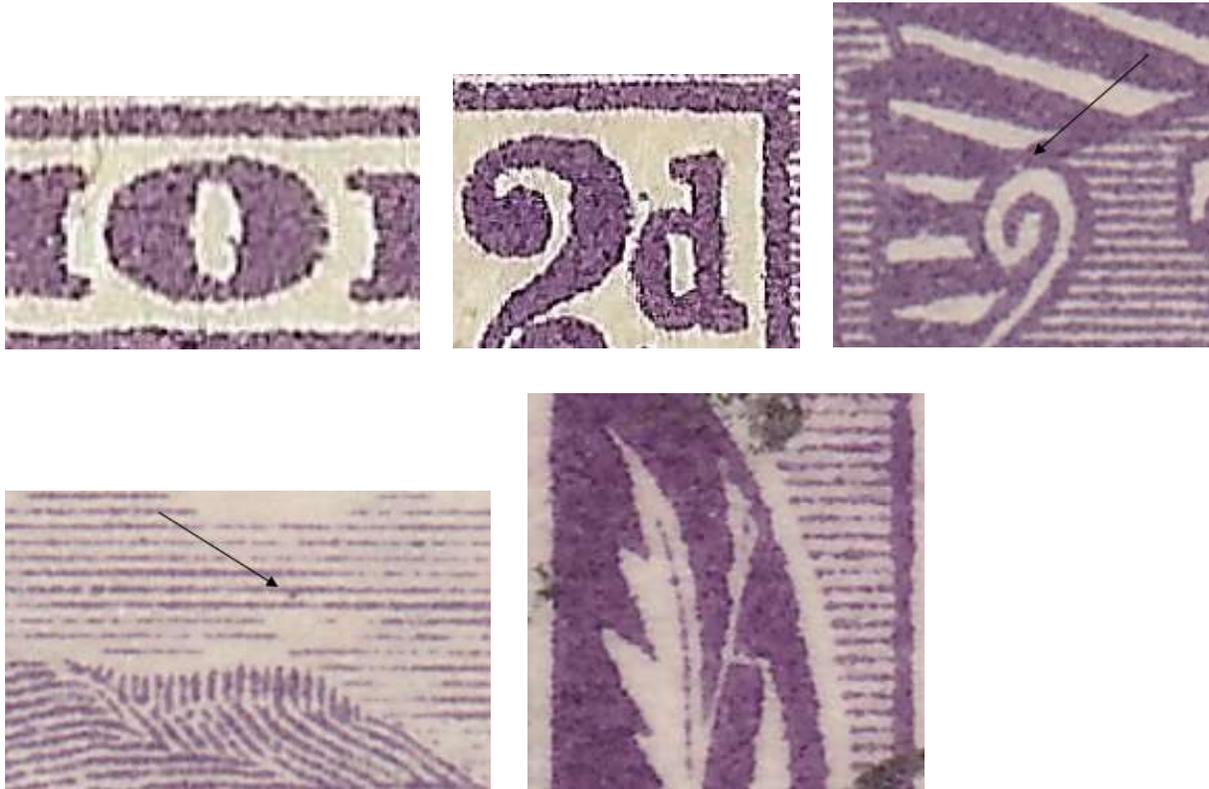
- a) Tiny color spur on inside of O of Hobart (variable and not constant).
- b) Color dot between 2 and d in RVT (variable).
- c) Tiny white dot above left scroll (variable and not constant).
- d) Tiny color flaw in sky above right ridge of mountain (not constant).
- e) White flaw between top ferns (sometimes connecting ferns) in left fern cluster (variable). [Note: White flaws in this area are not unique to this position, but this flaw tends to be more horizontal than others.]

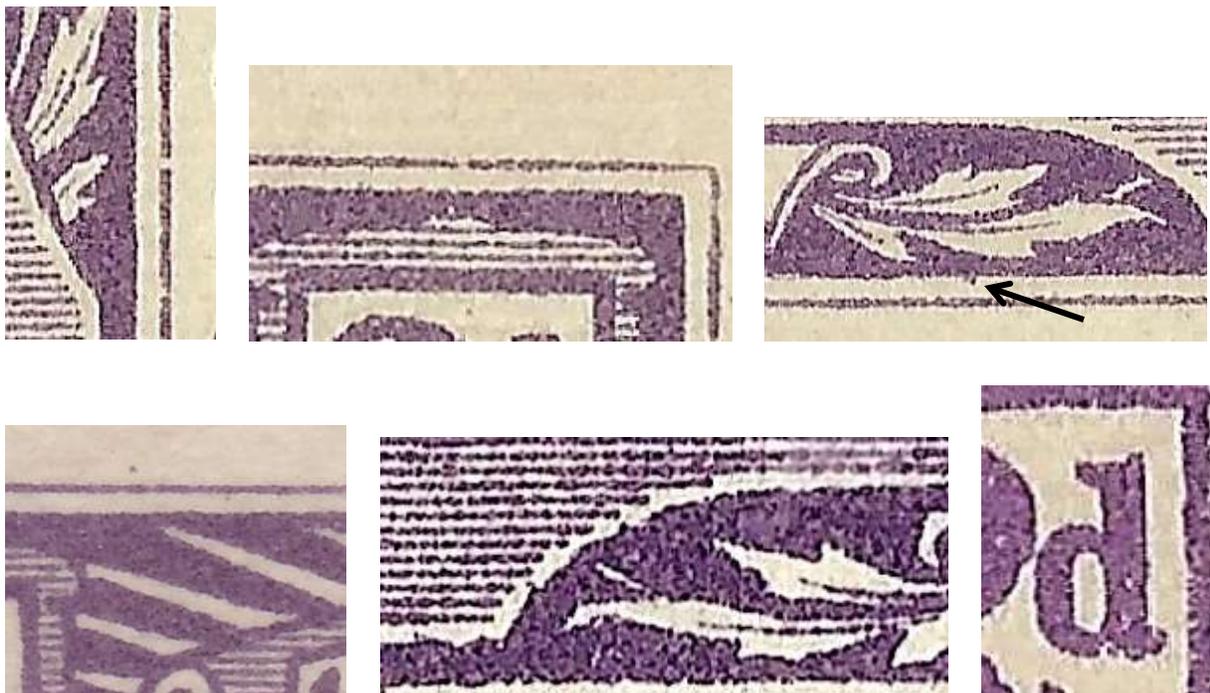
- a) Break in right frame, 4.5 mm above right corner.
- b) Thin break in top frame above RVT, 3.0 mm from right corner (variable).
- c) Tiny color spur below right base ferns (variable).
- d) Tiny color dot above top frame, 6.5 mm from top left corner (not constant).

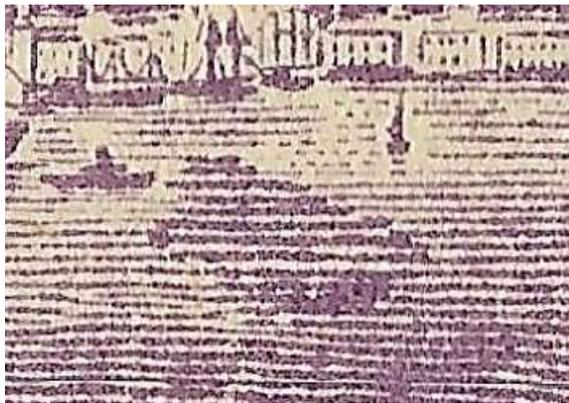
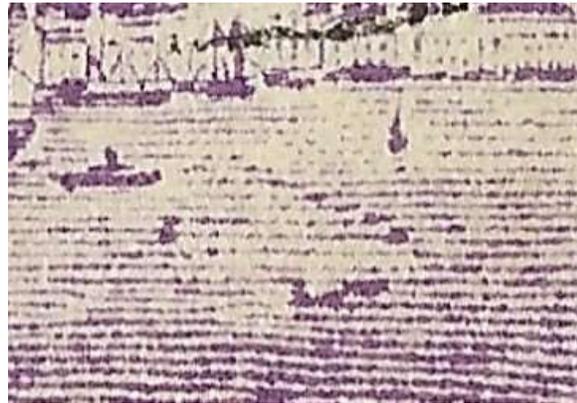
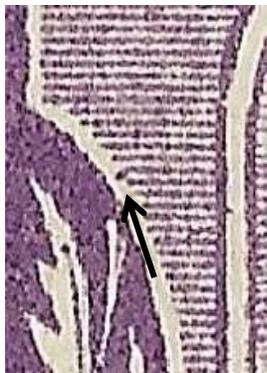
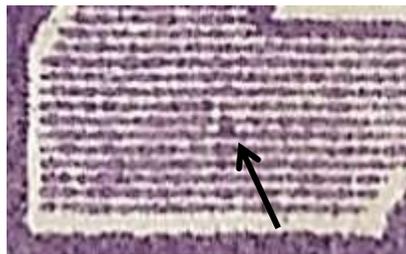
- a) Retouch in water (variable): Twelve water shading lines just left of center recut with one shading line removed during the retouching. In the first state, the retouched shading lines are thick. In the second state, the shading lines are thin. A color flaw is at the bottom of the retouched area in both states. (A

similar retouch technique that resulted in a missing shading line is found on plate 24, position 23.)

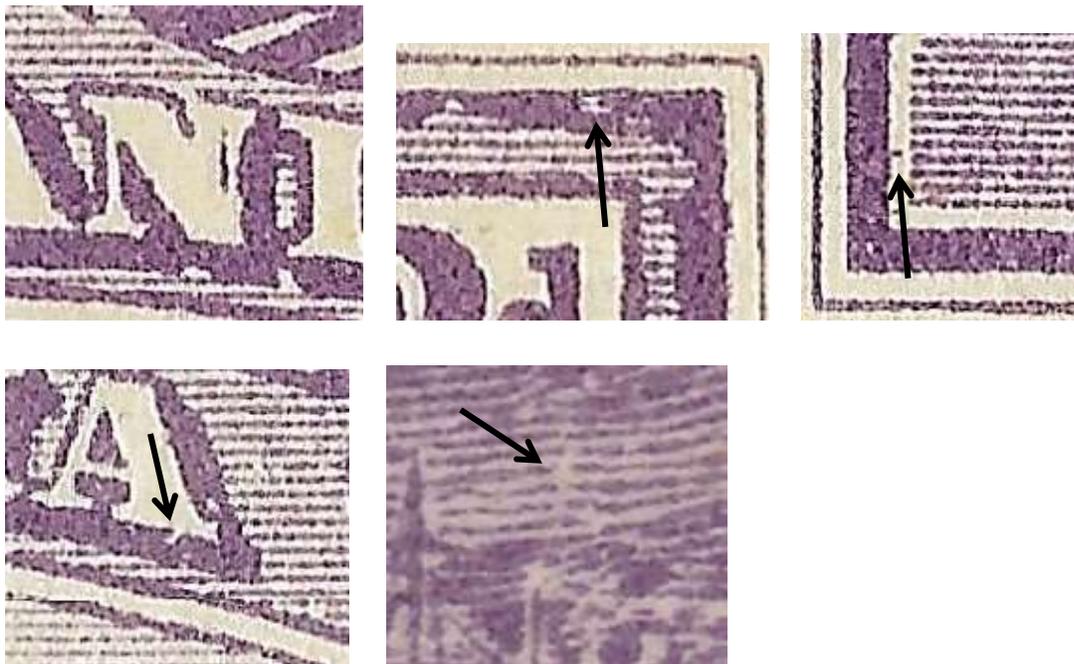
- a) Vertical white flaw in center of N of Tasmania.
- b) Small white flaw in top solid color above right of RVT (variable).
- c) Color flaw in white margin of lower left panel wing.
- d) Tiny white spur on right foot of third A of Tasmania (variable).
- e) Break in three or four shading lines on mountain side above the right mast of frigate (variable and not constant).

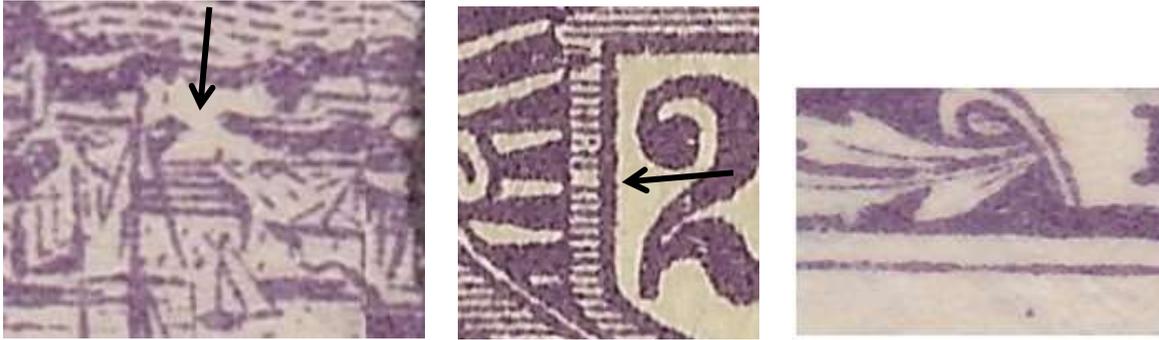
- a) Break in lower tree line to right of the top of the mast of the yacht.
- b) Missing shading line on left side of RVT. Similar flaws on plate 28, positions 3 and 34.
- c) Color flaw in lower margin below left end of title tablet (not constant).

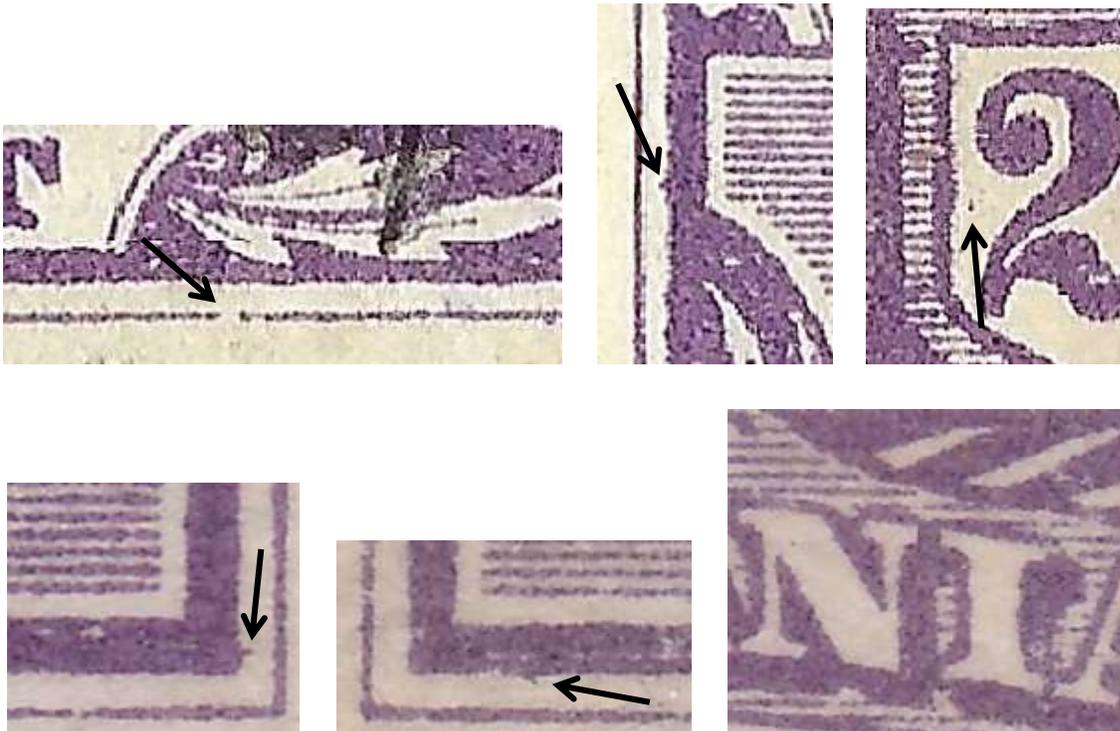
- a) Break in bottom frame below right base ferns, 9.5 mm from right corner.
- b) Tiny color spur on left solid color, 8.5 mm below top frame (not constant).
- c) Tiny color dot in front of 2 in LVT (not constant).

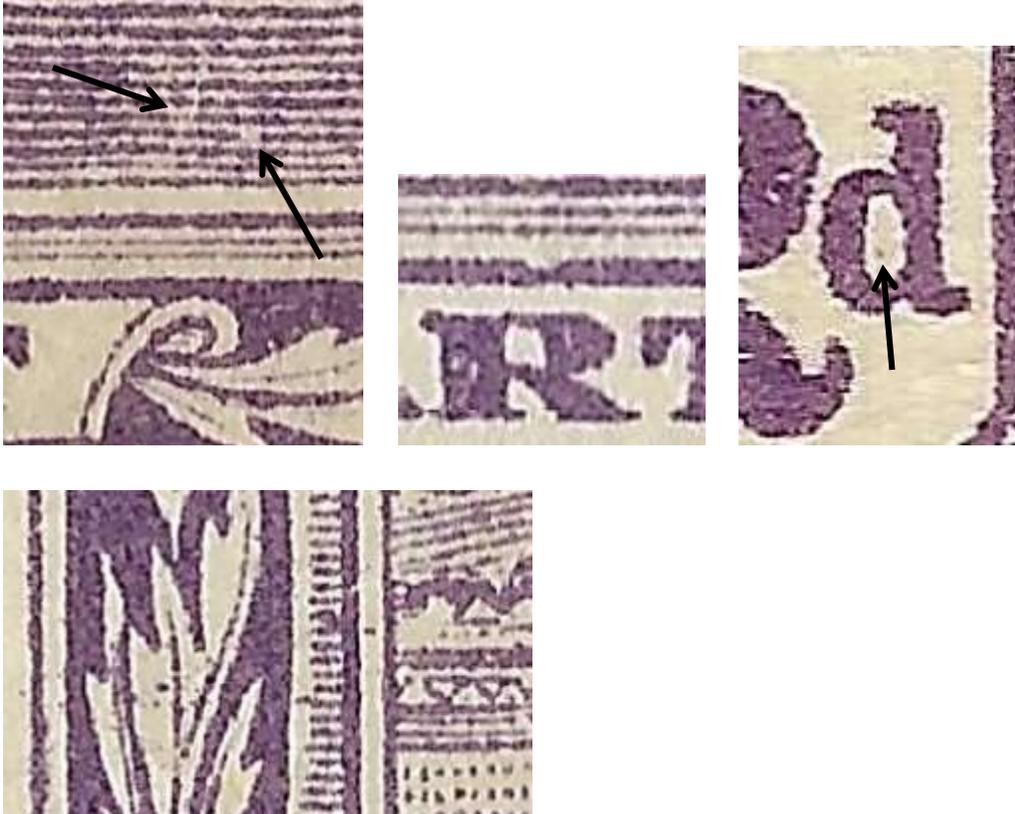
- a) Break in top frame, 5.0 mm from left corner.
- b) Color flaws between bottom frame and lower left solid color, up to 4.0 mm from left frame (not constant).
- c) Break in water shading (3<sup>rd</sup> line up) above right base ferns.
- d) Faint diagonal white line in water breaking above right end of title tablet (variable and not constant)
- e) Shallow indentation in top of title tablet frame above R of Hobart.
- f) Color dot inside loop of d in RVT. Similar flaw on plate 28, position 9.
- g) Color flaw in left panel and color dot between left vignette frames near middle (variable and no constant).
- h) Color flaws in large fern at left, left margins and left panel (possible remnants of a color line) (variable and not constant).

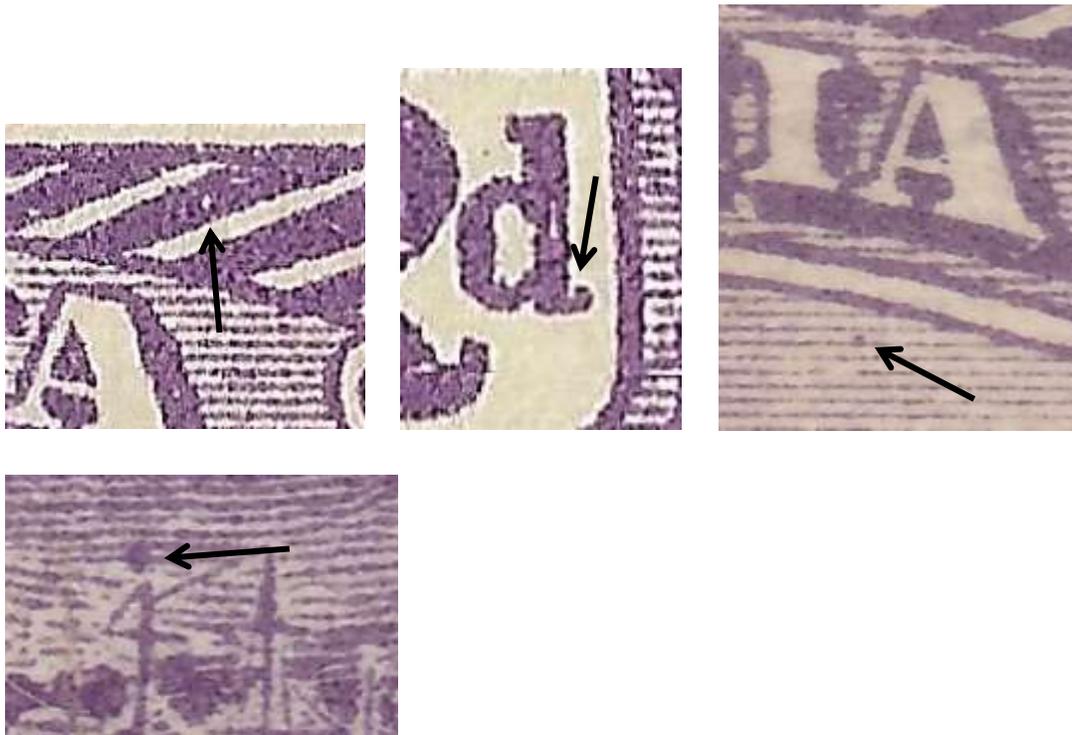
- a) White flaw between 7<sup>th</sup> and 8<sup>th</sup> spokes from right (variable).
- b) White flaw almost severs the lower serif on d in LVT.
- c) Small color flaw in sky below third A of Tasmania (variable and not constant).
- d) Color flaw in mountain shading above left mast of frigate (not constant).

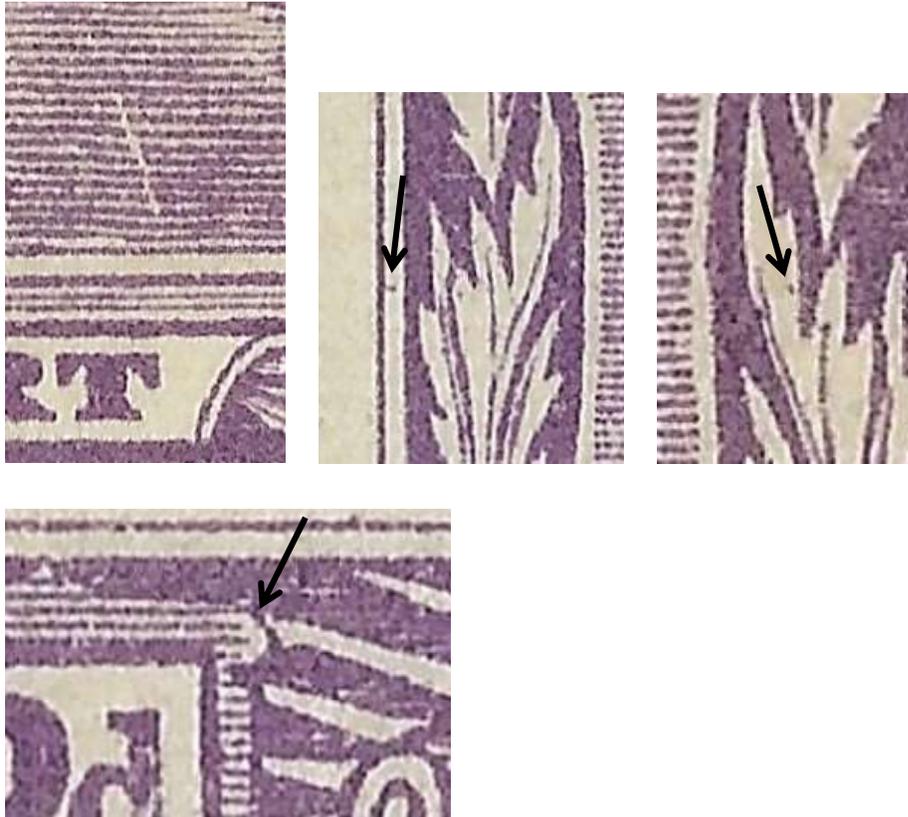
- a) Diagonal white line breaking water shading above T of Hobart.
- b) Tiny color dot inside left frame, 9.0 mm above bottom frame (not constant).
- c) Color dot in upper left leaf of large fern of right fern cluster.
- d) Three shading lines at top right of LVT shortened on right ends. Similar flaw on plate 28, position 11.

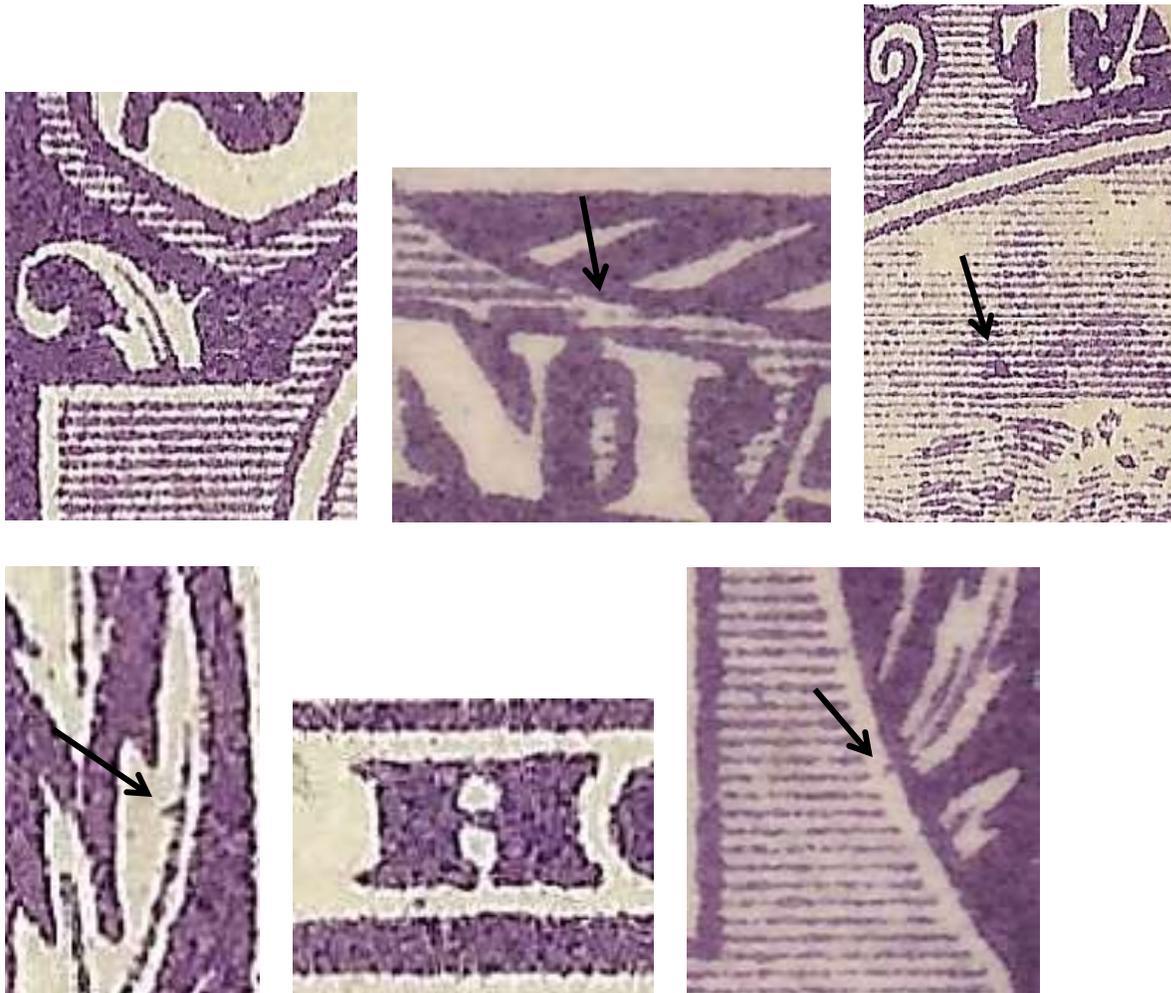
- a) White line extending off top right of topmost left fern.
- b) Break in panel shading above NI of Tasmania.
- c) Color flaw in sky (between 4<sup>th</sup> and 5<sup>th</sup> shading lines) above mountain ridge and below T of Tasmania (variable).
- d) Small color flaw on vein near top of large fern in left fern cluster (variable and not constant).
- e) Color dot below left upright of H of Hobart (variable).
- f) Small color spur in white margin adjacent to second fern in right fern cluster (variable and not constant).

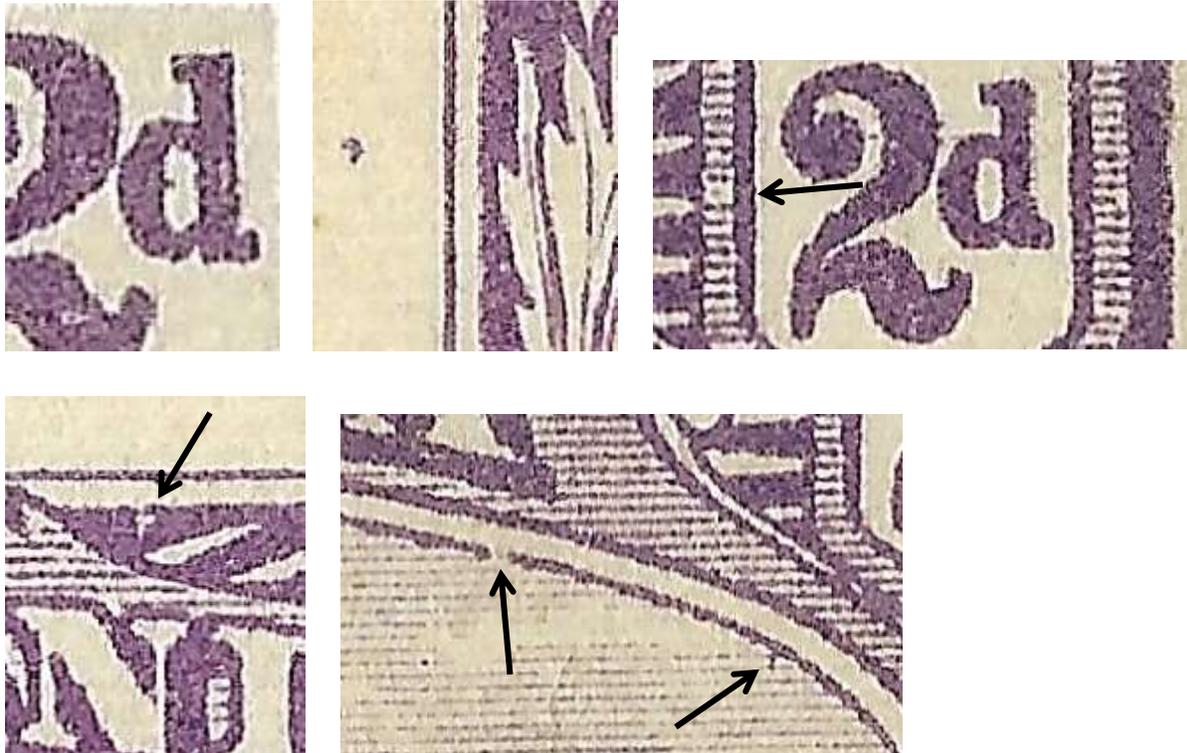
d) Color spur inside loop of d in LVT.

f) Missing shading line on left side of RVT. Similar flaws on plate 28, positions 3 and 21.

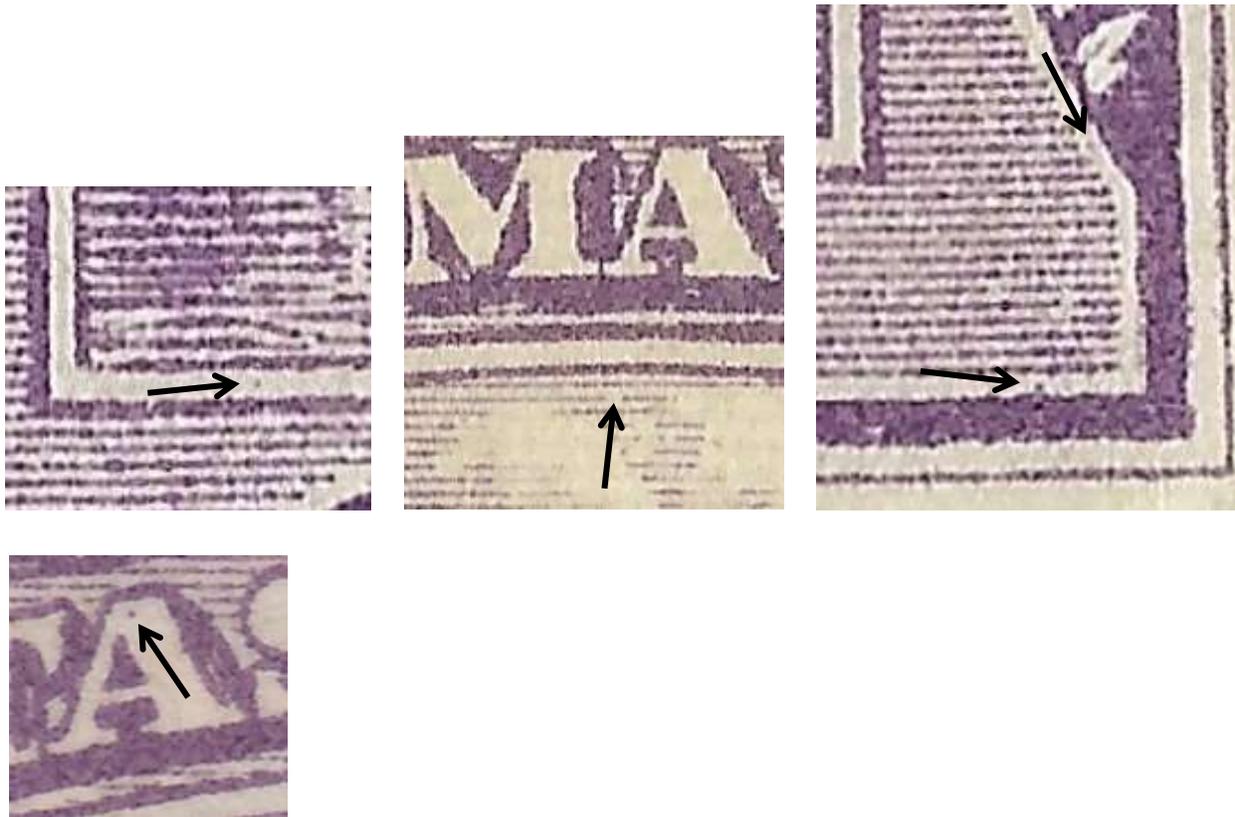
- a) Color dot between vignette frames below yacht, 2.0 mm from outer vignette corner.
- b) Break in sky shading (2<sup>nd</sup> line down) below MA of Tasmania.
- c) Two color dots in white margin of lower right panel wing—one in lower margin and a smaller dot in diagonal white margin (variable).
- d) Color dot in top of first A of Tasmania.

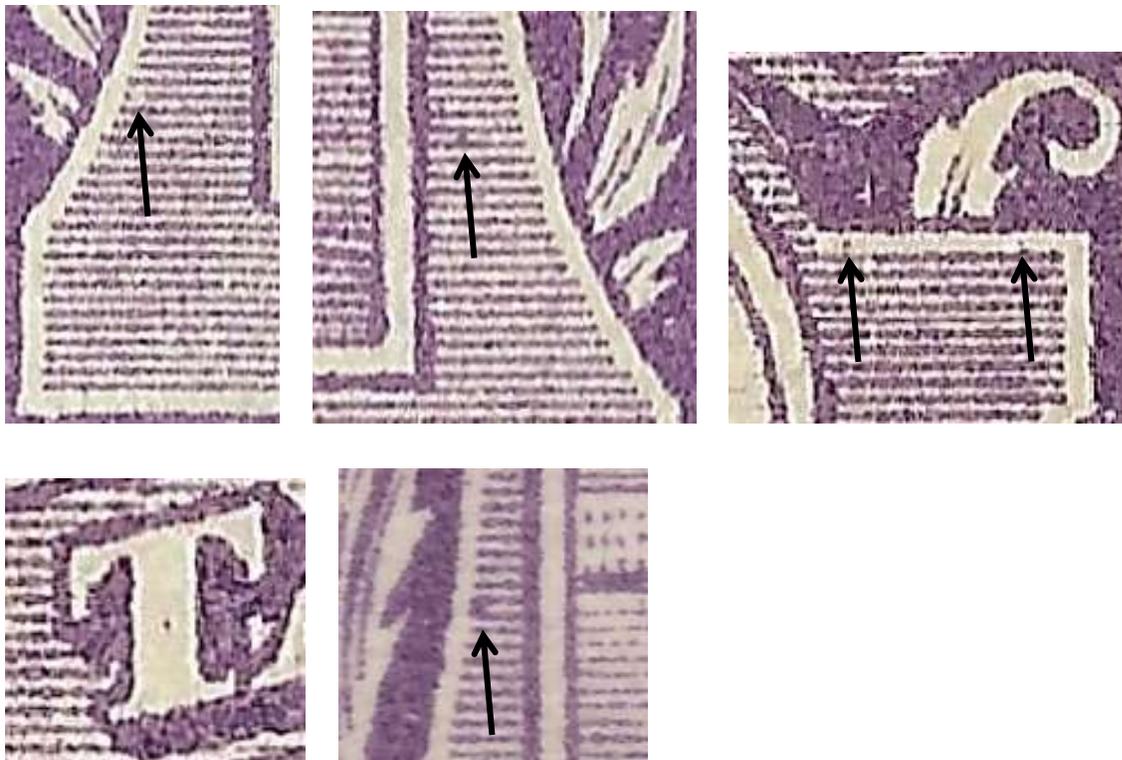
- a) Break in panel shading (21<sup>st</sup> line up) in left panel, 4.0 mm above bottom frame.
- b) Color flaw in right panel shading, 8.0 mm above bottom frame.
- c) Color dot above each end of the first shading line of upper right panel wing (variable).
- d) Tiny color dot in center of T of Tasmania (variable).
- e) Color flaw in left panel shading, 8.0 mm above bottom frame (not constant).

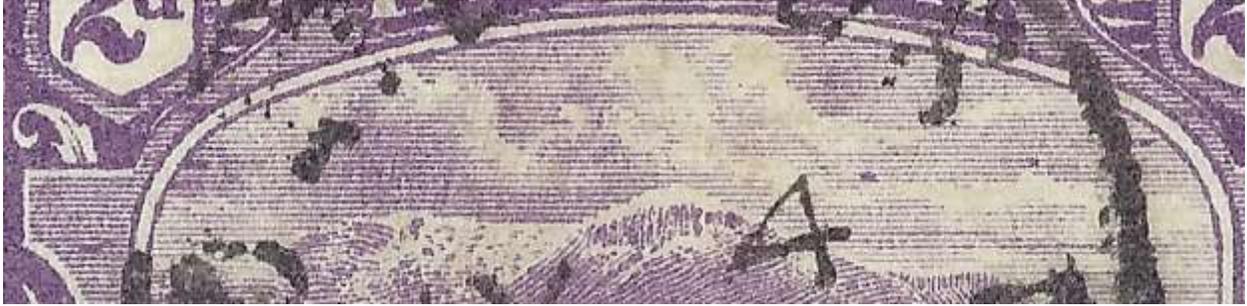
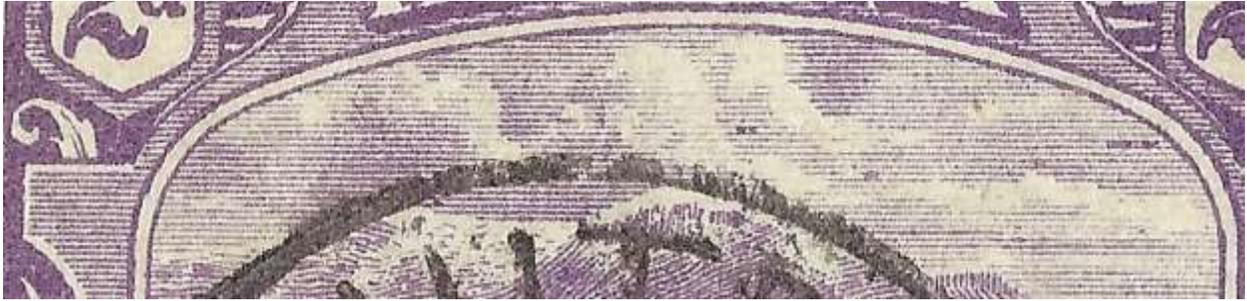
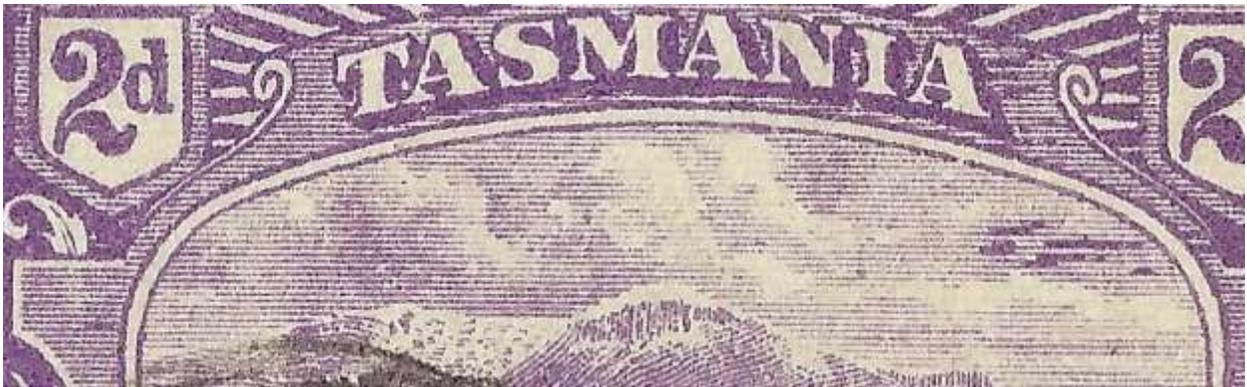
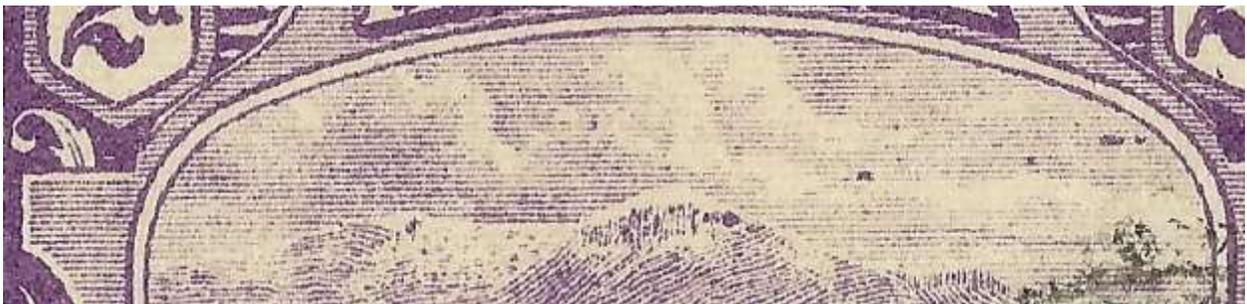
- a) Color dot in curved leaf of topmost fern at right.
- b) Color dot in top margin above T of Tasmania, 9.75 mm from left frame.
- c) Color flaw in sky below M of Tasmania
- d) Variable color flaws in sky and panel shading (not constant). The first state is normal (i.e., no flaws). In the middle states, color flaws develop between

shading lines in sky, upper left panel, and upper right panel in many different configurations. In the late state (reddish lilac printings), most color flaws have been removed leaving only a few in sky at right. Similar type flaws are also found on plate 28, position 60.

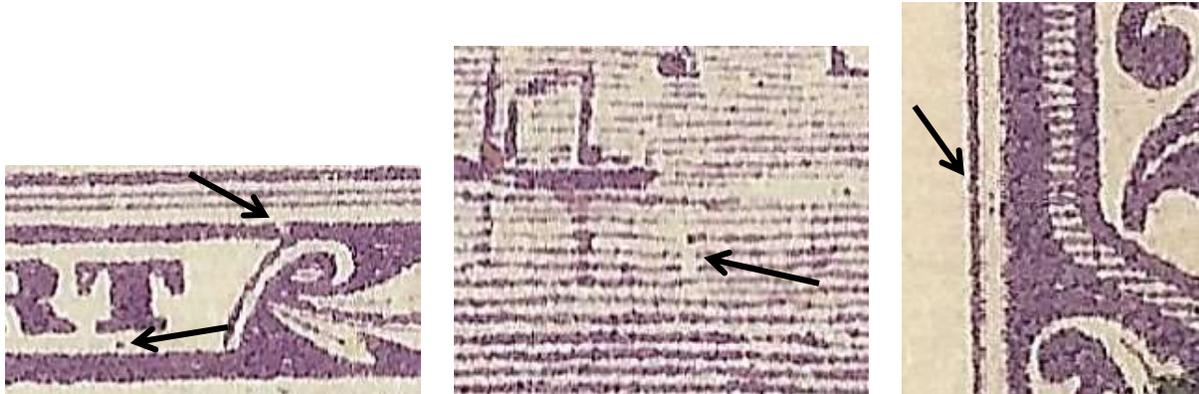
- a) Nick in solid color above right end of title tablet.
- b) Color dot below T of Hobart.
- c) Break in three water shading lines below right end of steamship.
- d) Two color flaws inside left frame, about 4.5 mm below top frame (variable and not constant).

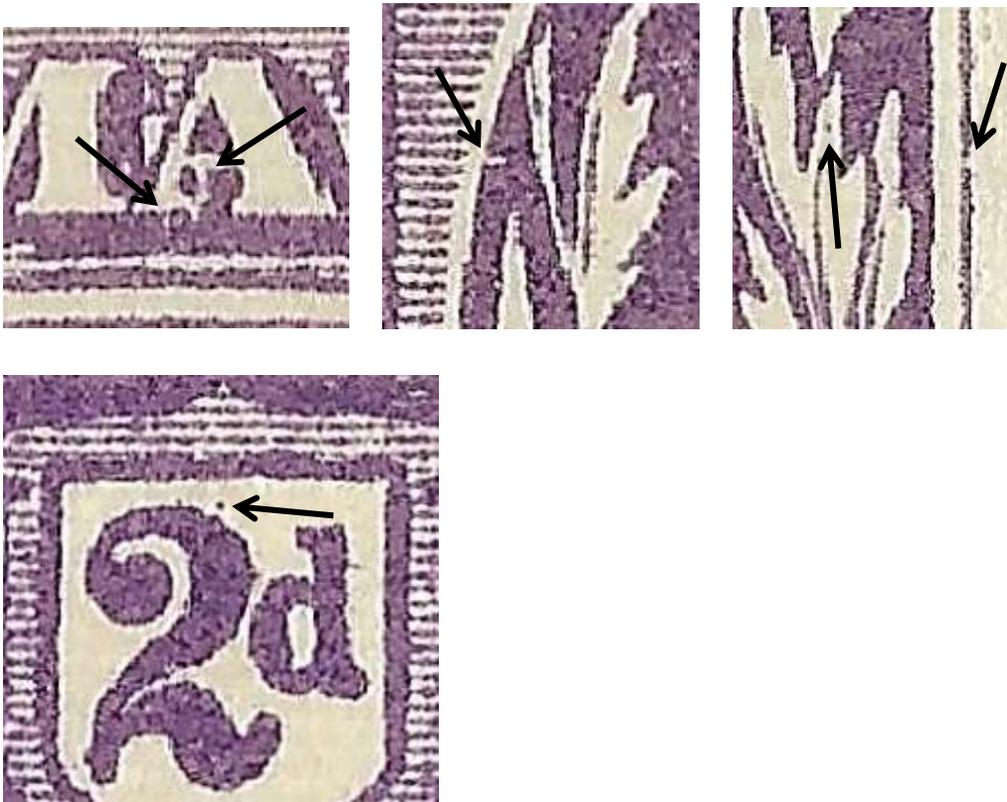
- a) White flaw under left leg of second A of Tasmania (variable).
- b) Thin white arc connecting left serif to crossbar on second A of Tasmania (variable and not constant).
- c) White flaw in left side of right solid color, 10.5 mm below top frame (variable).
- d) Master Plate Flaw: Color dot in top of middle leaf of large fern in right fern cluster (variable). Similar flaw on position 45 of plates 23 to 28. (Also seen on position 45 of at least some of the plates 1-22.)
- e) Thin break in right frame, 14.0 mm below right corner.
- f) Tiny color flaw above 2 in RVT.

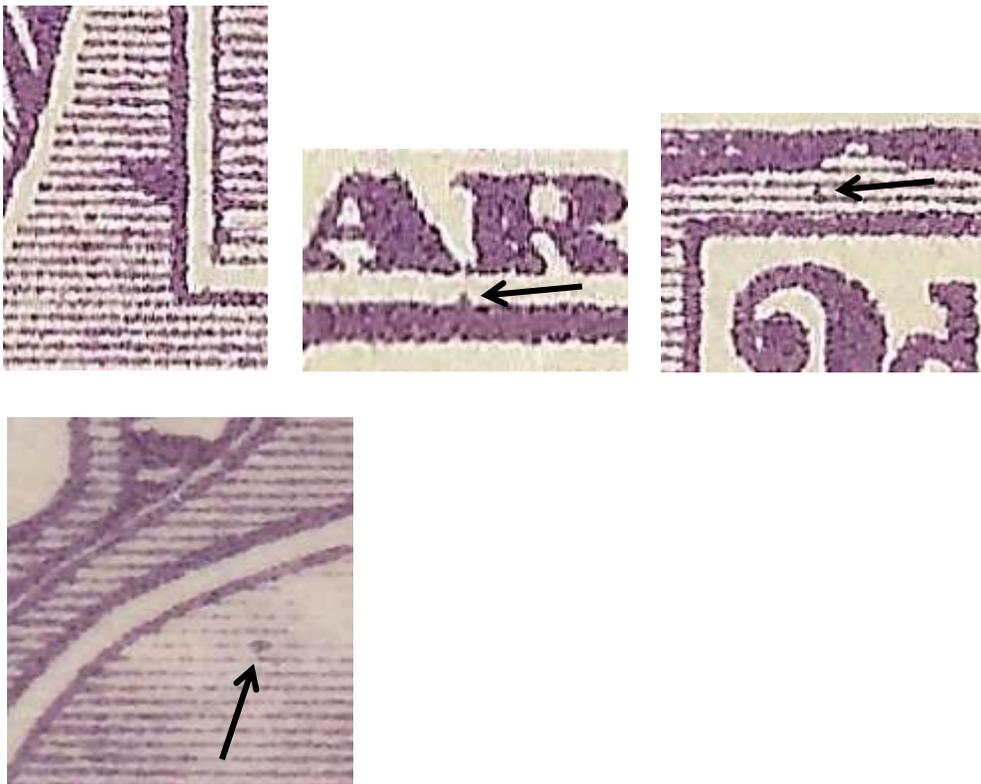
- a) Color flaw attached to outer left vignette frame, 1.0 mm above vignette corner, and protruding into left panel.
- b) Color spur on color frame below AR of Hobart.
- c) Tiny color flaw in shading above RVT.
- d) Small color flaw in upper left sky (not constant).

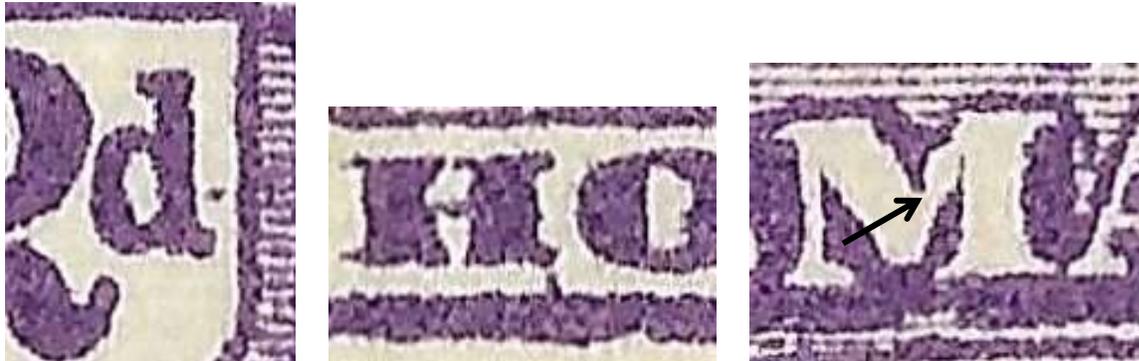
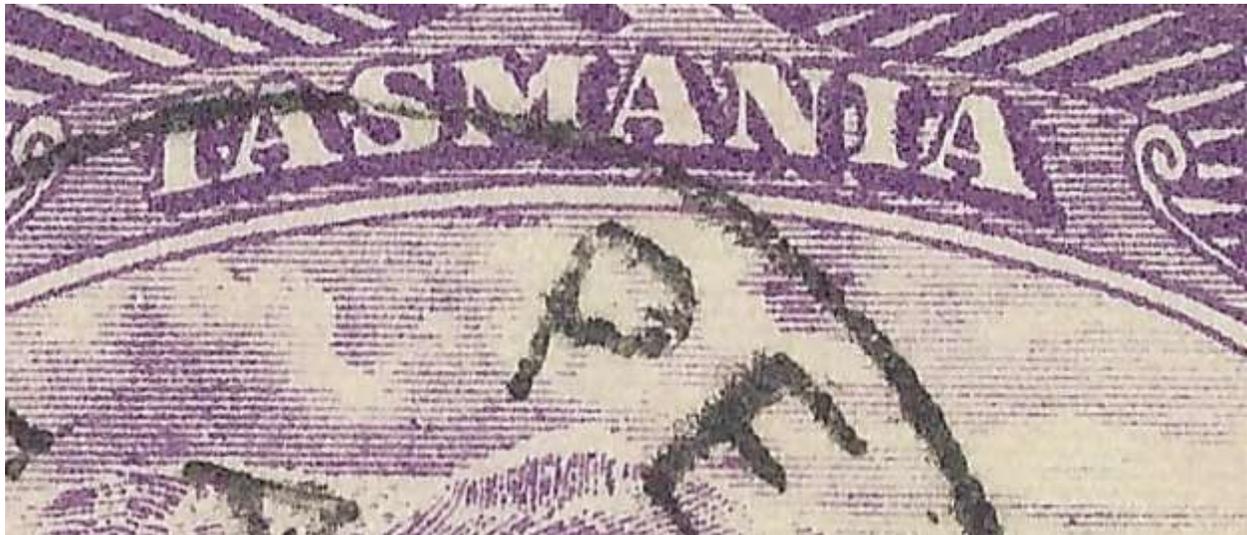
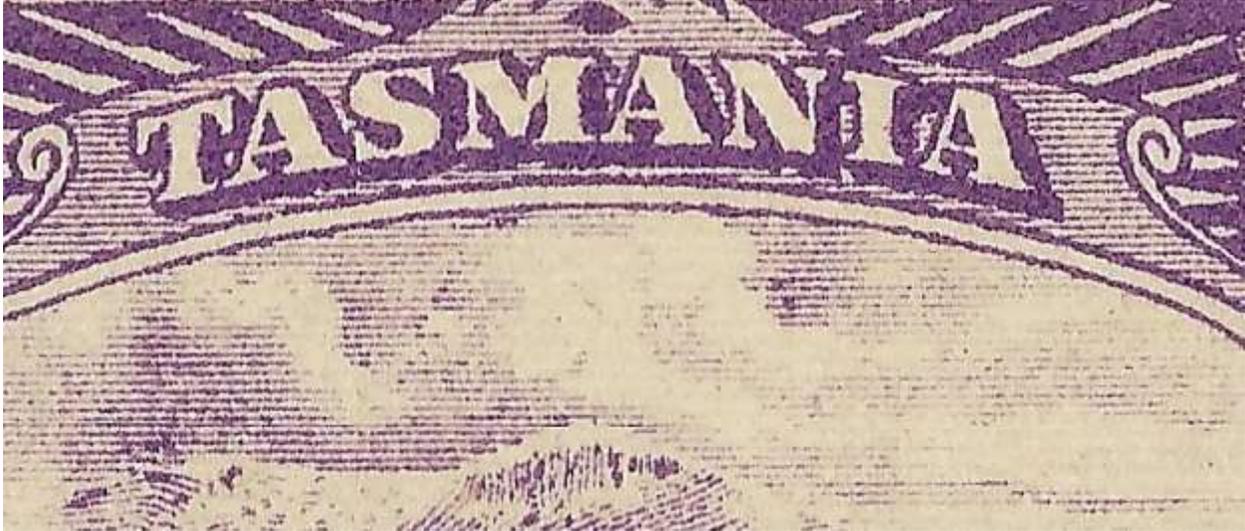
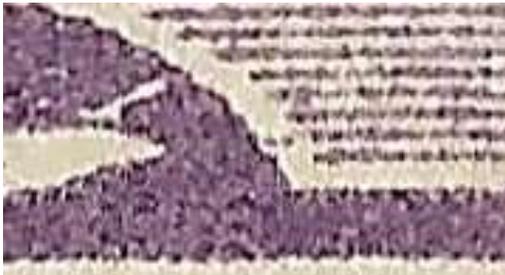
- a) Small color flaw on right of d in RVT.
- b) Color spur below right upright of H of Hobart.
- c) White flaw on right diagonal of M of Tasmania.
- d) Variable color flaws in sky, upper panel, and around NIA of Tasmania (variable and not constant). The sequence of the flaw development on this position is currently unknown. Similar type flaws are also found on plate 28, position 42.
- e) Master Plate Flaw: Short horizontal color flaw between right base fern color and lower right panel wing even with 2<sup>nd</sup> shading line (variable and not constant). Similar flaw on position 60 of plates 23-28. (Also seen on position 60 of most of plates 1-22.)
