# The Plate and Print Flaws of the 2d Lithograph Pictorial

## Plates 27 and 28

Jerry Weirich

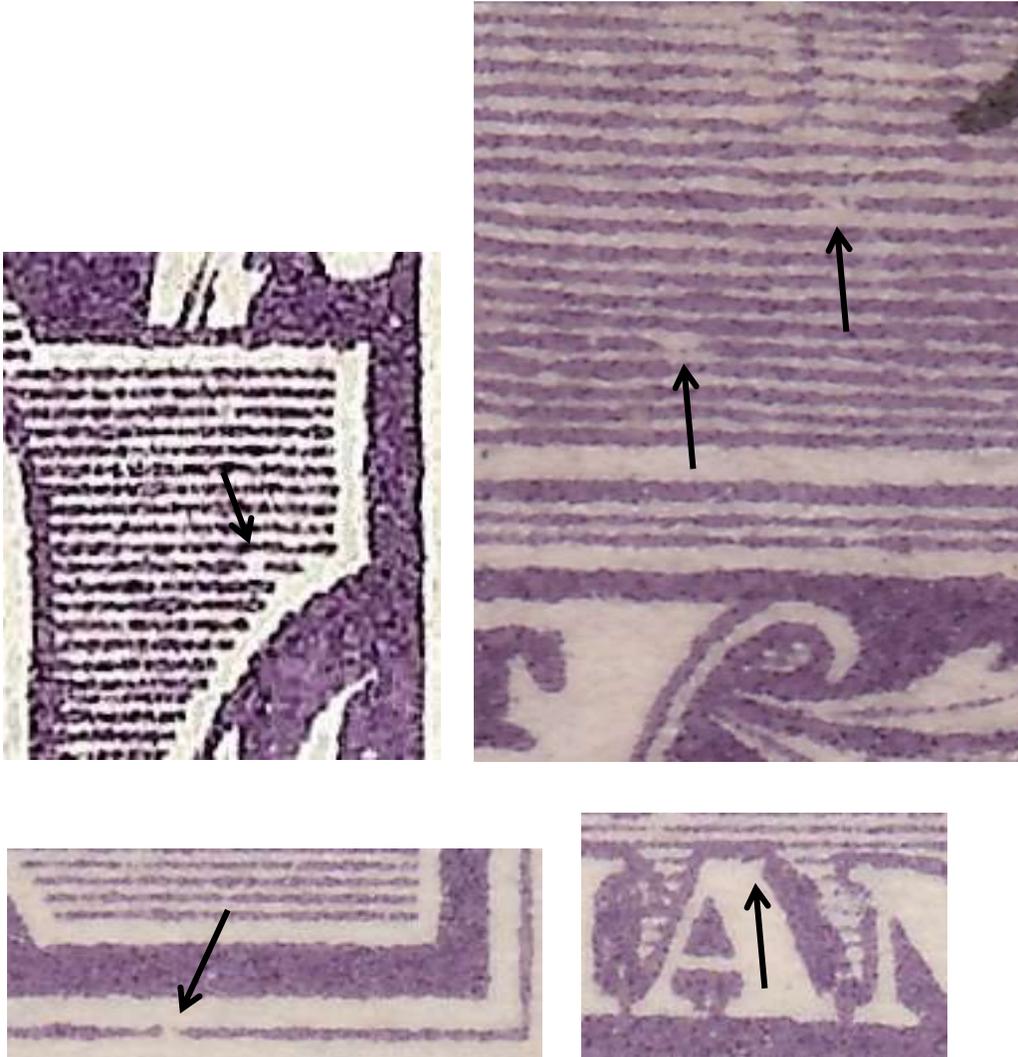
- a) Break in panel shading (11<sup>th</sup> line down) in upper right panel wing.
- b) Break in water shading (4<sup>th</sup> line up) above right end of title tablet. Similar flaw on plate 27, position 18.
- c) Break in water shading (10<sup>th</sup> line up) above right end of title tablet (variable).
- d) Break in bottom frame, 3.5 mm from right corner.
- e) Spur on top right of second A of Tasmania (variable).
