# The Plate and Print Flaws of the 2d Lithograph Pictorial

## Plates 27 and 28

Jerry Weirich

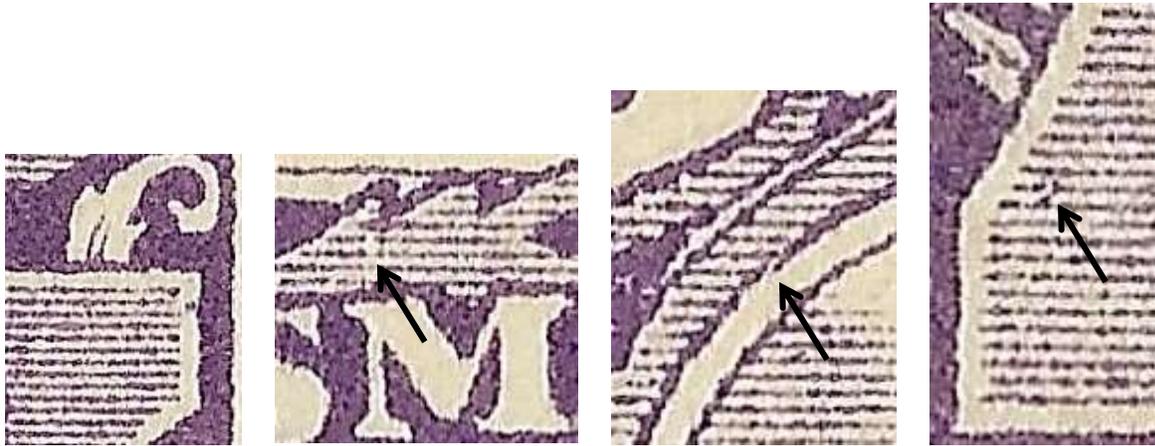
### 27-1

- Color flaw in white margin adjacent to the 2<sup>nd</sup> and 3<sup>rd</sup> shading lines of upper right panel wing.
- Break in upper panel shading above left upright of M of Tasmania.
- Diagonal white line breaks outer vignette frame at upper left.
- Tiny color flaw in lower left panel wing between 12<sup>th</sup> and 14<sup>th</sup> lines.

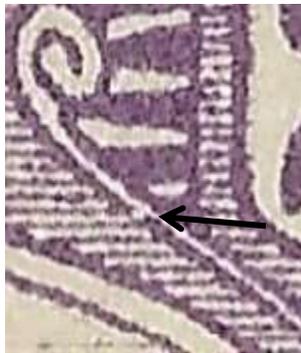
### 27-2

- Tiny white spur on white frame of right scroll adjacent to 1<sup>st</sup> spoke from right.

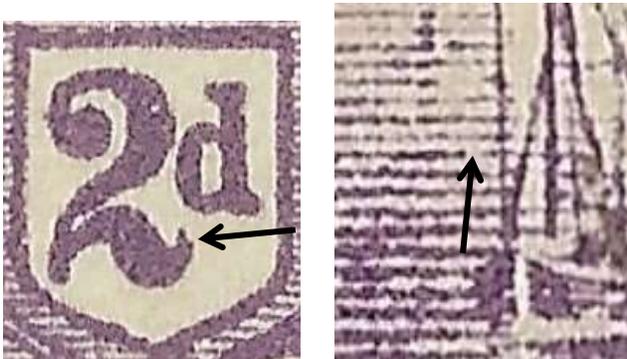
27-4

- a) Tail of 2 clipped slightly resulting in a more pointed tail in RVT.
- b) Break in water shading (6<sup>th</sup> line above top of hull) left of yacht's left vertical rope.

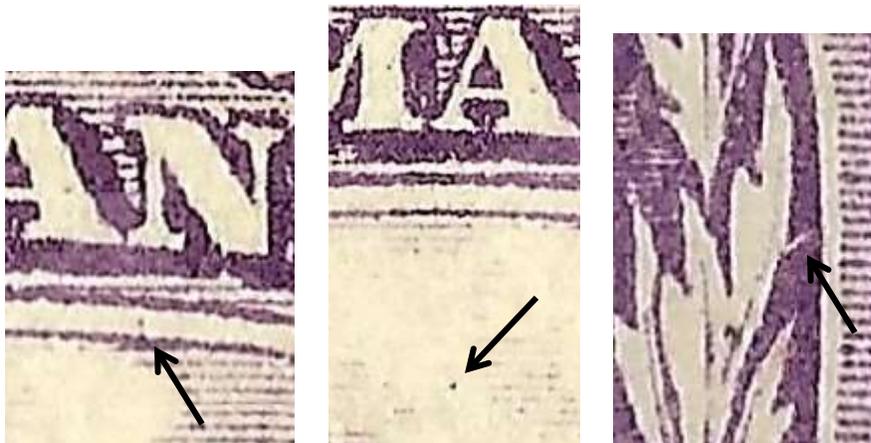
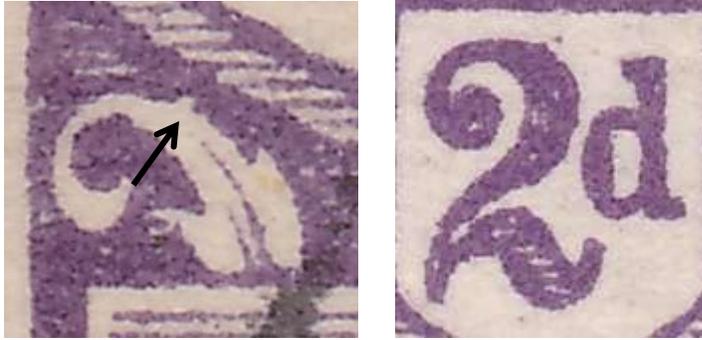
**27-8**

- a) Small color dot between vignette frames below left upright of N of Tasmania.
- b) Tiny color dot in sky below second A of Tasmania, 6.25 mm below top frame.
- c) Diagonal white line extending upward from right side of large fern in left fern cluster (variable).
- d) Small white spur on top left of topmost right fern (variable).
- e) Tiny color flaw above 2 in RVT (variable).

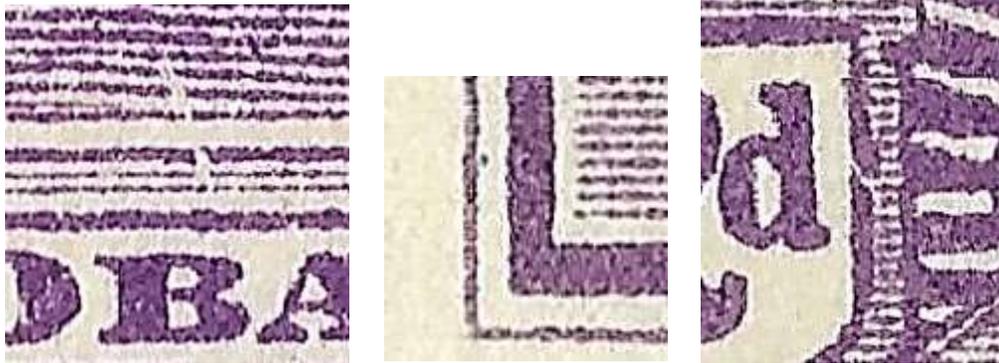
27-12

- a) Diagonal white line breaks water and lower shading panel above B of Hobart.
- b) Color dot on inside of left frame, 1.5 mm above bottom frame.
- c) Diagonal white line breaks right frame of LVT (variable).

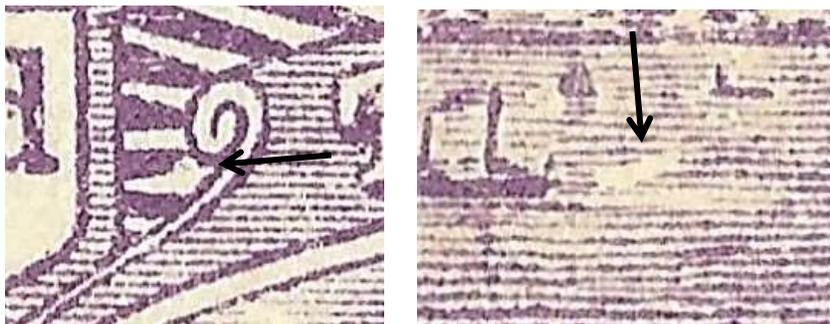
27-13

- a) White flaw above right end of 2<sup>nd</sup> spoke from left.
- b) Diagonal white flaw above wake of steamship.

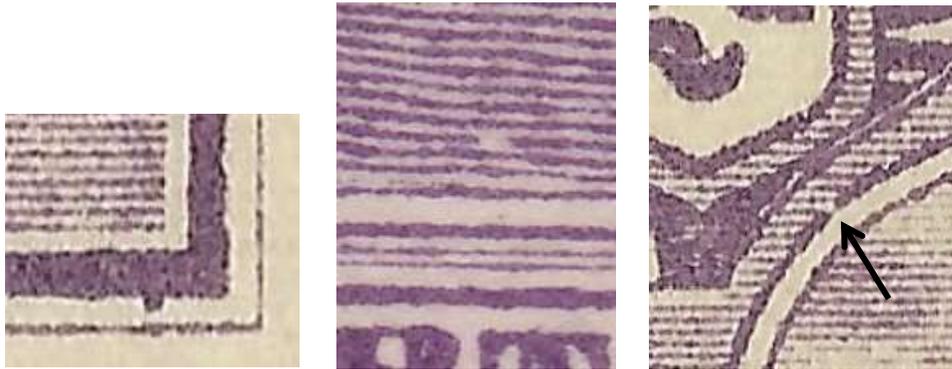
27-14

- a) Color spur beneath solid color at lower right, 1.0 mm from right frame.
- b) Break in water shading (3<sup>rd</sup> line up) above T of Hobart.
- c) Nick in outside of outer vignette frame at upper left, 6.0 mm from top frame (variable).

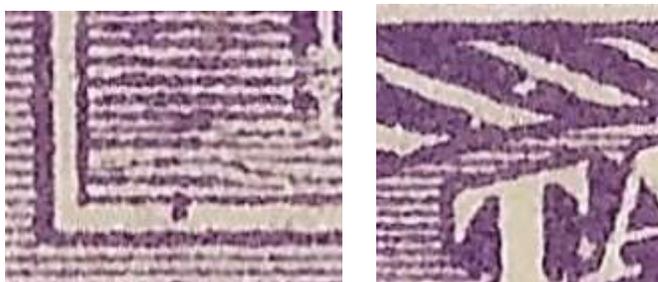
**27-19**

- a) Color dot between lower vignette frames, 1.5 mm from lower left vignette corner.
- b) White flaw between 7<sup>th</sup> and 8<sup>th</sup> spokes from left and above T of Tasmania.
- c) White spur under 7<sup>th</sup> spoke from left and adjacent to shading panel border (variable).

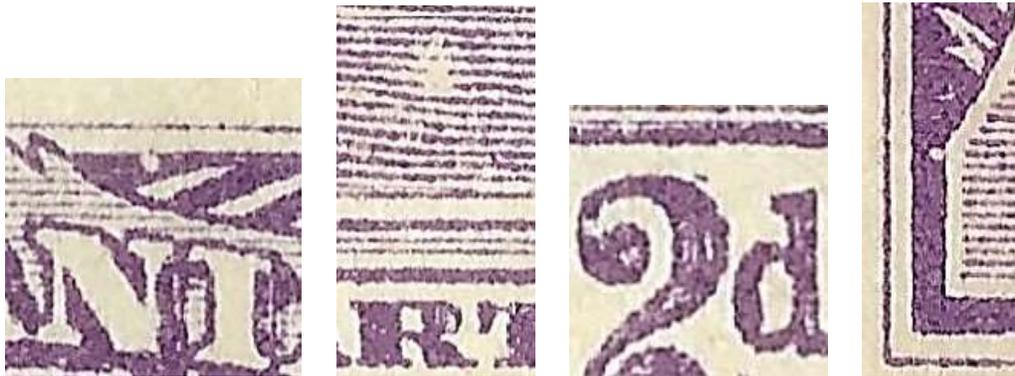
27-20

- a) White flaw in solid color above N of Tasmania (variable).
- b) Break in two water shading lines (9<sup>th</sup> and 10<sup>th</sup> lines up) above R of Hobart.
- c) Tiny color flaw above 2 in RVT (variable).
- d) White flaw in solid color at lower left, about 2.5 mm above bottom frame.

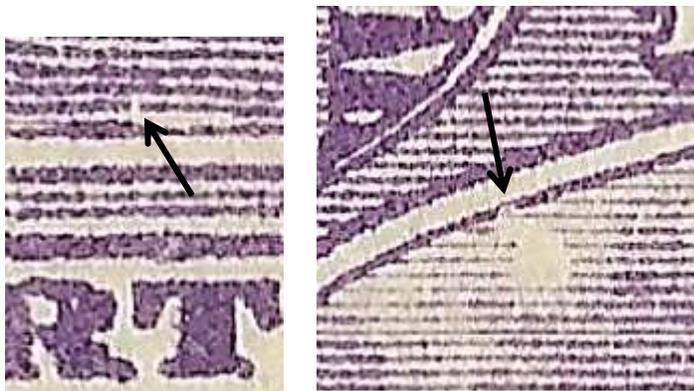
**27-23**

- a) Break in water shading (1<sup>st</sup> line up) above RT of Hobart.
- b) White flaw in the inner vignette frame at upper left (variable). Almost appearing as if the white cloud is encroaching on frame.

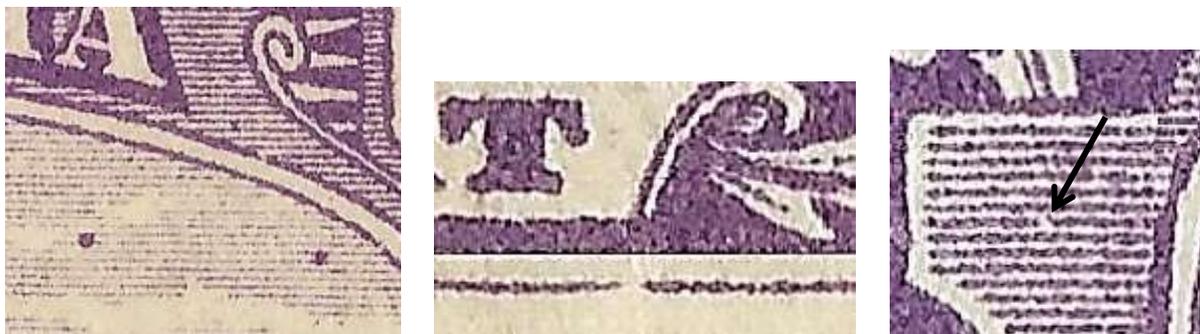
**27-24**

- a) Color flaw in upper right sky, 6.75 mm below top frame and 6.0 mm from right frame.
- b) Color flaw in sky below third A of Tasmania, 6.25 mm below top frame and 10.5 mm from right frame (not constant).
- c) Break in bottom frame below right end of title tablet, 10.5 mm from right corner. (Similar flaw on plate 27, position 22.)
- d) Nick, sometimes break, in panel shading (7<sup>th</sup> line down) in upper left panel wing.

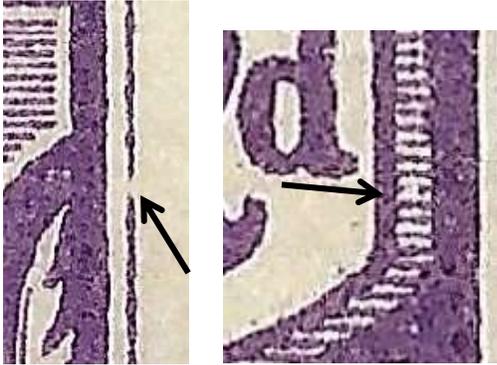
27-27

- a) Break in right frame, 9.5 mm below right corner.
- b) Break in right shading of RVT.

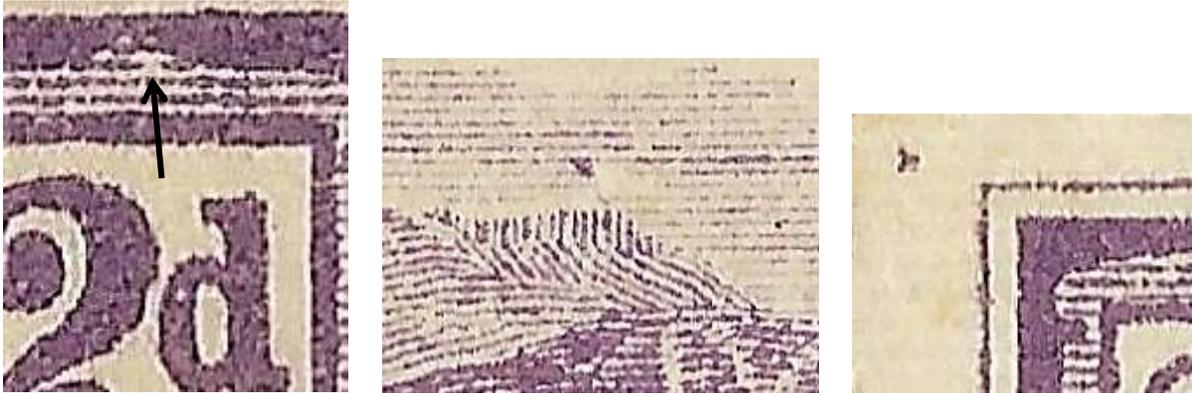
27-35

- a) Break in top shading line above RVT.
- b) Small spur, sometimes a color dot, on top of d in RVT (variable).
- c) Color flaw in sky just above mountain ridge and below third A of Tasmania.
- d) Color flaw off top left corner.

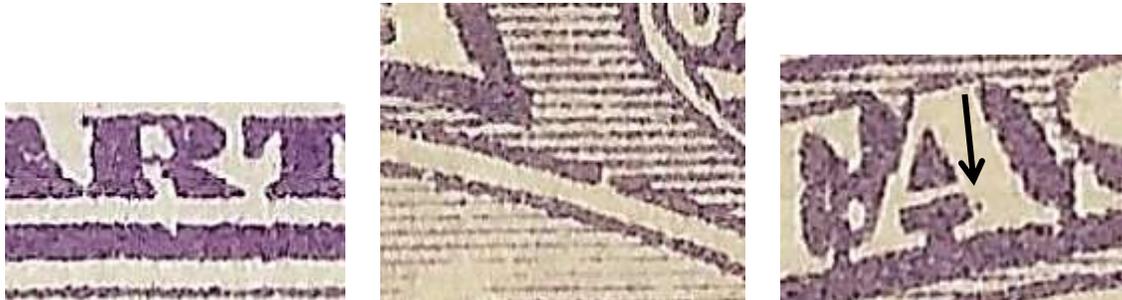
**27-37**

- a) Nick in color under R of Hobart.
- b) Break in outer vignette frame at upper right.
- c) Color dot in first A of Tasmania.

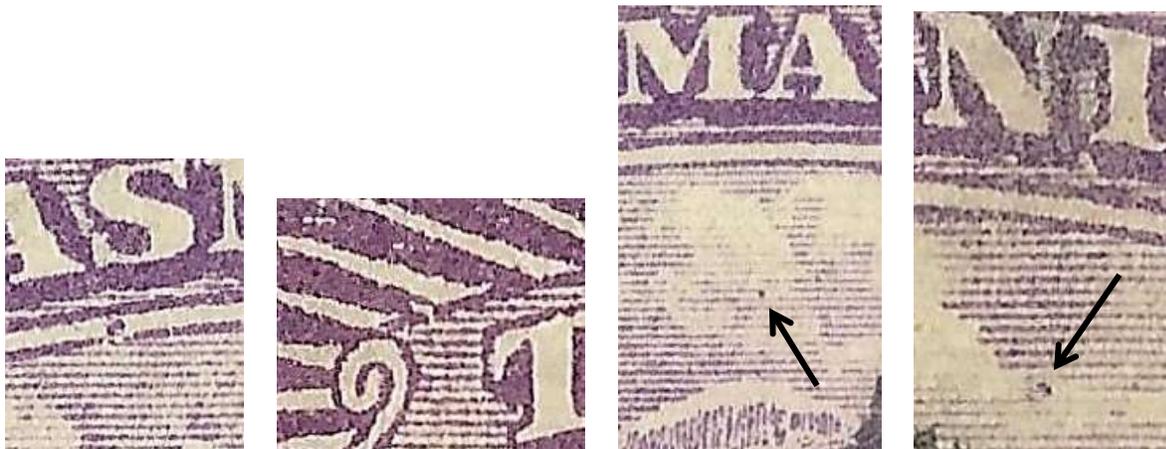
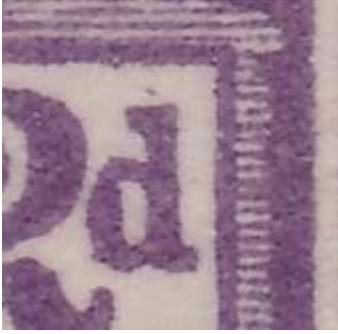
**27-38**

- a) Color flaw between vignette frames below S of Tasmania.
- b) White flaw on upper panel shading between 5<sup>th</sup> and 6<sup>th</sup> spoke from left (variable).
- c) Small color flaw in sky above mountain summit and below MA of Tasmania (variable).
- d) Color flaw in sky below N of Tasmania (variable and not constant).
- e) Small color flaw above d in RVT (variable).

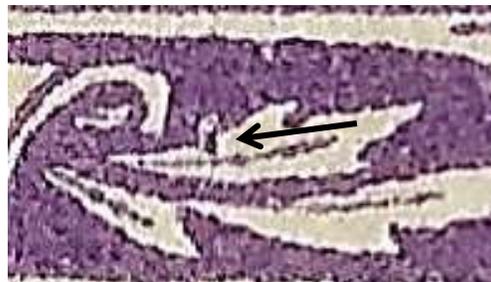
**27-39**

- a) Break in right end of panel shading adjacent to T of Tasmania.
- b) Small white flaw above right base ferns with a small color flaw in fern right below.
- c) Shallow notch in top of topmost fern at right (variable and not constant). Similar flaw on plate 27, position 43.

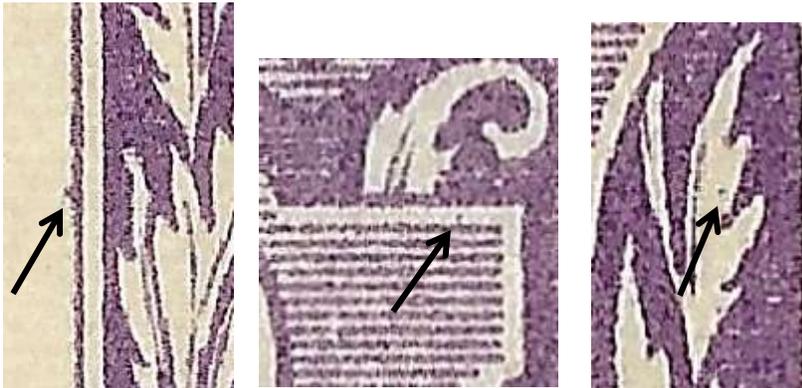
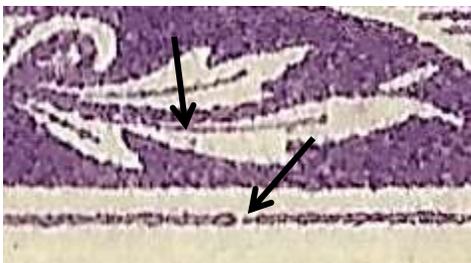
27-40

- a) Color spur on left frame, 10.75 mm above bottom frame.
- b) Tiny color dot in upper white border of upper right panel wing (variable).
- c) Tiny color dot in upper fern in right fern cluster.
- d) Tiny color dot in base of right base ferns (variable).
- e) Break in bottom frame below right base ferns, 7.5 mm from right corner (variable and not constant).

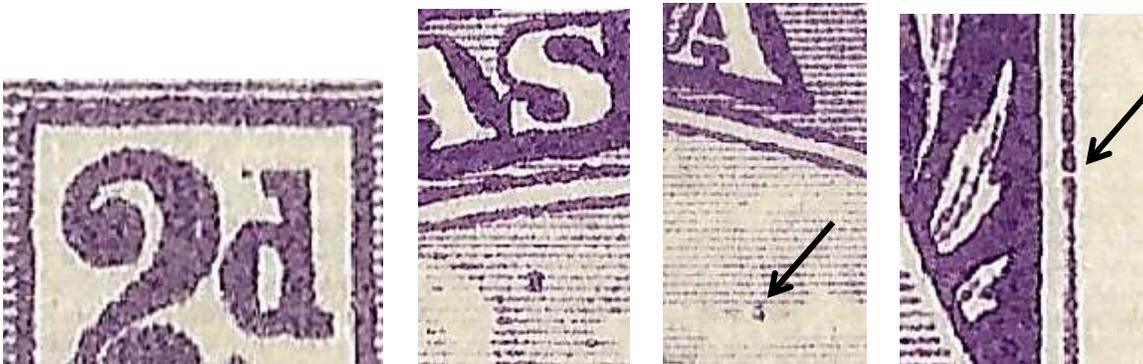
27-41

- a) Color dot top left of d in RVT (variable).
- b) Color flaw in sky below S of Tasmania (variable and not constant).
- c) Color flaw in sky below third A of Tasmania, 7.5 mm below top frame (not constant).
- d) Thin break in right frame, 5.5 mm above right corner.
- e) Color dot inside right frame, 9.0 mm above bottom frame.

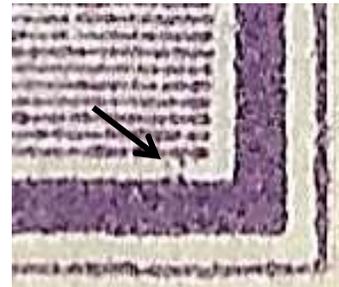
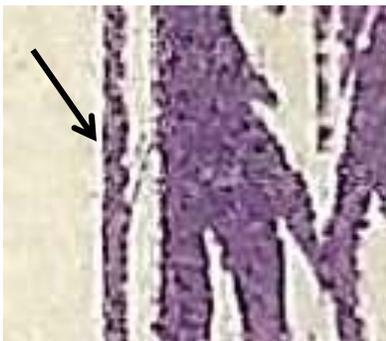
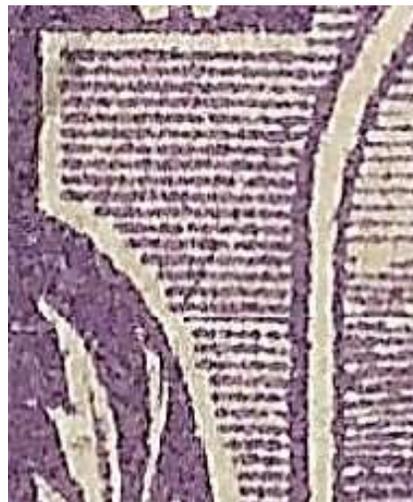
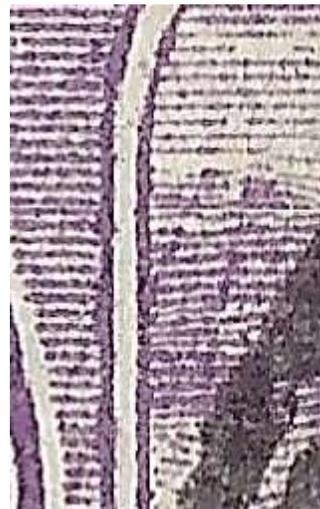
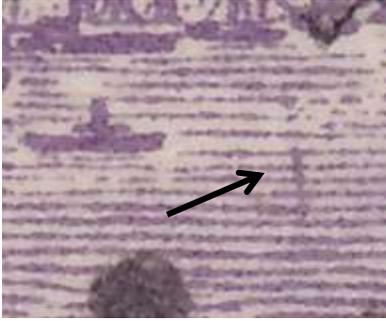
**27-42**

- a) Color dot inside right frame, 9.75 mm below top frame.
- b) Small white nick in 2 above ball in RVT.
- c) Break in sky shading (3<sup>rd</sup> line up), 1.0 mm inside left vignette frame.
- d) Small color flaws in lower white frame of lower right panel wing (not constant).
- e) Two thin color lines between left frame and left fern cluster, 13.0 mm below top frame. Some copies show a faint extension of one line into left margin.
- f) Traces of color lines in upper left panel wing and left side of vignette (variable and not constant). Two scans.
- g) Trace of color line in water to right of rowboat (variable).

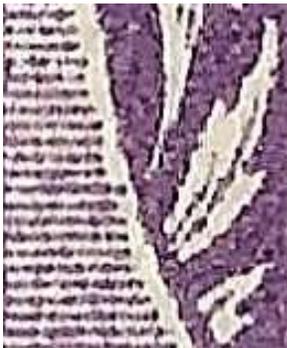
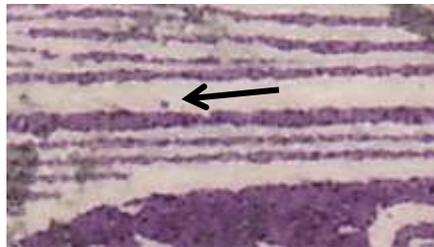
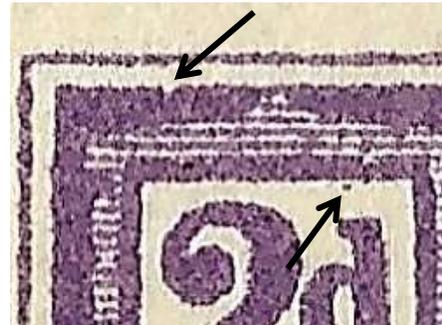
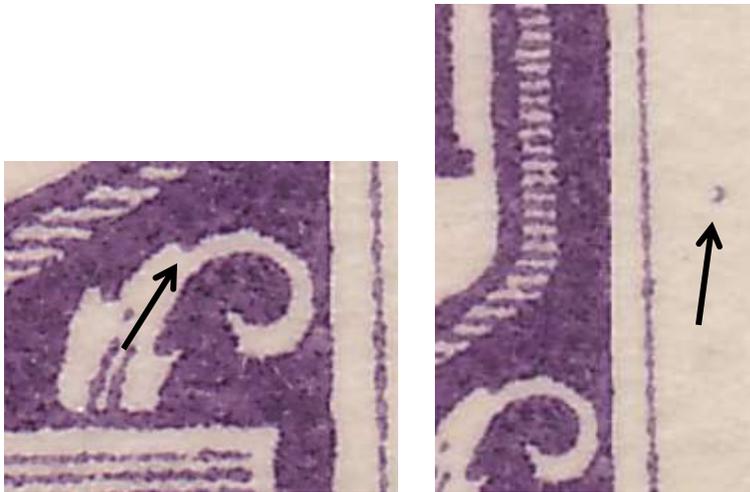
**27-43**

- a) Color dot in white margin of right panel adjacent to tip of stem of large fern in right fern cluster. Similar flaw, except slightly higher in margin, on plate 27, position 52.
- b) Color dot between lower vignette frames and above left base ferns, 7.25 mm from lower left vignette corner.
- c) Color dot above d and just below top frame of LVT (variable).
- d) Nick in solid color above LVT, 1.75 mm from left frame (variable and not constant).
- e) Small color dent in topmost fern at right (variable). Similar flaw on plate 27, position 39.
- f) Color flaw outside right frame, 4 mm from top frame (Variable and not constant).

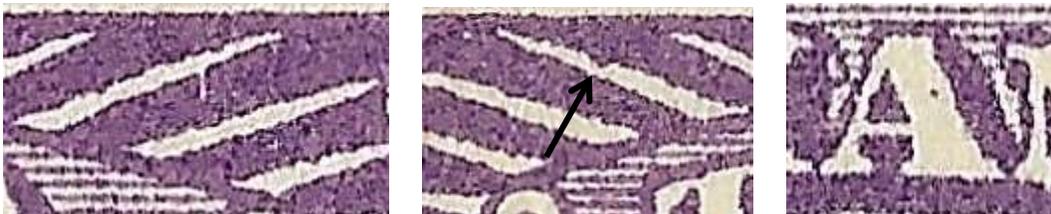
**27-44**

- a) Thin vertical white line hanging down from underside of 7<sup>th</sup> spoke from right (not constant, subject to inking).
- b) Color bulge in top of 7<sup>th</sup> spoke from left.
- c) Color dot in second A of Tasmania.

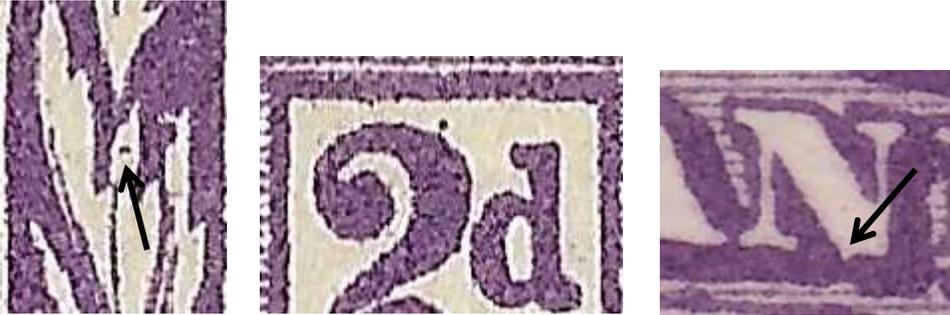
27-45

- a) Master Plate Flaw: Color dot in top of middle leaf of large fern in right fern cluster (variable). Similar flaw on position 45 of plates 23-28. (Also seen on position 45 of at least some of the plates 1-22.)
- b) Color dot above 2 in RVT.
- c) Small white spur on bottom right of N of Tasmania (variable).

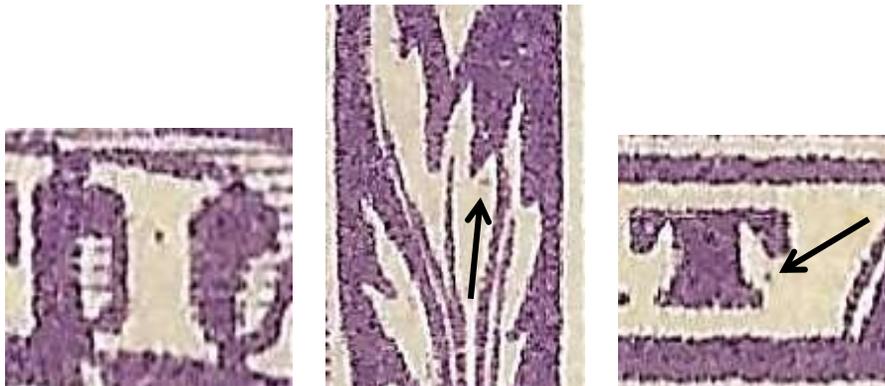
**27-47**

- a) Color dot in I of Tasmania.
- b) Master Plate Flaw: Color dot in top of large fern in right fern cluster. Similar flaw on position 47 of all plates 23-28.
- c) Color dot to right of T of Hobart (not constant).

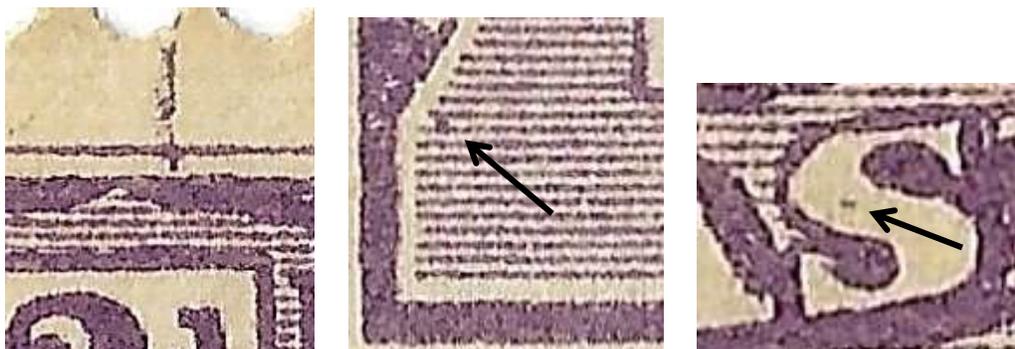
**27-48**

- a) Vertical color flaw above LVT extending from solid color through top frame to top margin.
- b) Color flaw in panel shading (between 11<sup>th</sup> and 12<sup>th</sup> lines up) in lower left panel wing (variable).
- c) Color flaw in S of Tasmania.
- d) Color dot between lower vignette frames over right end of title tablet (not constant).

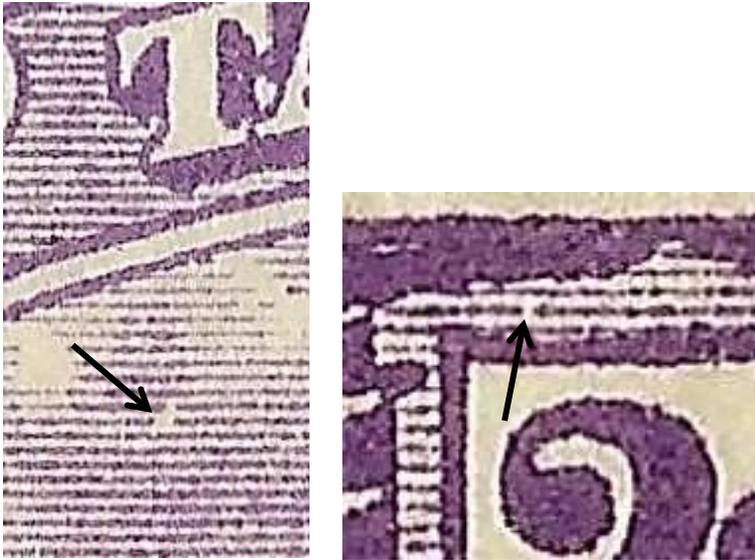
**27-50**

- a) Break in sky shading (10<sup>th</sup> and 11<sup>th</sup> lines down) below T of Tasmania and 6.5 mm below top frame.
- b) Break in shading (1<sup>st</sup> line up) above left side of RVT (not constant).

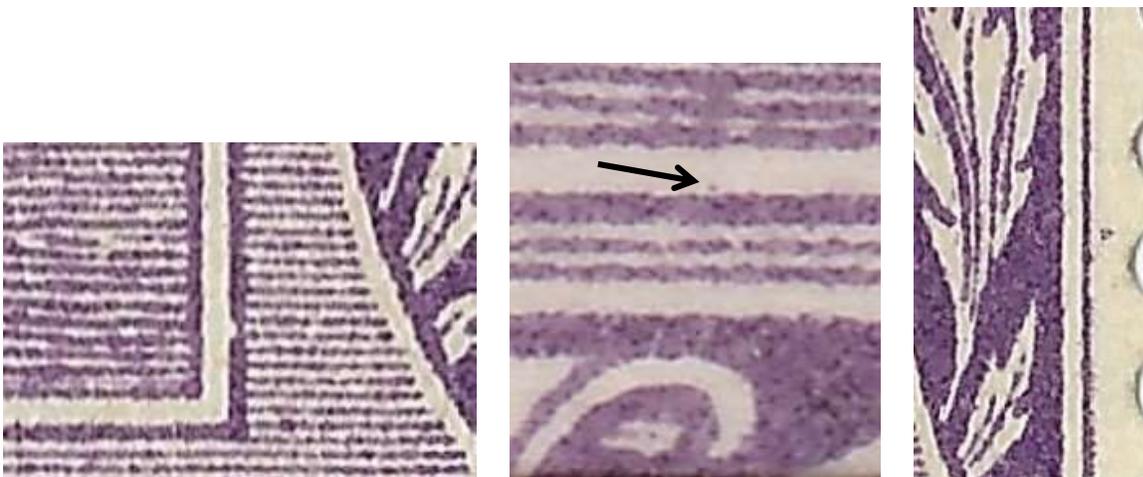
**27-51**

- a) Near break in outer vignette frame at right, 1.0 mm above lower right vignette corner.
- b) Tiny color dot between lower vignette frames above right end of title tablet.
- c) Color dot outside right frame, 8.0 mm above bottom frame (not constant).

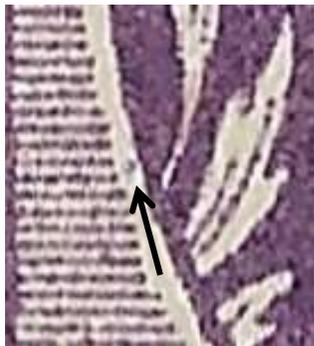
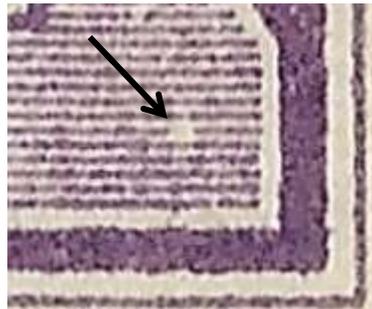
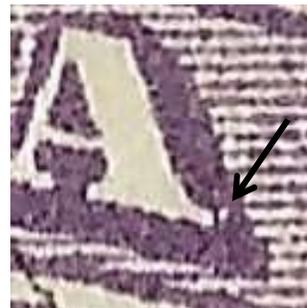
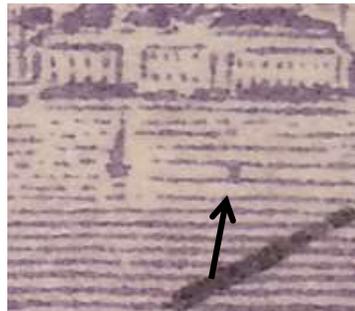
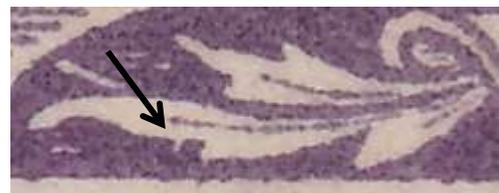
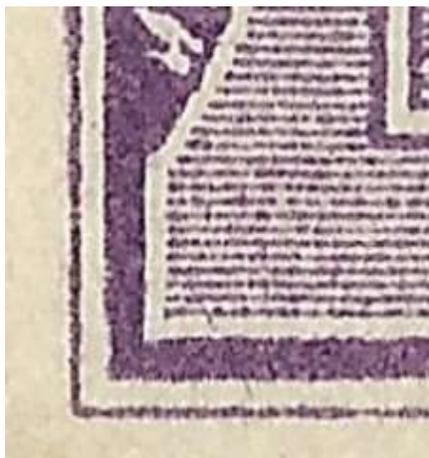
**27-52**

- a) Color dot in white margin of right panel adjacent to stem of large fern in right fern cluster. Similar flaw, except slightly lower in margin, on plate 27, position 43.
- b) Break in panel shading (6<sup>th</sup> line up) in lower right panel wing.
- c) Tiny white dot adjacent to right serif of third A of Tasmania (variable).
- d) Tiny white dot in upper solid color between 7<sup>th</sup> and 8<sup>th</sup> spokes from right (not constant).
- e) Color flaw in water shading right of buoy.
- f) Tiny white spur on left base ferns (not constant).
- g) Hairline: Intermittent color line across lower left corner (variable and not constant). Continues into position 58.

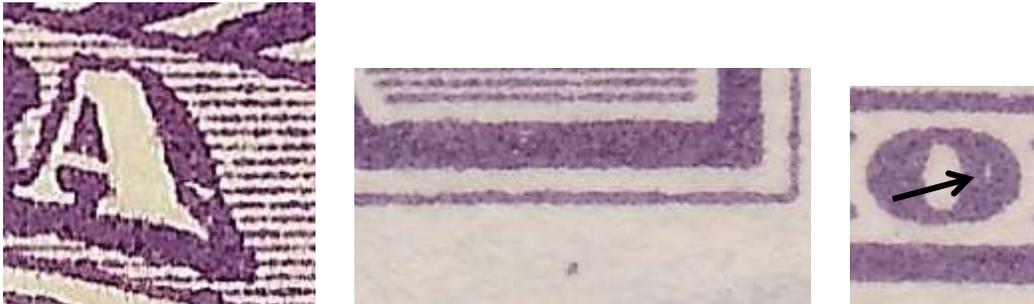
**27-53**

- a) White flaw on right side of third A of Tasmania (variable). This flaw varies from a thin line to a thin line with thicker right side or star burst on right side.
- b) Color flaw outside bottom frame, 2.5 mm from right frame (not constant).
- c) Tiny white flaw in O of Hobart (variable and not constant).

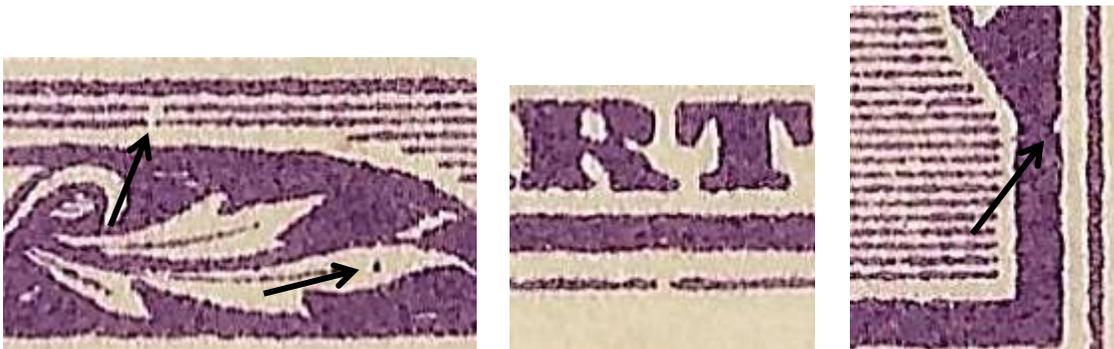
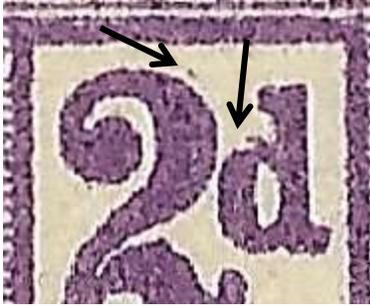
**27-54**

- a) Color dot in right base ferns (variable).
- b) Break in lower panel shading (both lines) above right base ferns (variable).
- c) Break in bottom frame below R of Hobart, 12.5 mm from right corner (variable and not constant). The break is usually very thin or shows as a nick in frame.
- d) Nick in right solid color, 2.75 mm above bottom frame.
- e) White flaw in top of loop of d in RVT.
- f) Color flaw above top right of 2 in RVT.

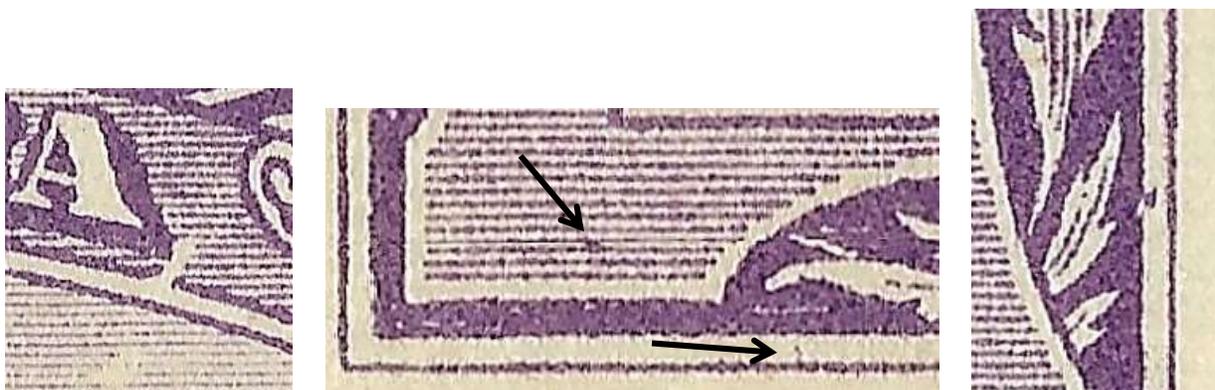
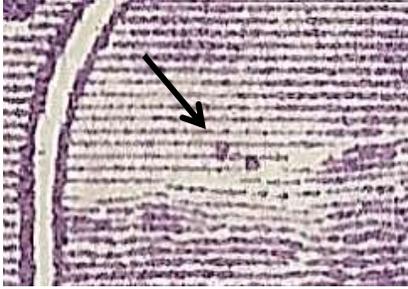
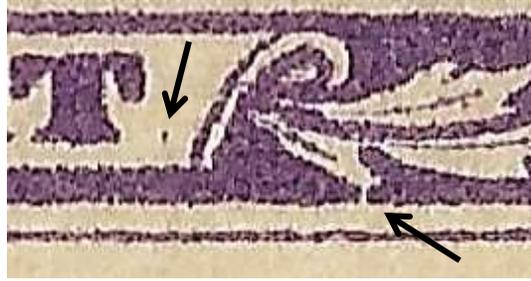
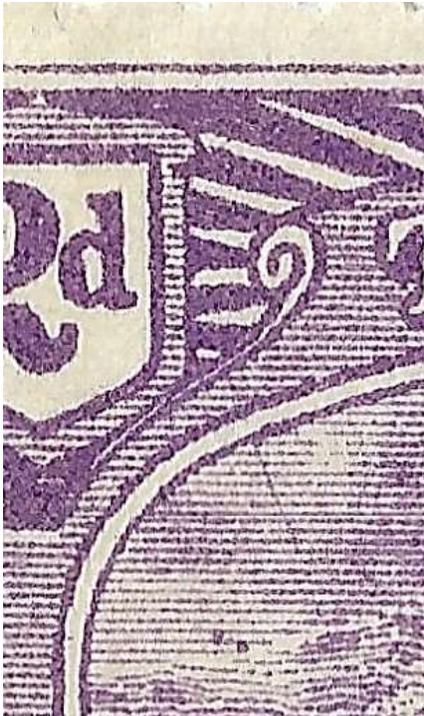
27-58

- a) Diagonal white flaw at lower right of third A of Tasmania breaking top vignette frame and surrounding shading.
- b) Color flaw in panel shading (between 3<sup>rd</sup> and 4<sup>th</sup> lines up) in lower left panel wing (variable).
- c) Thin curved color flaw on bottom frame, 5.5 mm from left frame (variable).
- d) Color flaw inside right frame and almost attached to solid color, 6.0 mm above bottom frame.
- e) Two color flaws in sky on mountain ridge (not constant).
- f) Master Plate Flaw: Vertical color dash after T of Hobart. Similar flaw on position 58 of plates 23-28. (Also seen on position 58 of most of plates 1-22.)
- g) White line connecting right base fern with lower margin (variable).
- h) Hairline: Faint intermittent color line above LVT, across sky to mountain ridge (variable and not constant). Continuation from position 52.

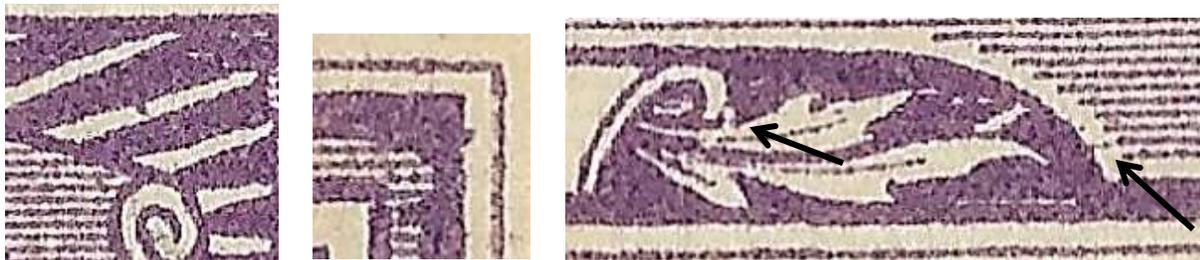
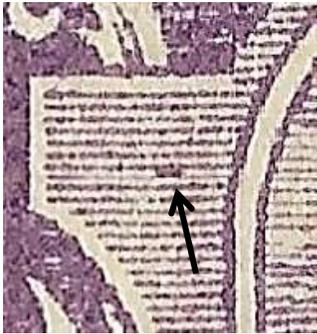
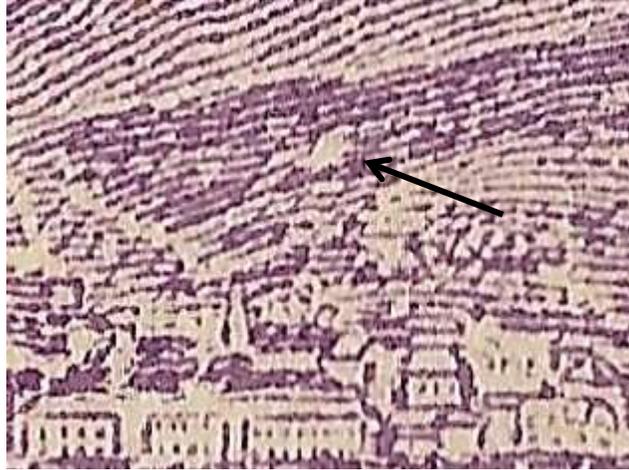
27-60

- a) Color dot in center of 6<sup>th</sup> spoke from right.
- b) Color spur on of right solid color, 0.5 mm below top corner.
- c) Small white flaw connecting top of right base ferns with right side of title tablet scroll.
- d) Master Plate Flaw: Short horizontal color flaw between right base fern color and lower right panel wing even with 2<sup>nd</sup> shading line. Similar flaw on position 60 of plates 23-28. (Also seen on position 60 of most of plates 1-22.)
- e) Color flaw in upper left panel wing between 7<sup>th</sup> and 8<sup>th</sup> shading lines (not constant).
- f) White flaw on hillside above town, about 12 mm from bottom frame and 13 mm from right frame.

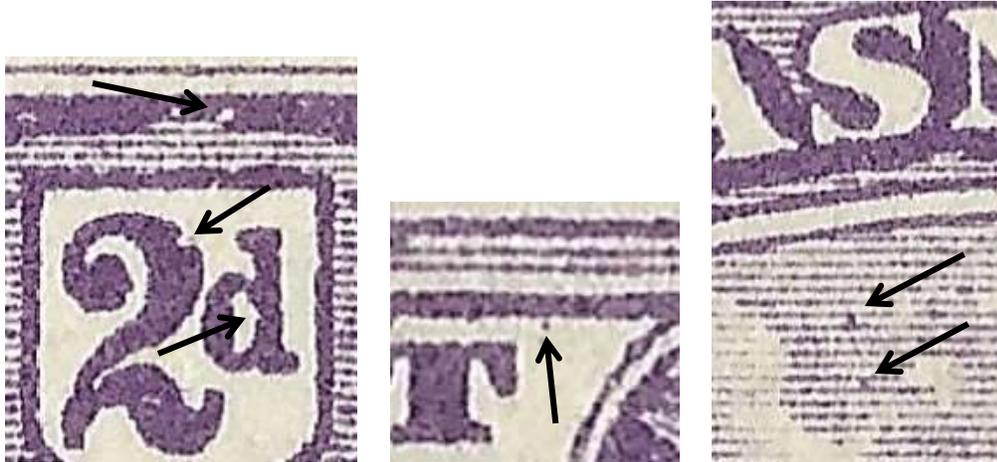
28-1

- a) Nick in top right of 2 in RVT.
- b) White flaw in solid color above shading near center of RVT.
- c) Nick on inside of d in RVT (variable).
- d) Color dot in title tablet at upper right of T of Hobart.
- e) Two tiny color flaws in sky below S of Tasmania (variable).

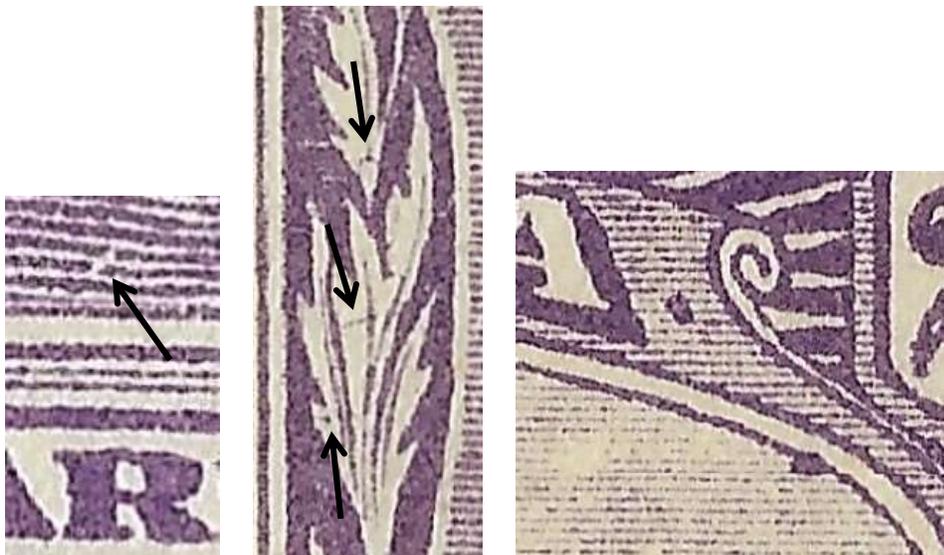
28-2

- a) Diagonal break in water shading (3<sup>rd</sup> and 4<sup>th</sup> lines up) above R of Hobart.
- b) Three small color flaws in left fern cluster—two in large fern and one in upper fern.
- c) Color flaw on inside of inner top vignette frame at lower left of RVT (not constant). An additional color flaw is occasionally seen after the third A of Tasmania (not constant). Both flaws apparently appear in late prints only.

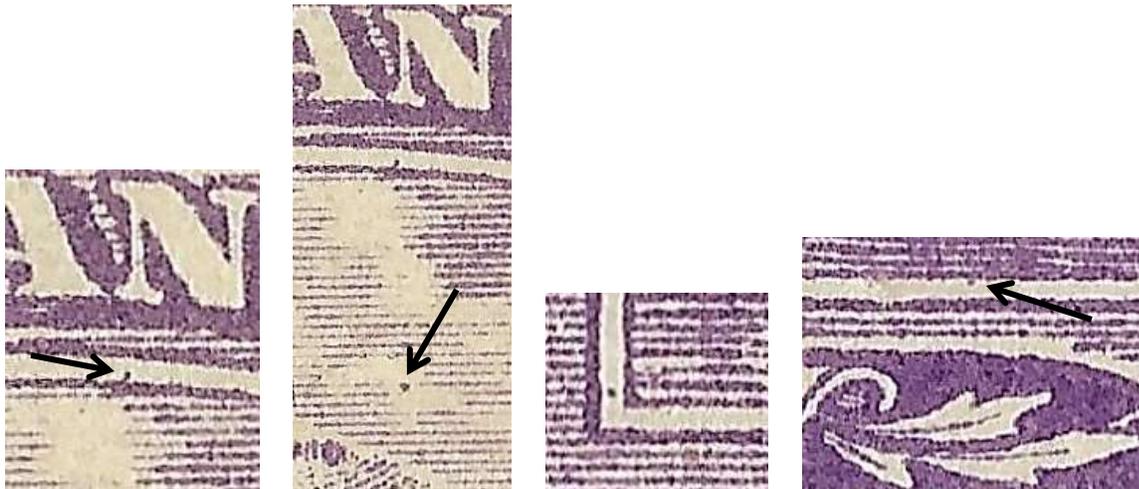
28-4

- a) Color spur on inner vignette frame below left upright of N of Tasmania.
- b) Color spot in sky below N of Tasmania, 7.5 mm below top frame (and directly below flaw a).
- c) Color dot between left vignette frames near lower left corner of vignette.
- d) Tiny color dot between lower vignette frames and above the right base ferns.

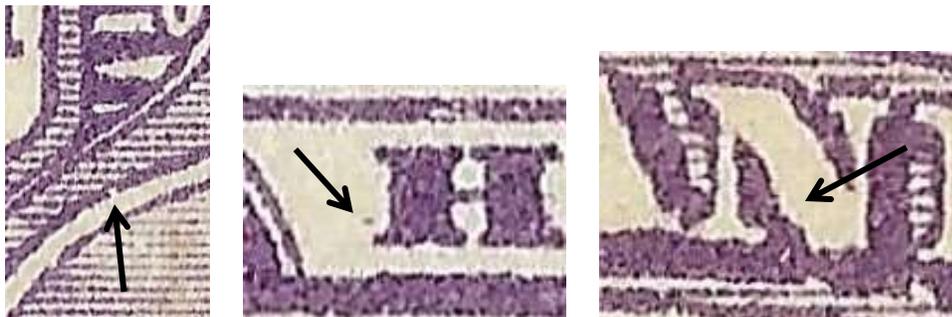
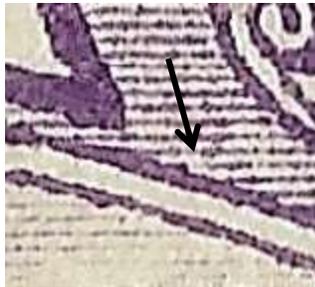
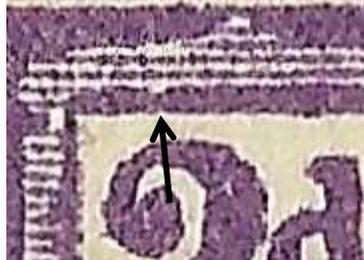
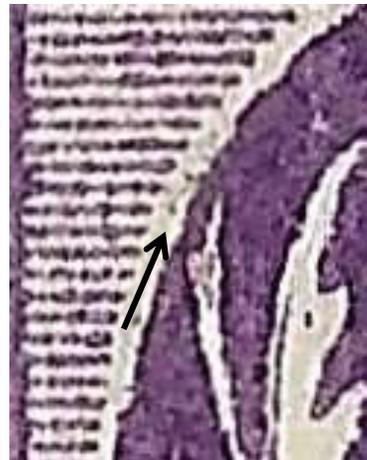
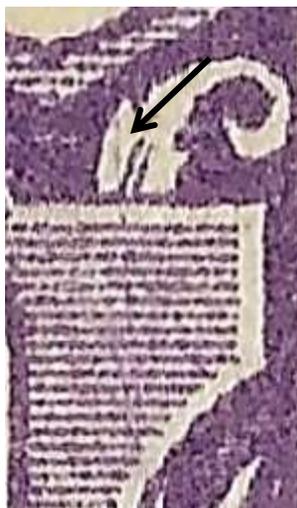
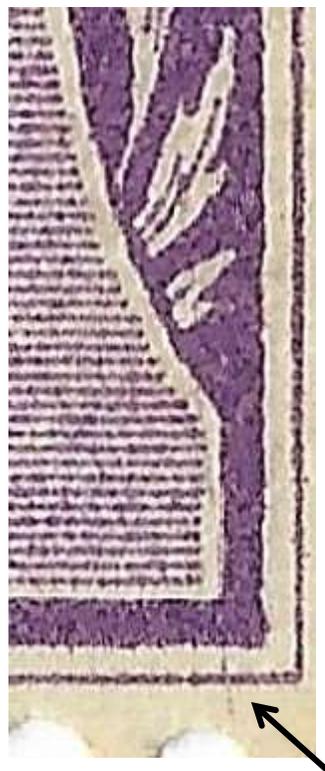
28-5

- a) Nick in the outer vignette frame at upper left.
- b) Tiny color dot to left of H of Hobart.
- c) Distorted and broader N of Tasmania (variable).
- d) Break or weakness in left end of panel shading (4<sup>th</sup> line down) from third A of Tasmania (not constant).
- e) Shallow nick in top frame of LVT left of center (variable).
- f) Color flaws in white margin of right panel between shading and right fern cluster (variable).

g) Hairline: Faint and intermittent color line from base of RVT through topmost right fern, right fern cluster, lower right panel wing, and exits bottom frame near lower right corner (variable and not constant). Shows best in left side of topmost right fern and lower right corner. Continues into position 11. Only two copies seen.

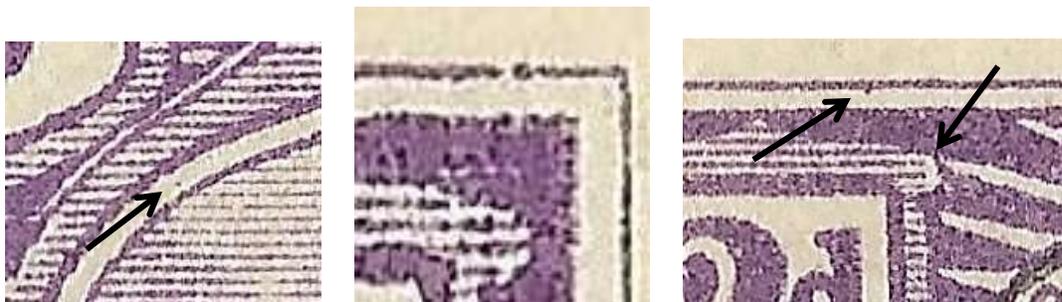
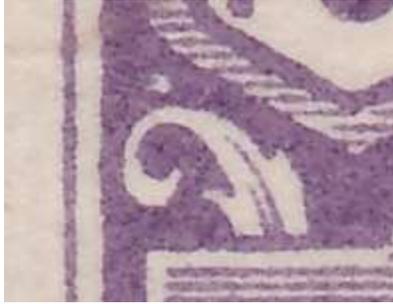
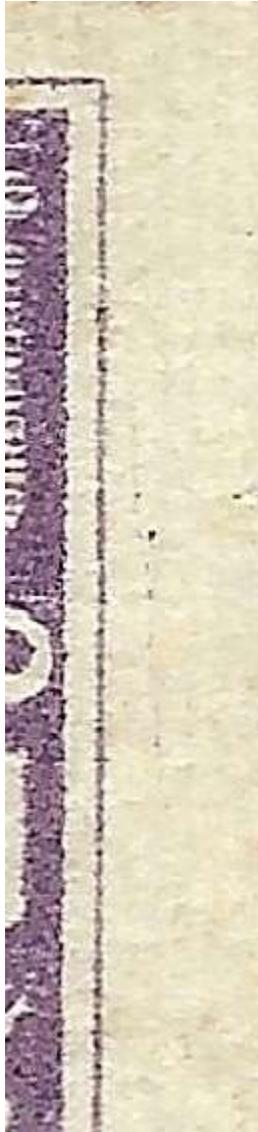
28-11

- a) Color dot between vignette frames at upper left.
- b) Thin break in top frame, 1.0 mm from right corner.

- c) Three shading lines at top right of LVT shortened on right ends. Similar flaw on plate 28, position 29.
- d) Tiny color spur on top frame above LVT, 4.5 mm from left corner (variable).
- e) White flaw above topmost fern at left (variable).
- f) Tiny color spur on lower solid color, 0.75 mm from left frame (variable).
- g) Two faint color flaws between solid color and bottom frame, about 1.5 mm from left frame (variable). Two scans.
- h) Hairline: Very faint and intermittent color line enters (from position 5) above top right corner and extends down right margin (not constant). Only one copy seen. The hairline may extend to position 12 and lower sheet positions, but has not been seen.

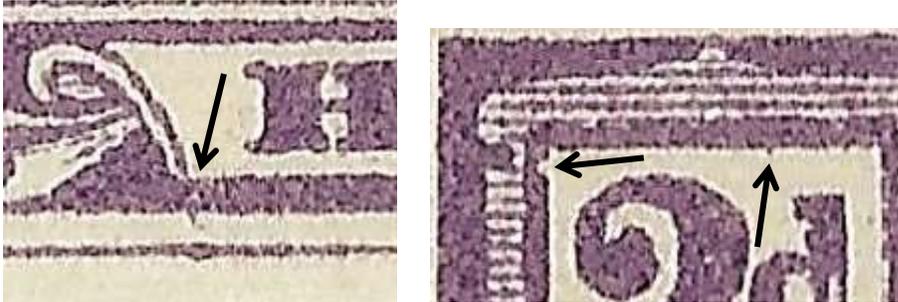
**28-12**

- a) Tiny color spur on solid color below left end of title tablet (variable).
- b) Tiny color spur on underside of top frame of LVT (variable).
- c) Nick on inside left frame of LVT near top (not constant).

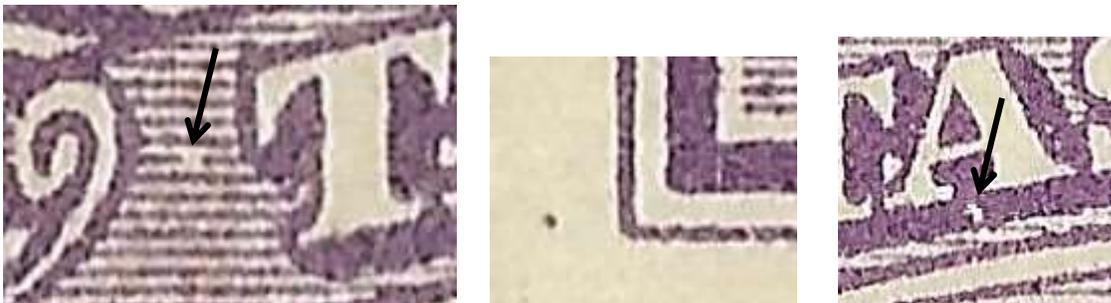
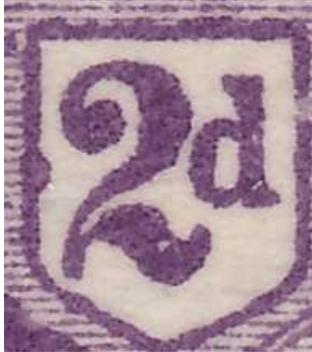
**28-13**

- a) Break in panel shading left of T of Tasmania.
- b) Color dot on left margin, 0.5 mm from lower left corner (variable).
- c) White flaw in color below first A of Tasmania.
- d) Color bulge on inside of left frame of LVT (not constant). Only seen in reddish lilac printings.

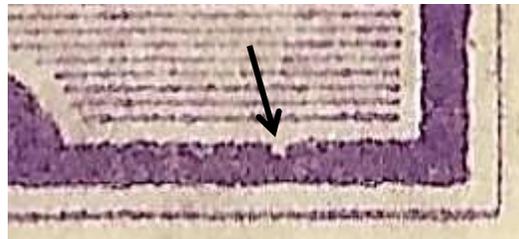
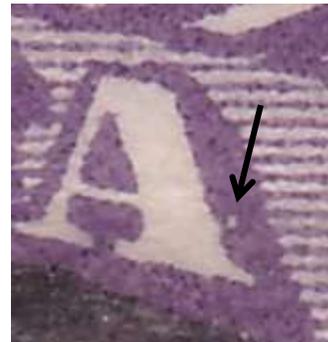
**28-14**

- a) Color dot inside right frame, 10.0 mm above right corner.
- b) Nick in solid color below lower right panel wing, 2.25 mm from right frame (variable).
- c) Tiny white dot in color right of third A of Tasmania (not constant).

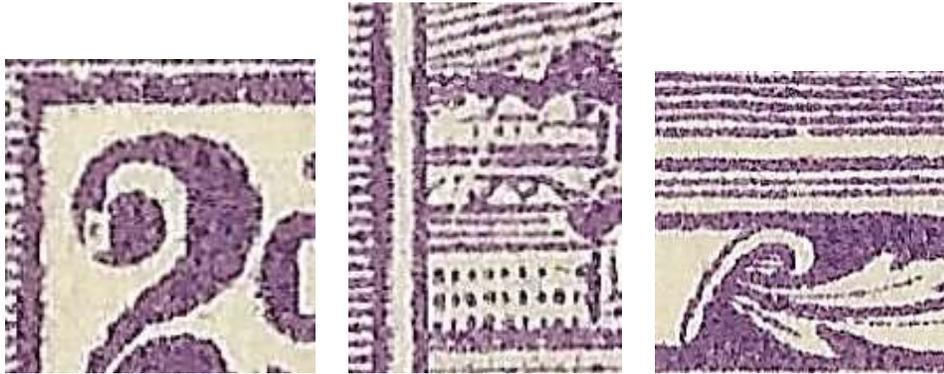
28-16

- a) White flaw with color dot in center on ball of 2 in LVT.
- b) Diagonal white line in buildings at far left.
- c) Break in the lower inner vignette frame above right end of title tablet.

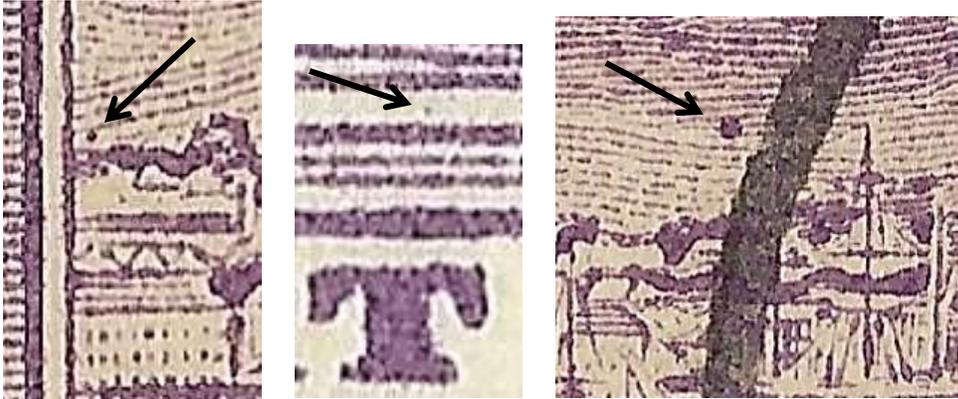
**28-23**

- a) Small color dot in mountain shading (1<sup>st</sup> line up) above trees and buildings at far left.
- b) Tiny color dot between vignette frames above T of Hobart.
- c) Color flaw on mountainside above and left of the left mast on frigate (not constant).
