# The Plate and Print Flaws of the 2d Lithograph Pictorial

## Plates 27 and 28

Jerry Weirich

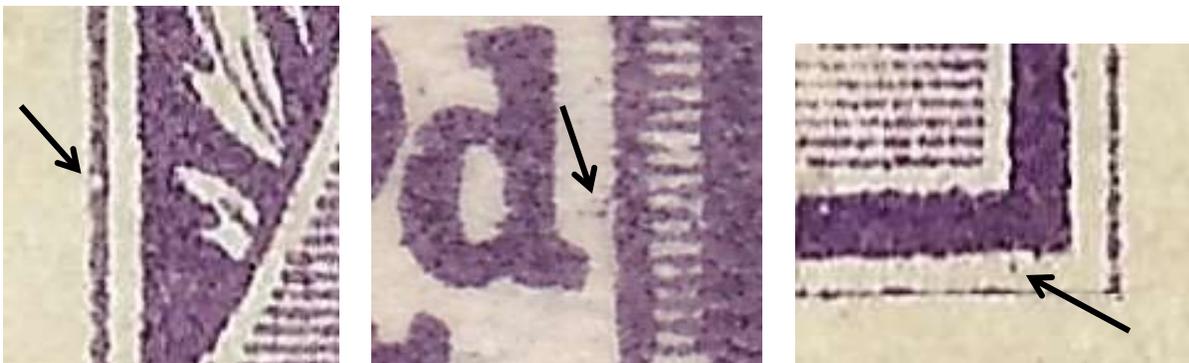
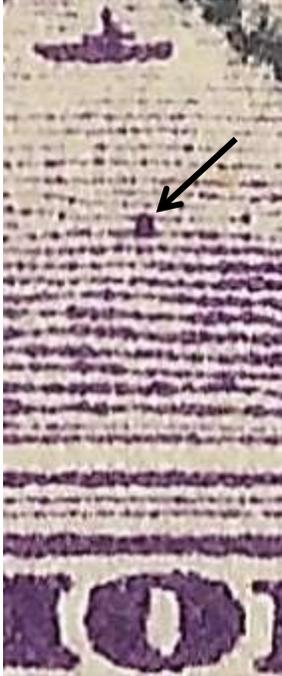
**28-24**

- a) Nick in left frame, 4.5 mm above left corner.
- b) Tiny color flaw along right frame of RVT (variable).
- c) Tiny color dot below solid color in lower right corner (variable).
- d) Color flaw in water (between 12<sup>th</sup> and 13<sup>th</sup> shading lines up) above O of Hobart (not constant). Appears more often in late printings (reddish lilac prints).

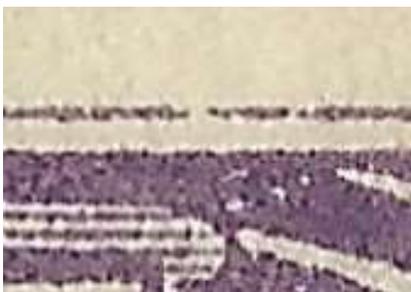
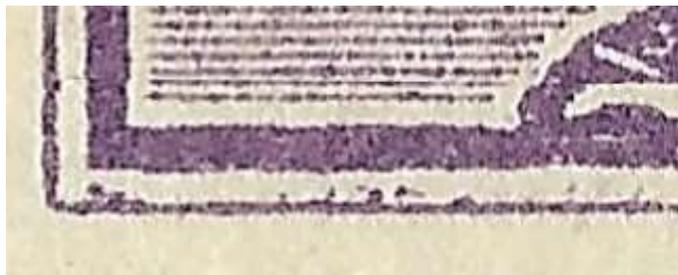
## 28-25

- a) Break in top frame, 5.0 mm from left corner.
- b) Color flaws between bottom frame and lower left solid color, up to 4.0 mm from left frame (not constant).
- c) Break in water shading (3<sup>rd</sup> line up) above right base ferns.
- d) Faint diagonal white line in water breaking above right end of title tablet (variable and not constant)
- e) Shallow indentation in top of title tablet frame above R of Hobart.
- f) Color dot inside loop of d in RVT. Similar flaw on plate 28, position 9.
- g) Color flaw in left panel and color dot between left vignette frames near middle (variable and no constant).
- h) Color flaws in large fern at left, left margins and left panel (possible remnants of a color line) (variable and not constant).

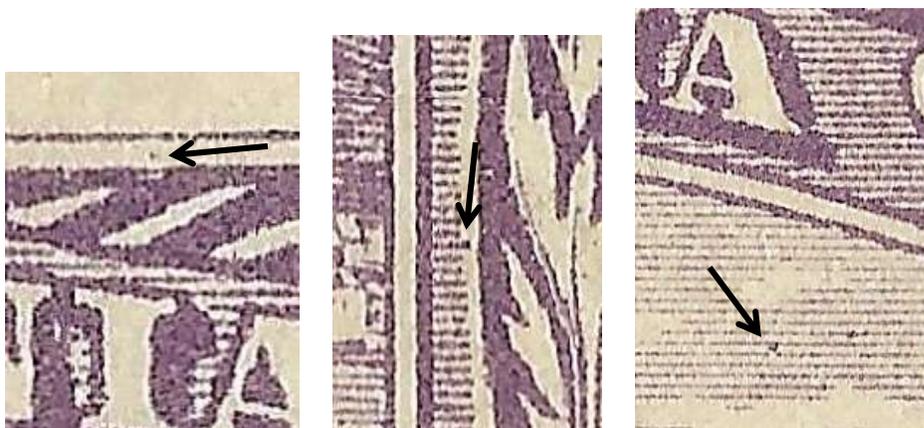
28-27

- a) Tiny color dot inside top frame above I of Tasmania, 11.25 mm from right corner.
- b) Color dot in white margin of near center of right panel (not constant).
- c) Color flaw in sky below third A of Tasmania (variable and not constant).
- d) Nick in title tablet above O of Hobart (not constant).
- e) Tiny white flaw on left side of trunk of T of Tasmania (variable and not constant).

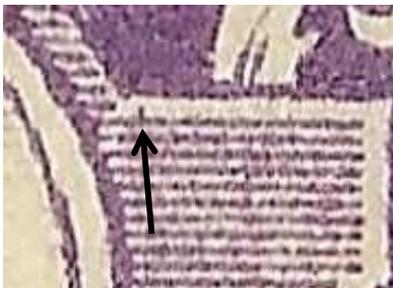
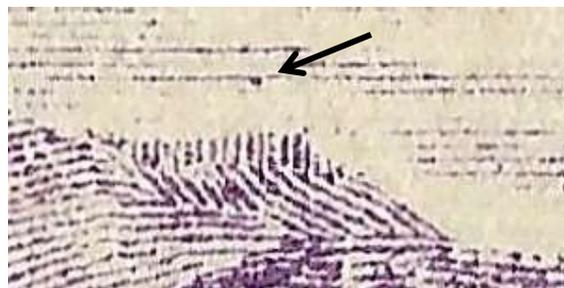
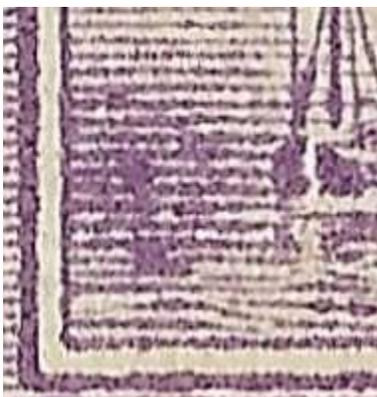
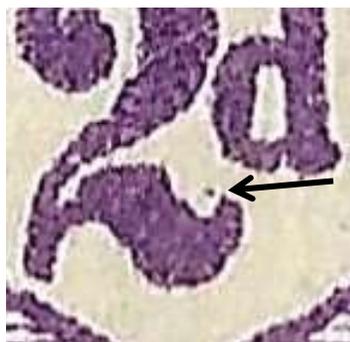
**28-59**

- a) Color spur on top of left end of shading (1<sup>st</sup> line) in upper right panel wing.
- b) Tiny color flaw in sky, 0.5 mm above ridge and below third A of Tasmania.
- c) Color flaws left of yacht.
- d) Tiny color dot on left side of tip of tail of 2 in LVT (variable).

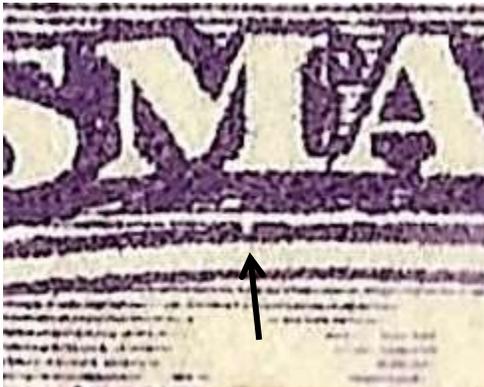
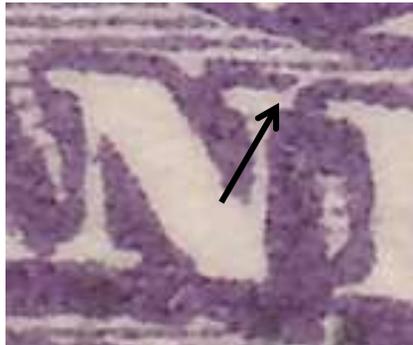
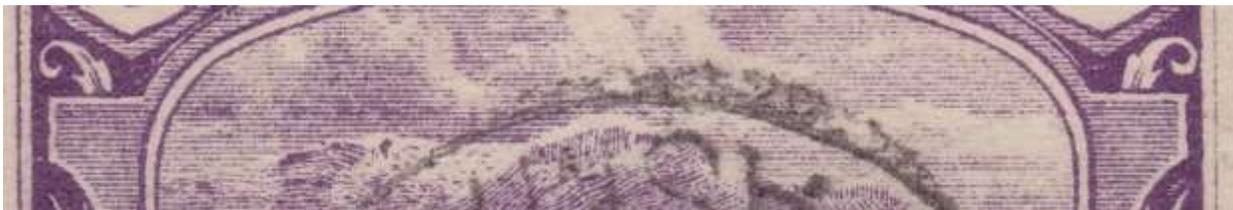
## UV-2

- a) Nick in top outer vignette frame below right upright of M of Tasmania.
- b) Break in top right corner of N of Tasmania (not constant).
- c) Sparse intermittent row of color flaws just above skyline (variable and not constant). Seen best on left side. Two copies seen, both in red-violet shade from the last printing.

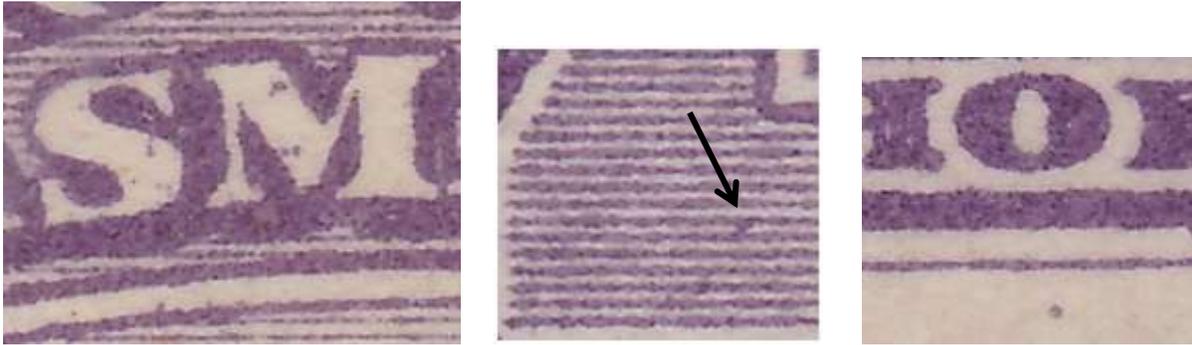
### UV-3

- a) Color flaws in SM of Tasmania (variable).
- b) Tiny color flaw in shading (between 6<sup>th</sup> and 7<sup>th</sup> lines up) in lower left panel wing (not constant).
- c) Color flaw below bottom frame below O of Hobart (not constant).

Note: This is probably from plate 28.

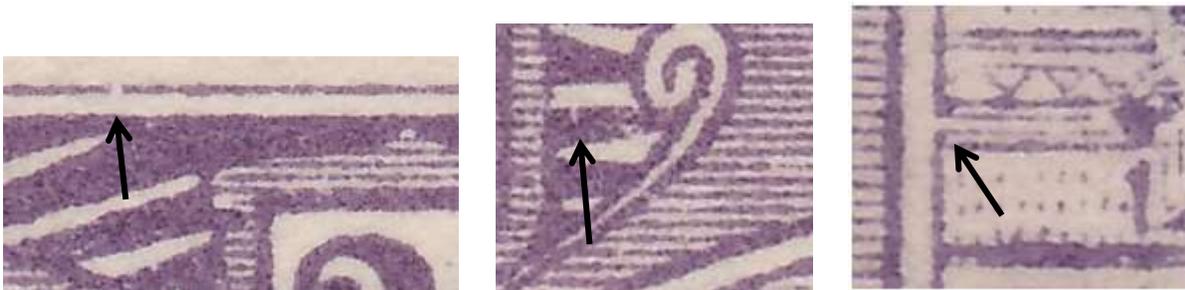
### UV-4

- a) Break in top frame, 6.5 mm from right corner.
- b) Tiny downward white spur on 3<sup>rd</sup> spoke from left (variable).
- c) Break in inner vignette frame adjacent to roof of shoreline building at left (not constant).
